**REPORT ON 2016-17 INSPECTION OF
LACDPW SCRDS FACILITIES**

**CONTRACT:STORMWATER CAPTURE RUBBER DAM
MAINTENANCE SERVICES (2014-IT001)**

AUGUST 20, 2018

RUBBER DAM INSPECTION REPORT

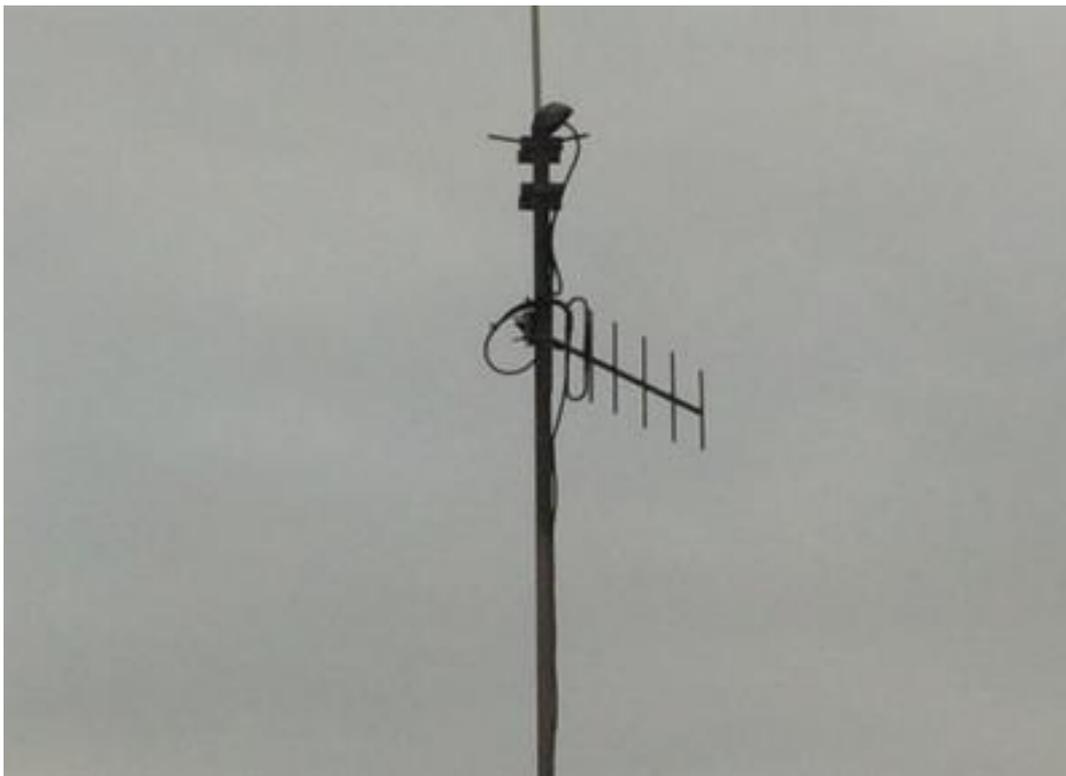
PHOTO 12

ANTENNA DETAIL

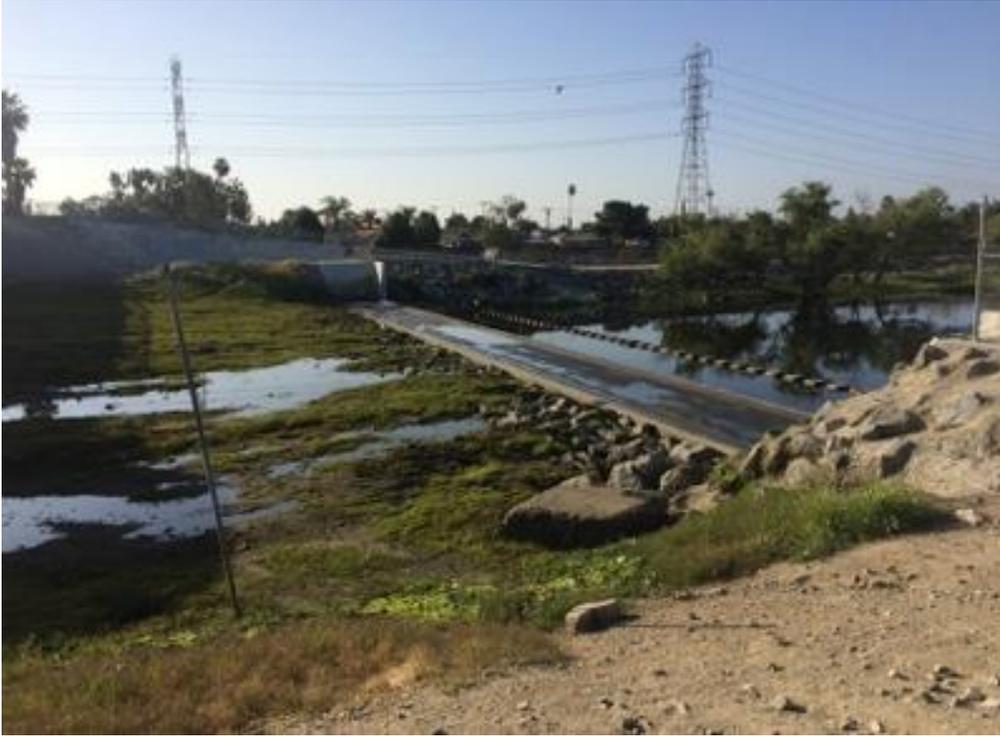
PHOTO 1

DEFLATED RUBBER DAM UPSTREAM VIEW

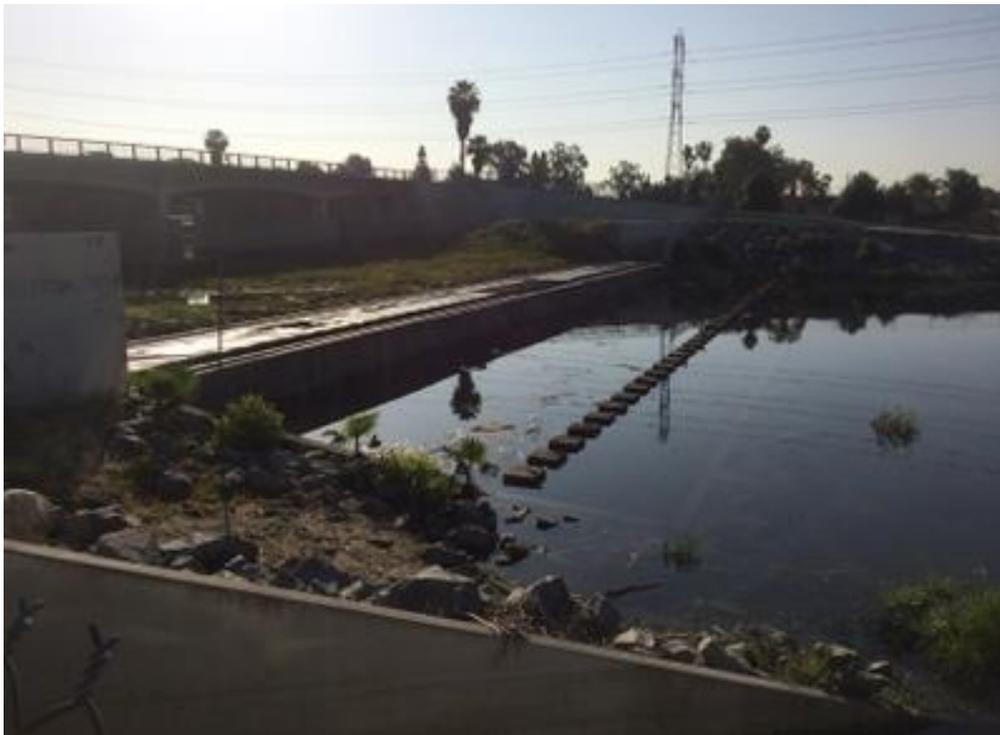
PHOTO 2

DEFLATED RUBBER DAM DOWNSTREAM VIEW

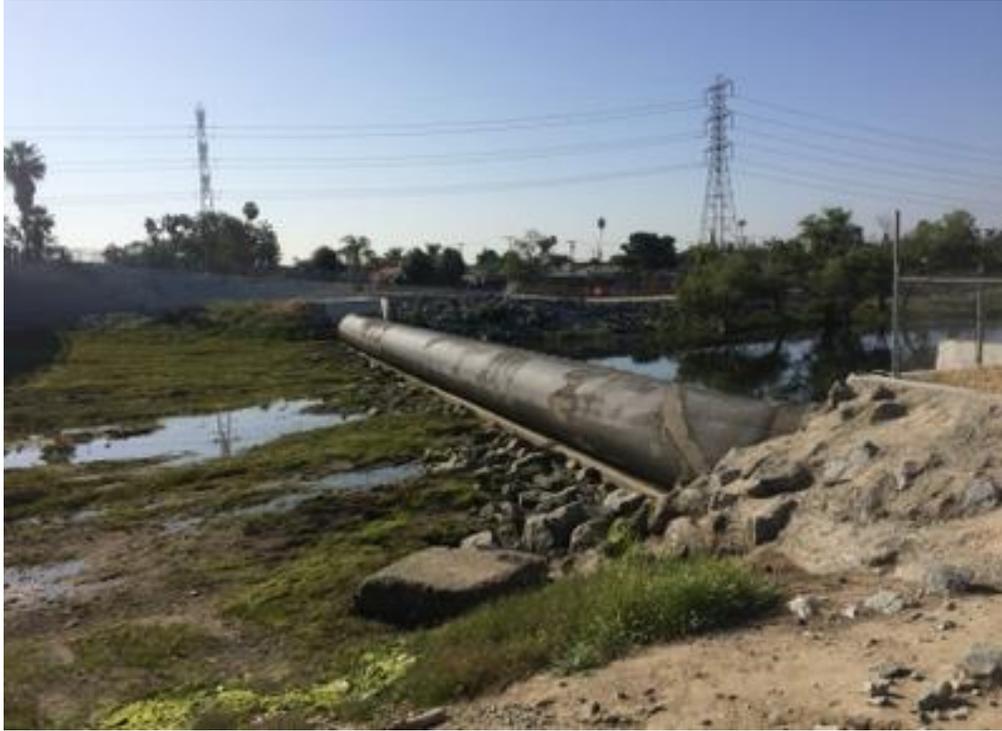
PHOTO 3

INFLATED RUBBER DAM UPSTREAM VIEW

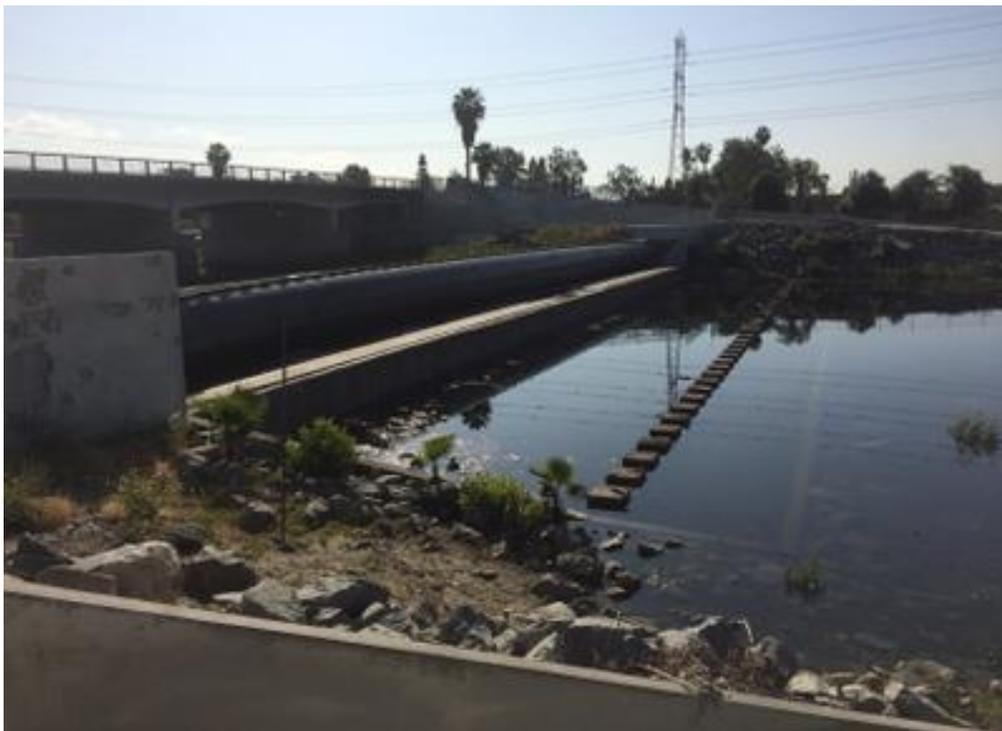
PHOTO 4

INFLATED RUBBER DAM DOWNSTREAM VIEW

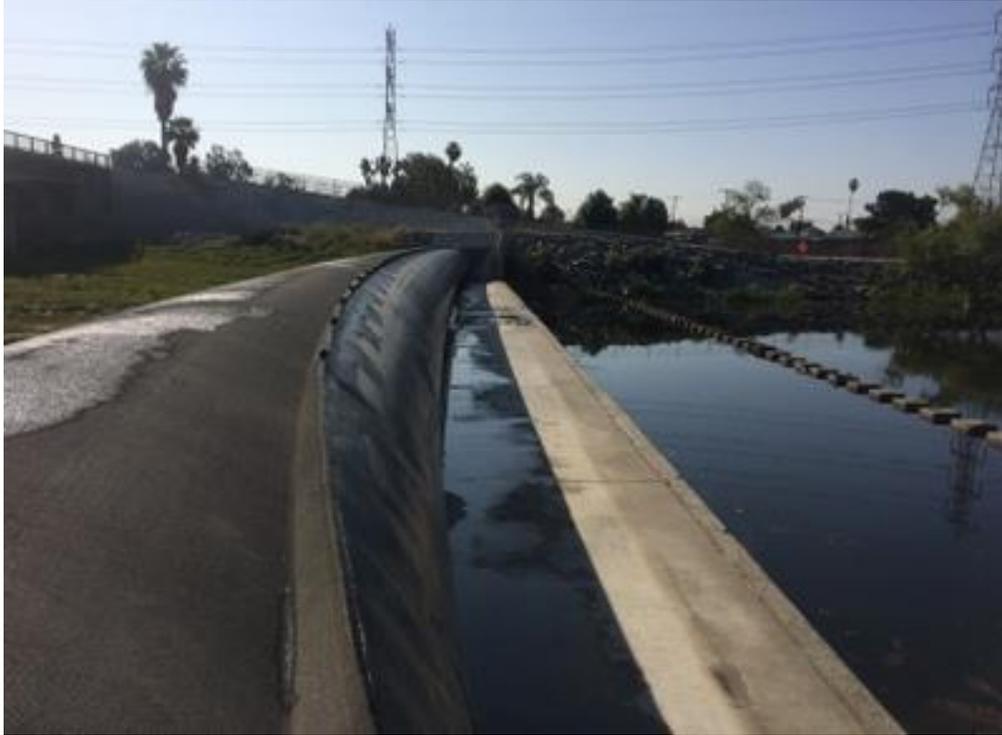
PHOTO 5

INFLATED RUBBER DAM UNDER FIN RIGHT ABUTMENT

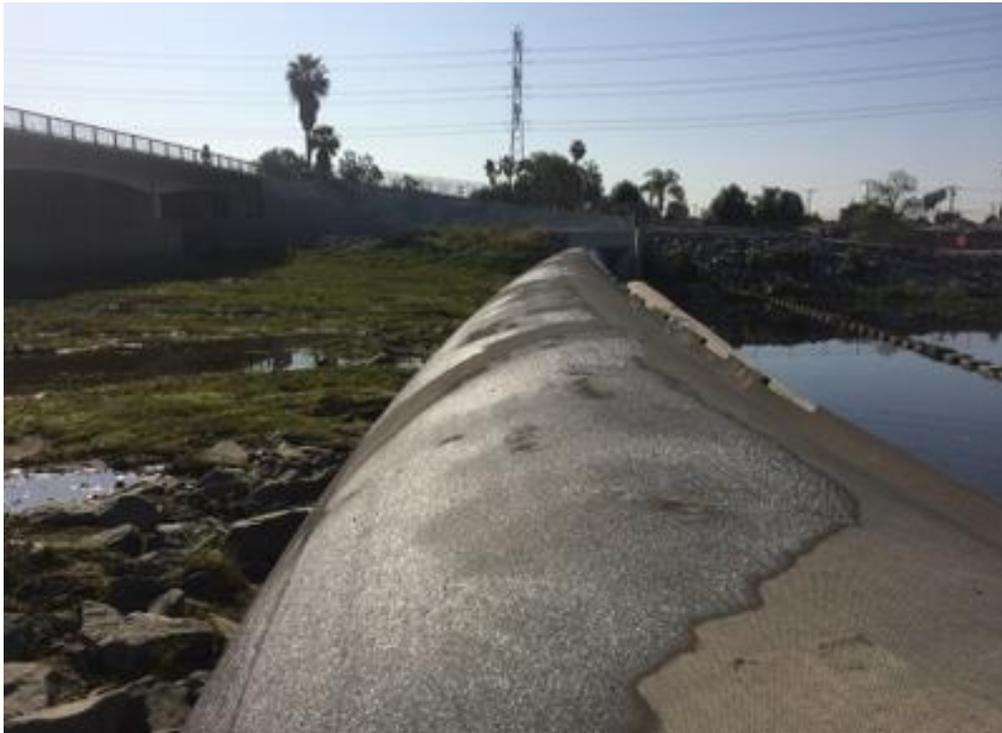
PHOTO 6

INFLATED RUBBER DAM TOP VIEW RIGHT ABUTMENT

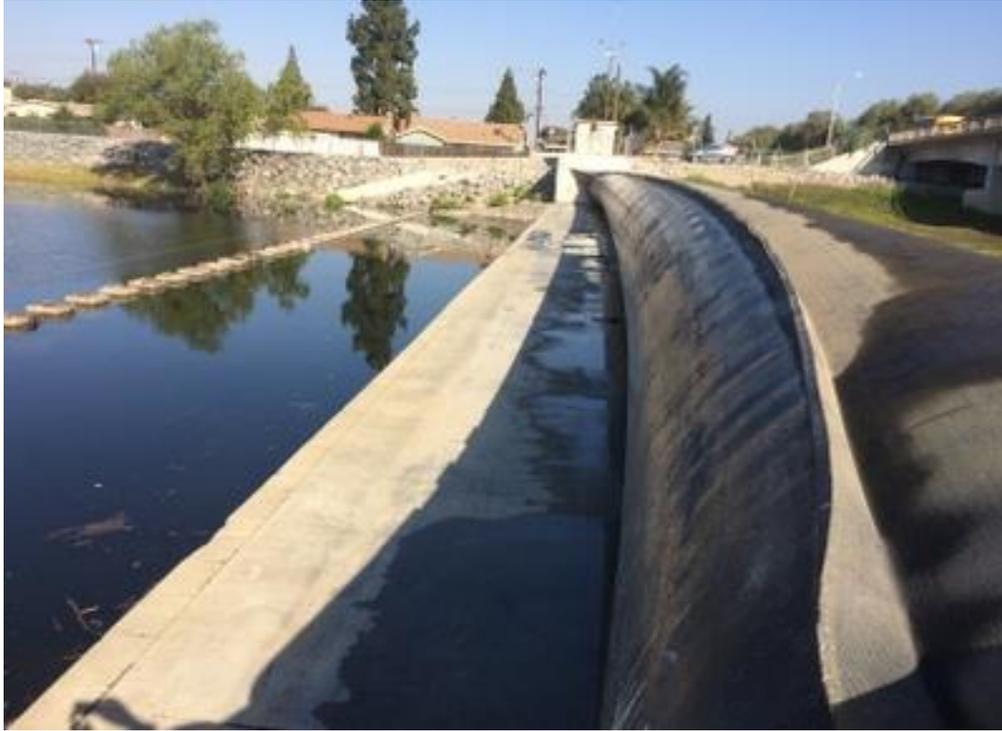
PHOTO 7

INFLATED RUBBER DAM UNDER FIN LEFT ABUTMENT

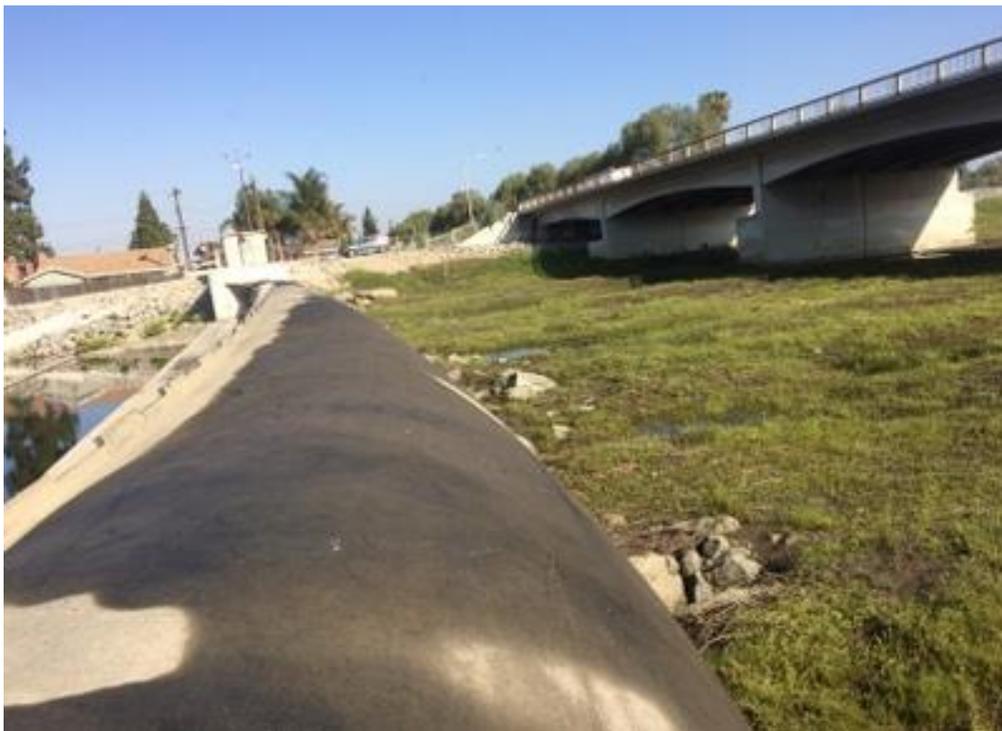
PHOTO 8

INFLATED RUBBER DAM TOP VIEW LEFT ABUTMENT

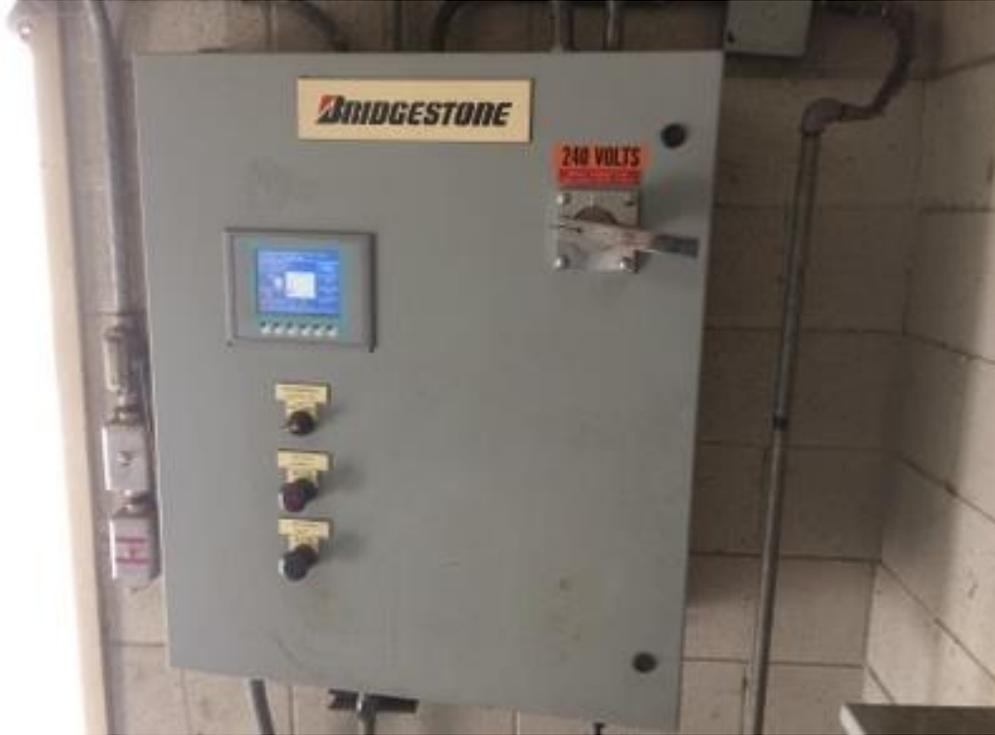
PHOTO 9 CONTROL PANEL EXTERIOR VIEW

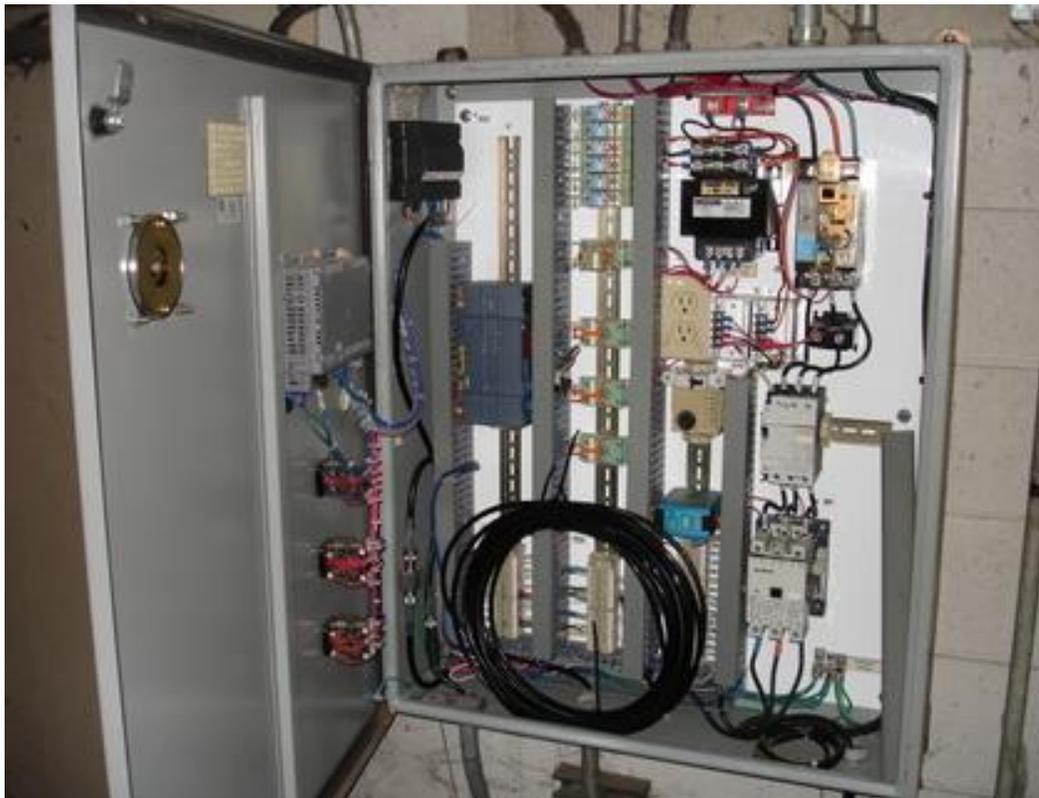
PHOTO 10 CONTROL PANEL INTERIOR VIEW

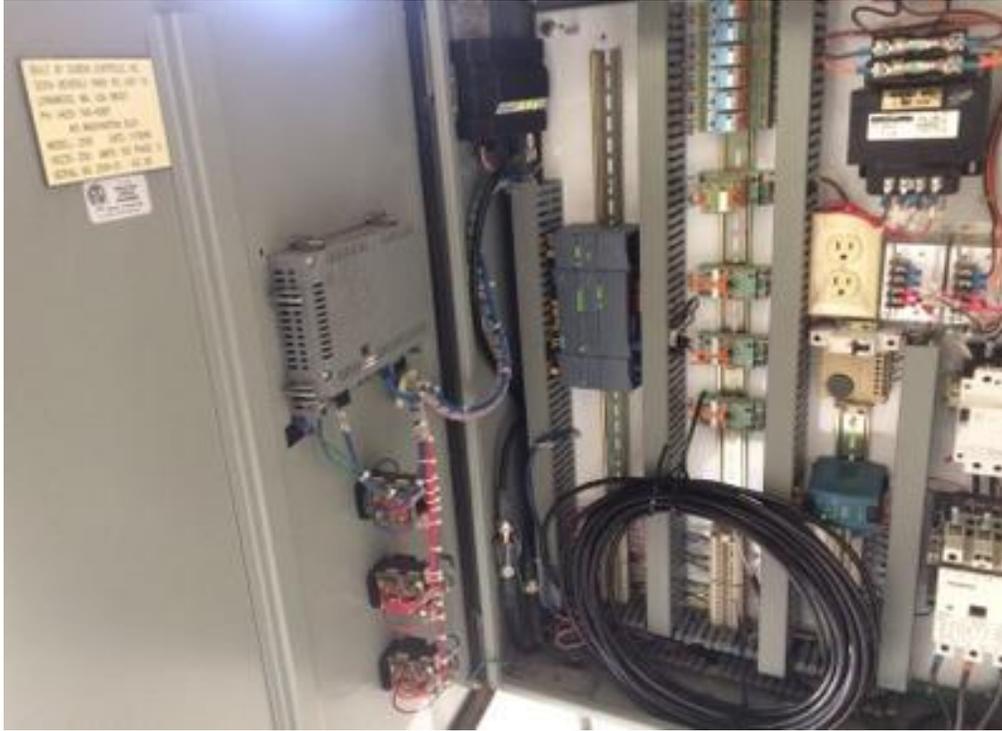
PHOTO 11 RADIO EQUIPMENT

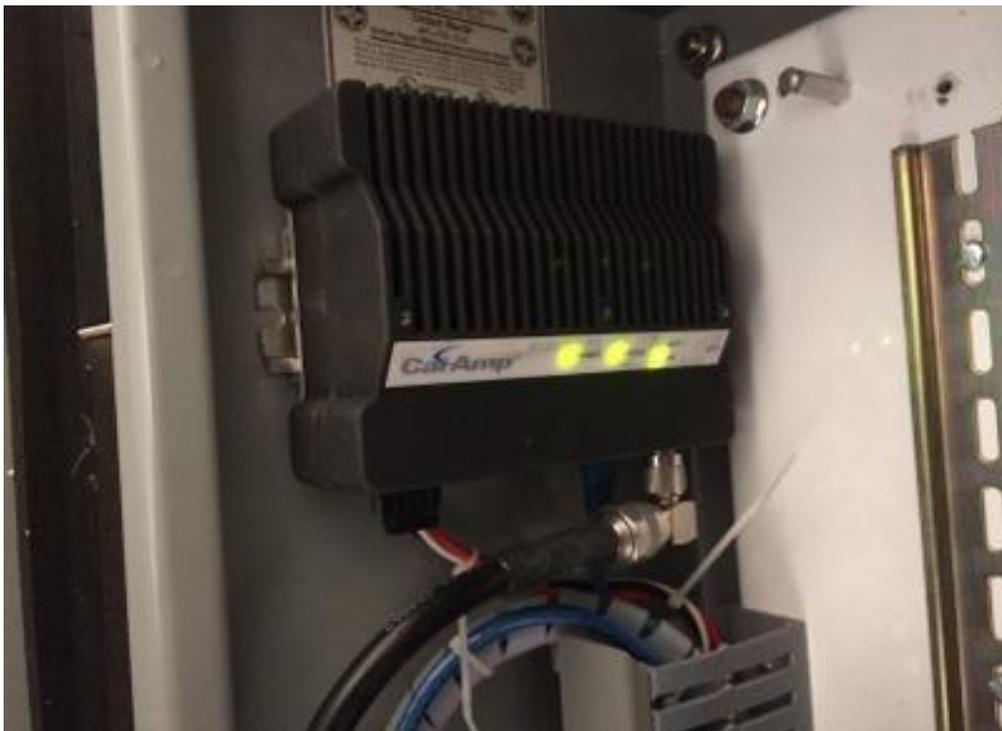
PHOTO 12 RADIO EQUIPMENT DETAIL

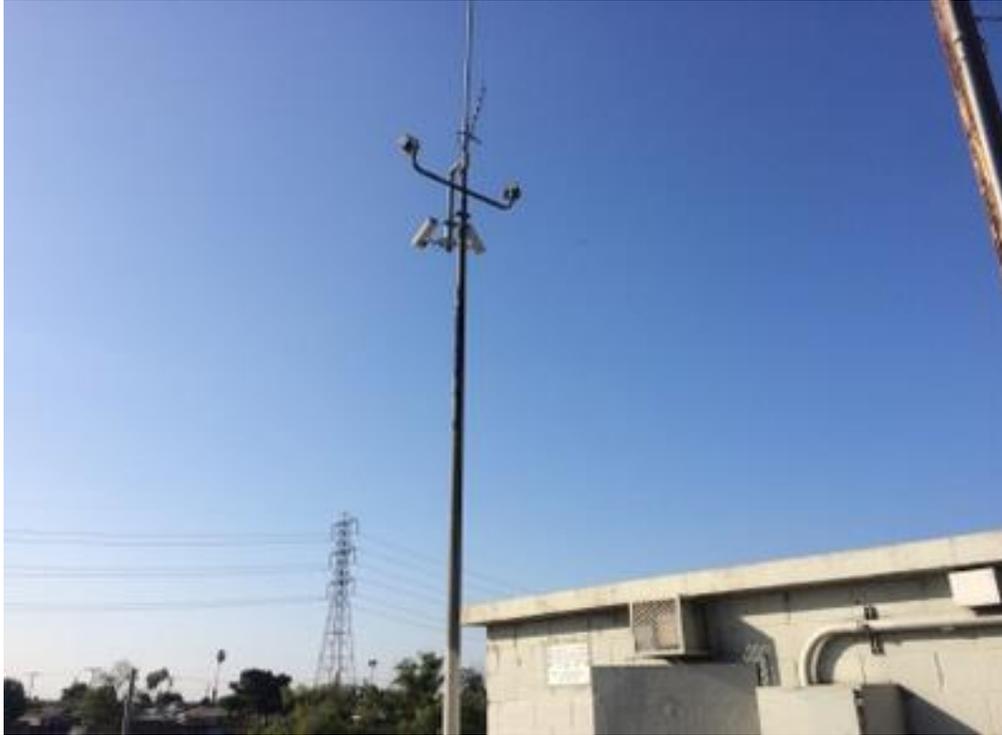
PHOTO 13

ANTENNA MAST

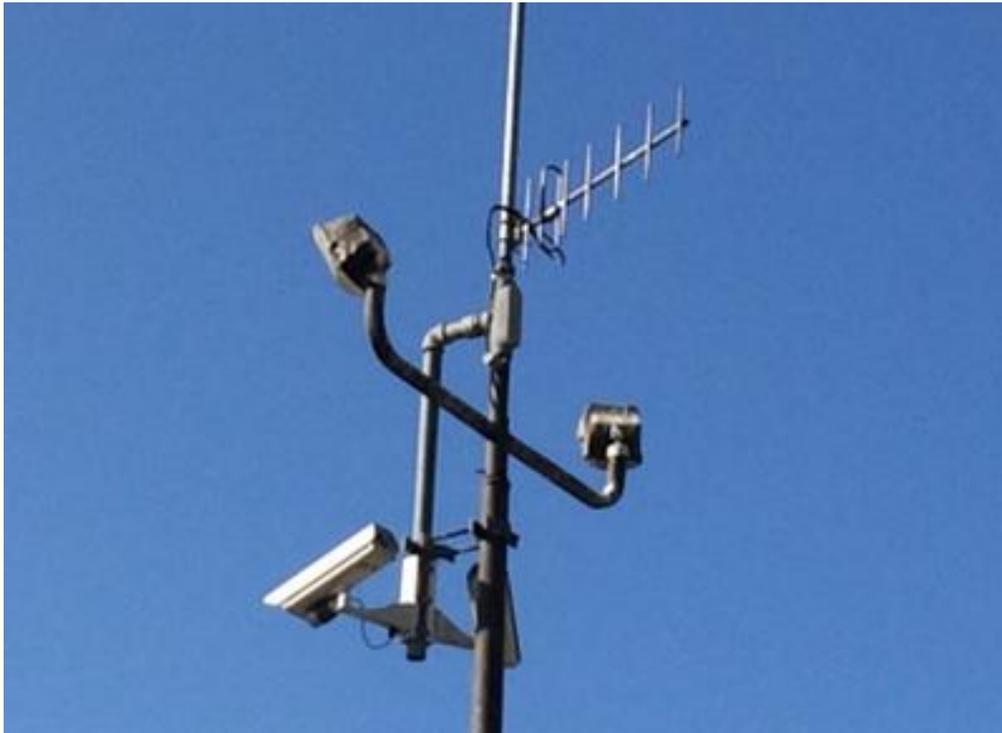
PHOTO 14

ANTENNA DETAIL

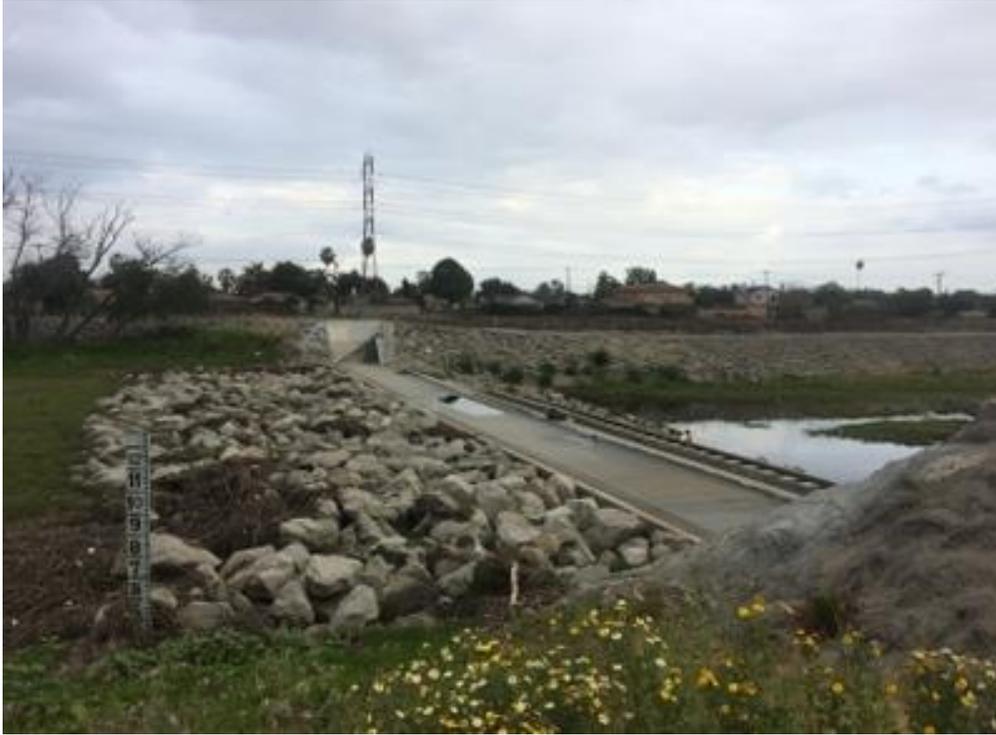
PHOTO 1

DEFLATED RUBBER DAM UPSTREAM VIEW

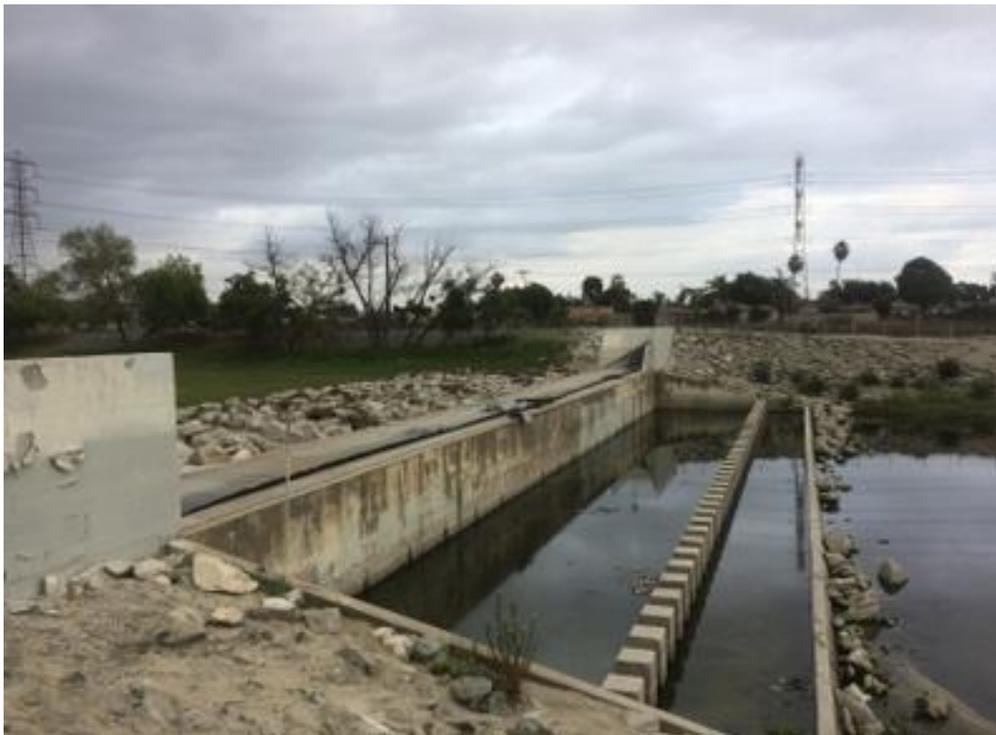
PHOTO 2

DEFLATED RUBBER DAM DOWNSTREAM VIEW

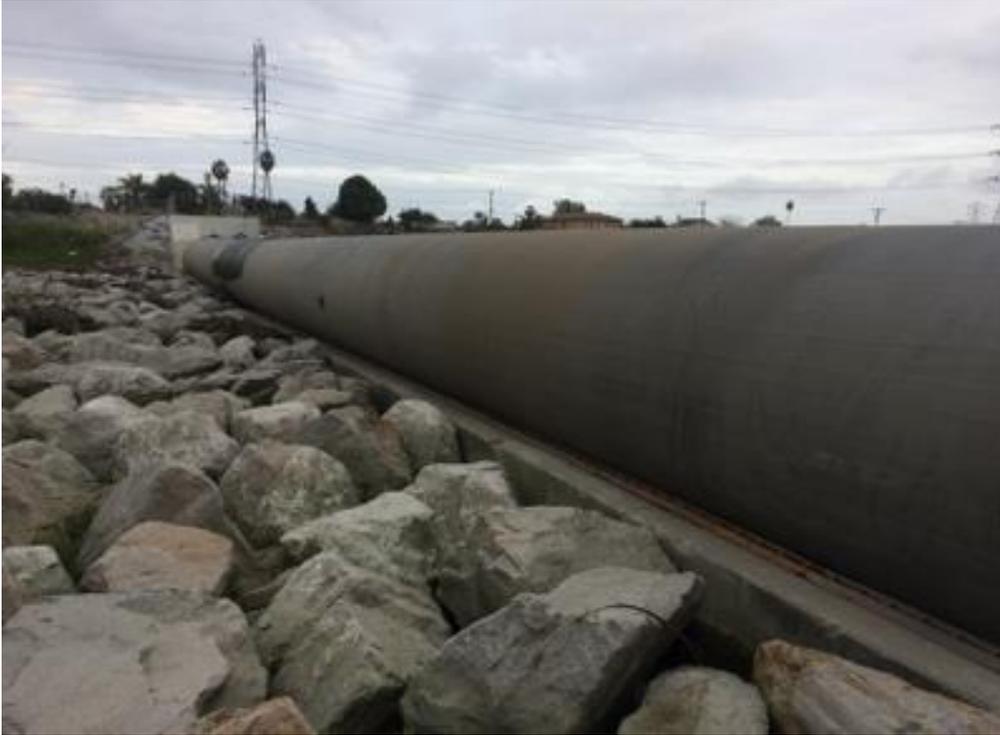
PHOTO 3

INFLATED RUBBER DAM UPSTREAM VIEW

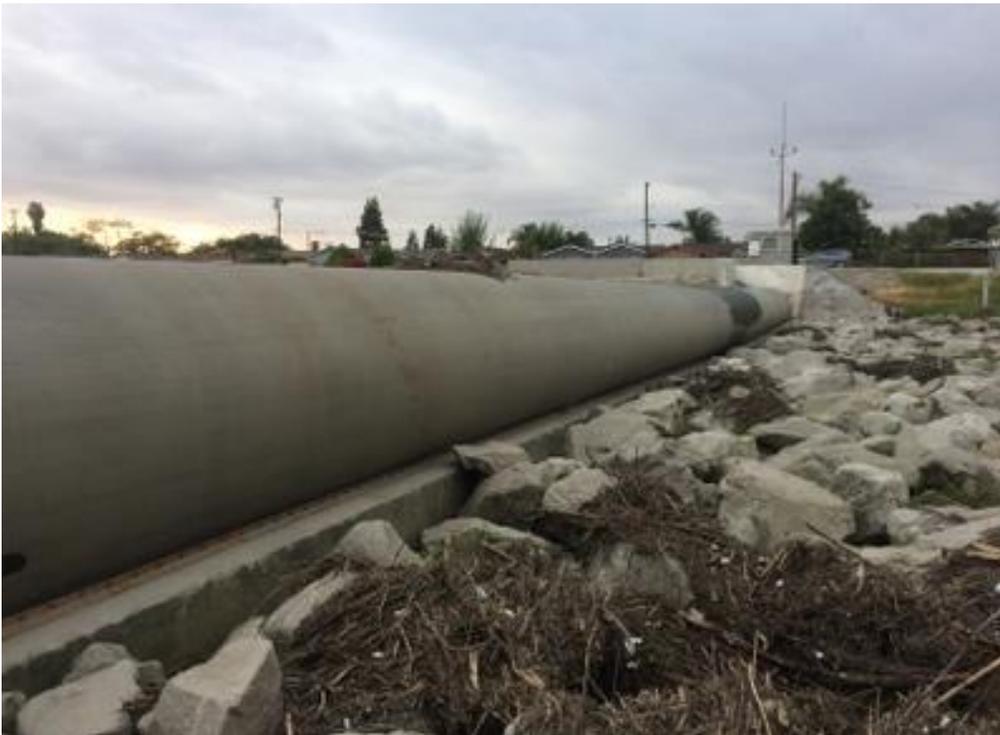
PHOTO 4

INFLATED RUBBER DAM DOWNSTREAM VIEW

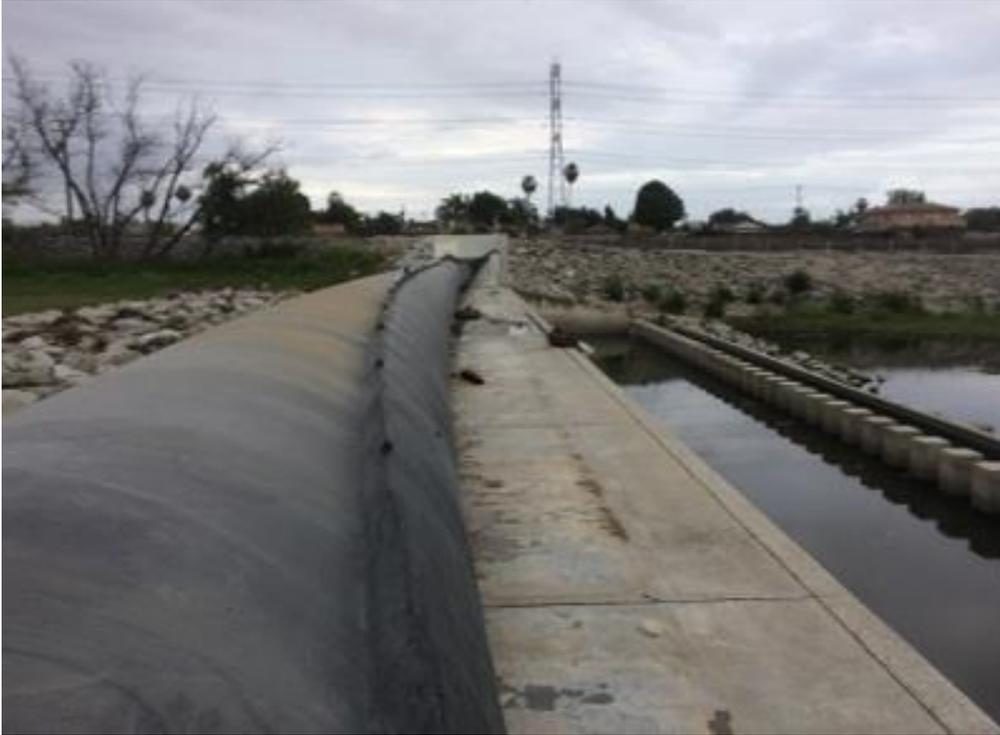
PHOTO 5

RIGHT ABUTMENT UNDER FIN

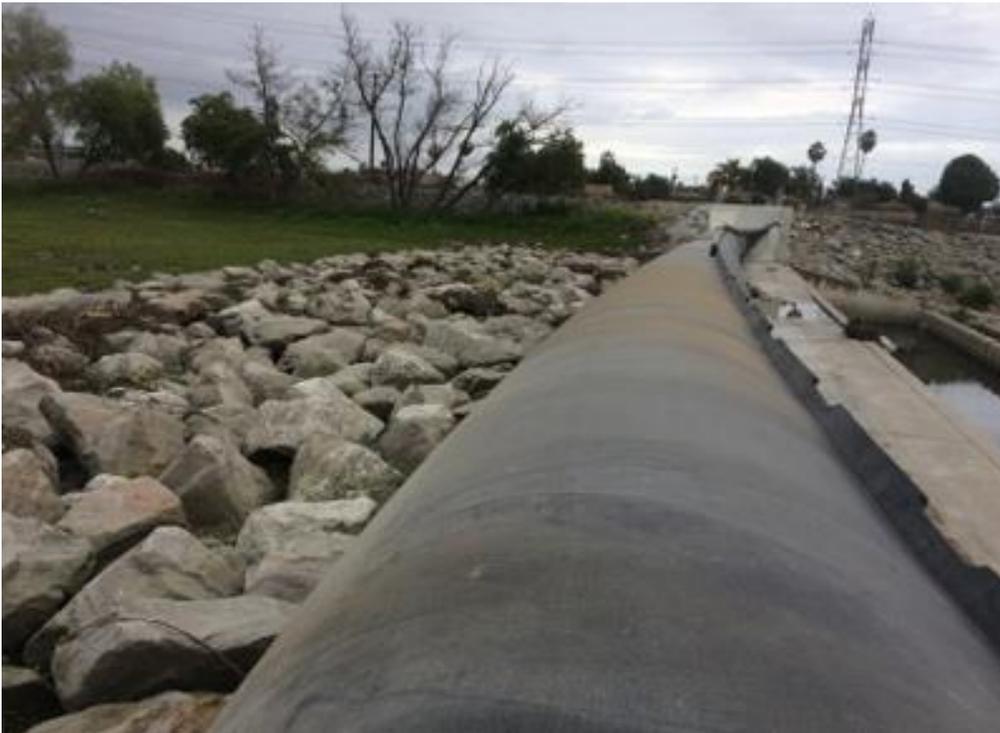
PHOTO 6

RIGHT ABUTMENT ON TOP

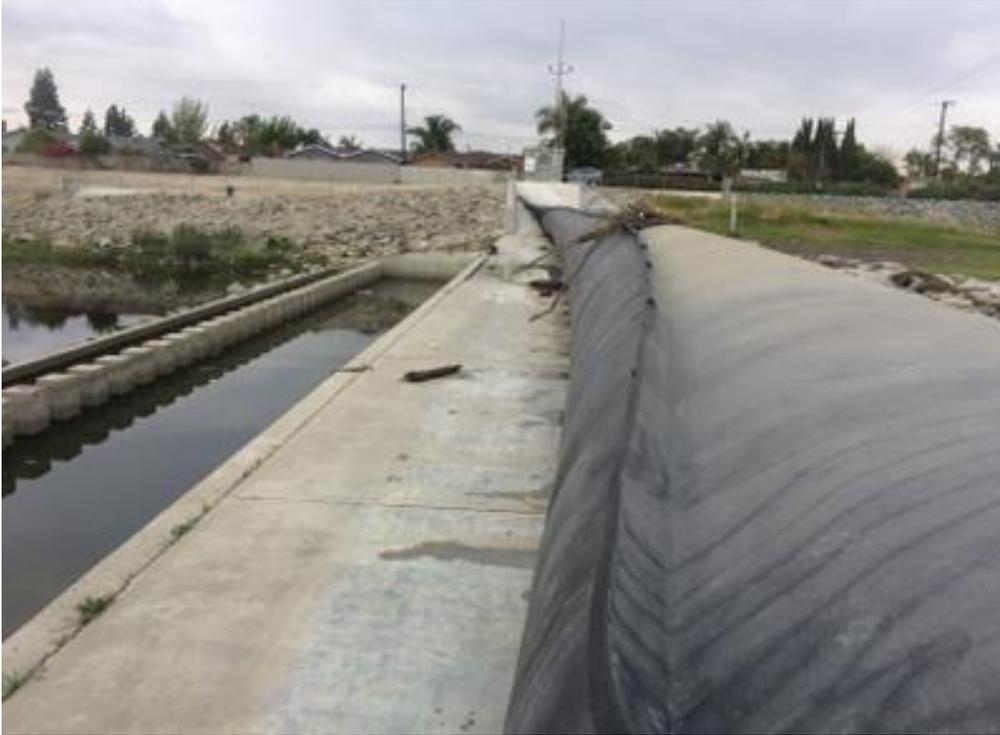
PHOTO 7 LEFT ABUTMENT UNDER FIN

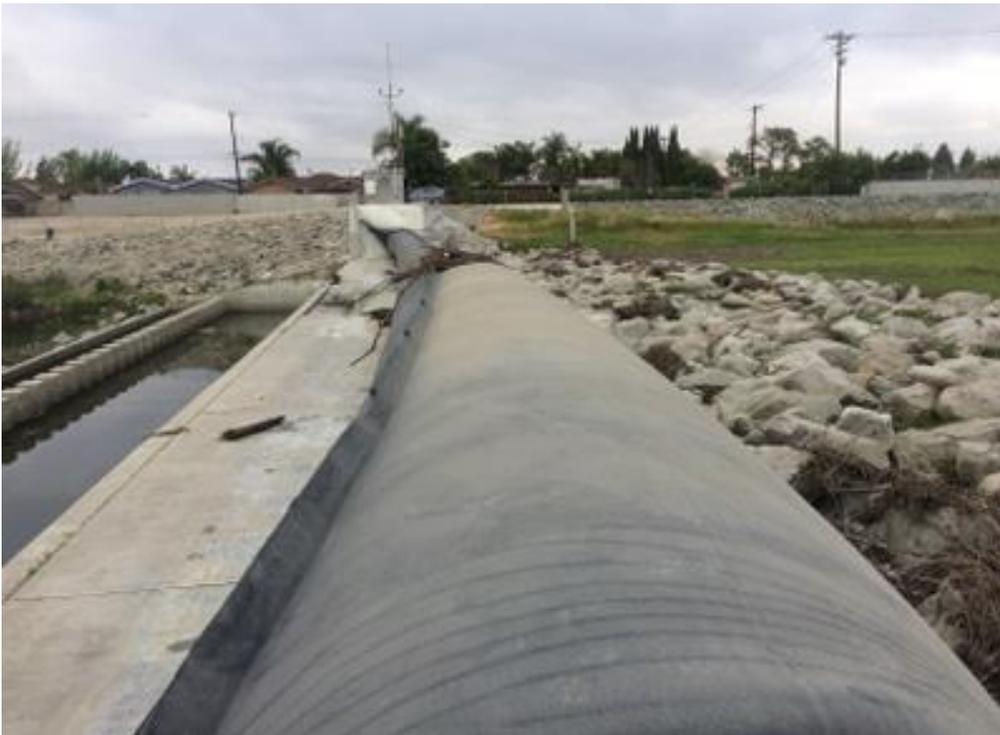
PHOTO 8 LEFT ABUTMENT ON TOP

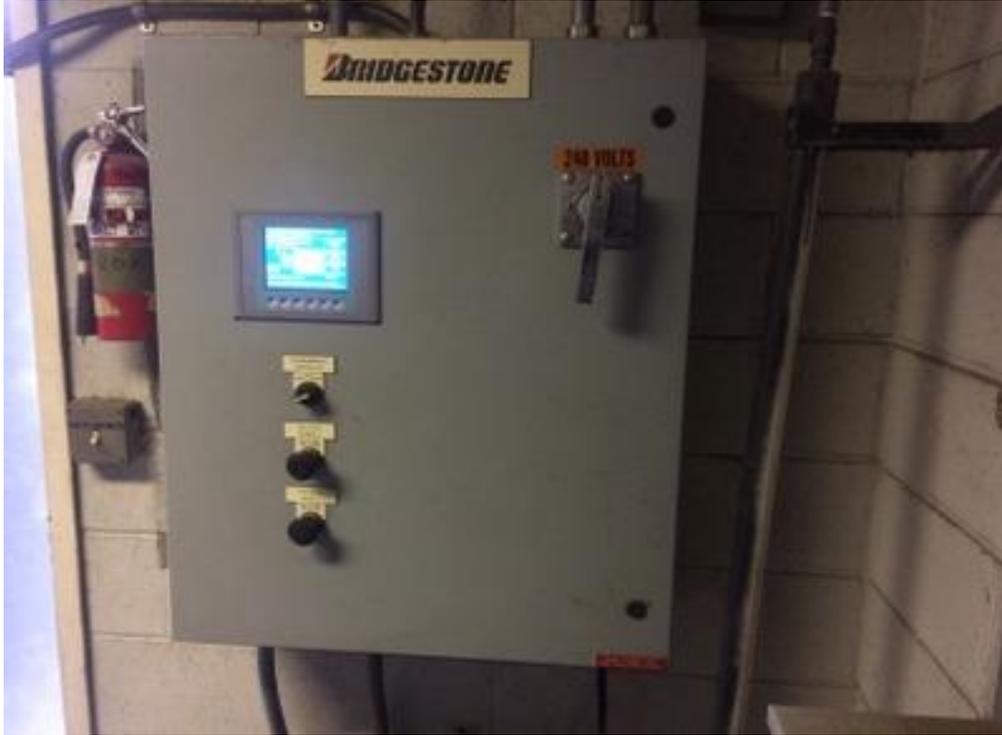
PHOTO 9 CONTROL PANEL EXTERIOR VIEW

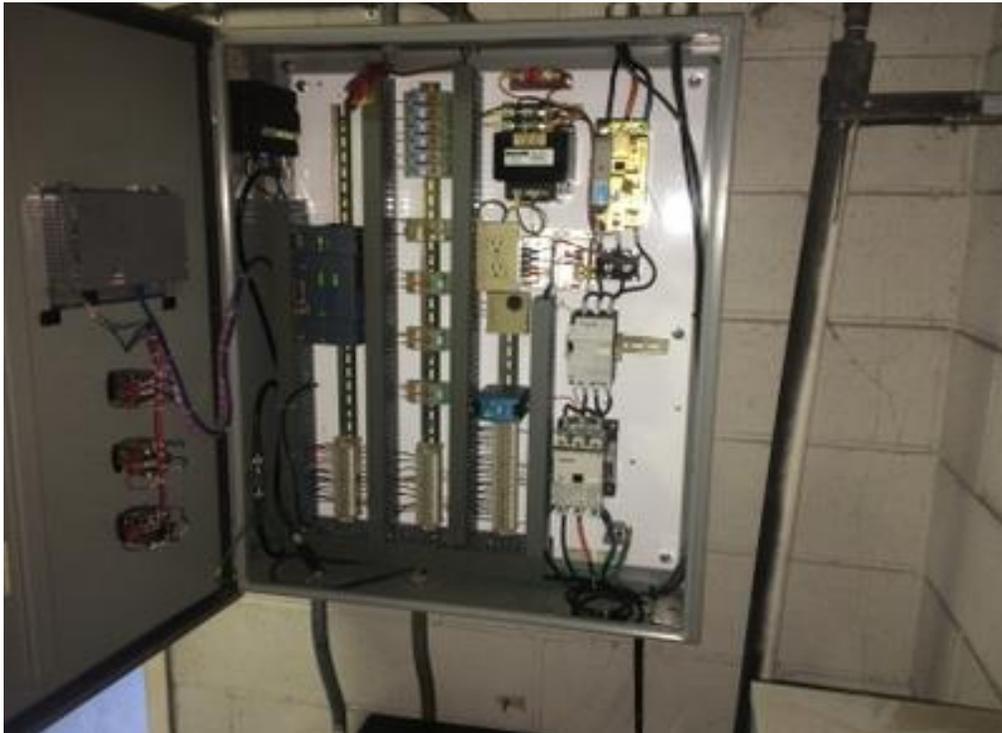
PHOTO 10 CONTROL PANEL INTERIOR VIEW

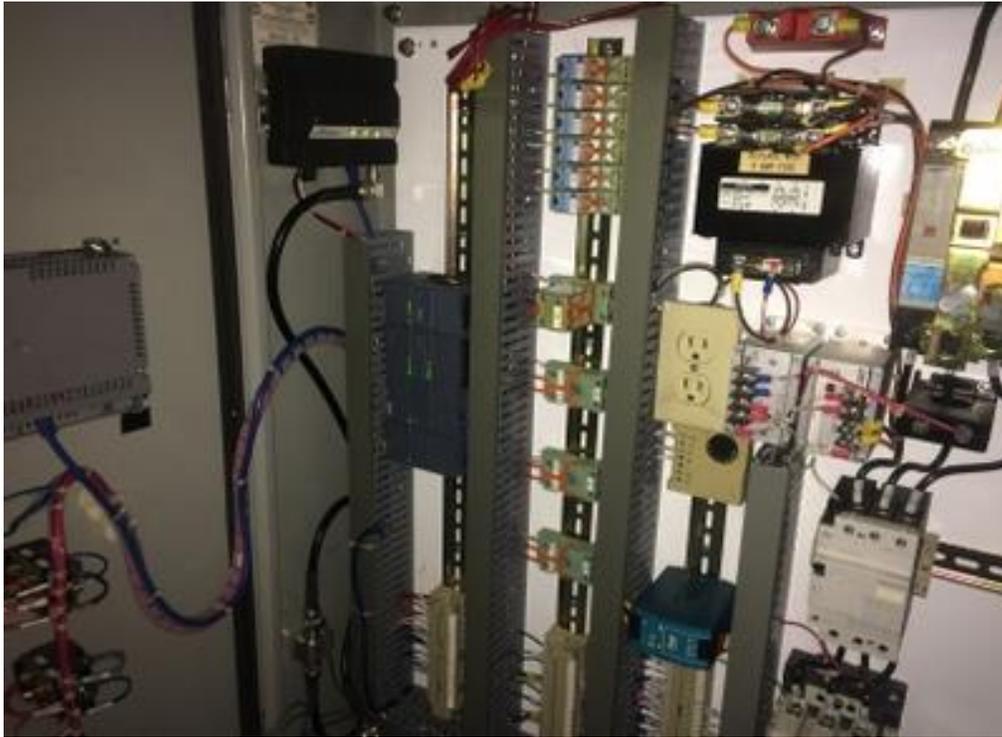
PHOTO 11 RADIO EQUIPMENT

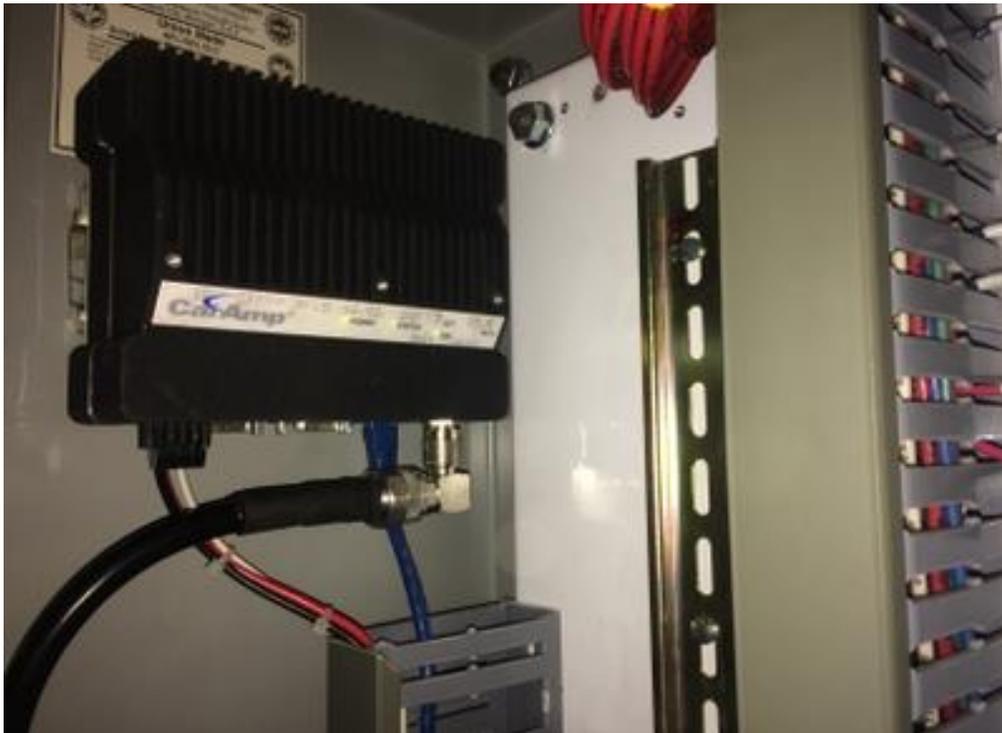
PHOTO 12 RADIO EQUIPMENT DETAIL

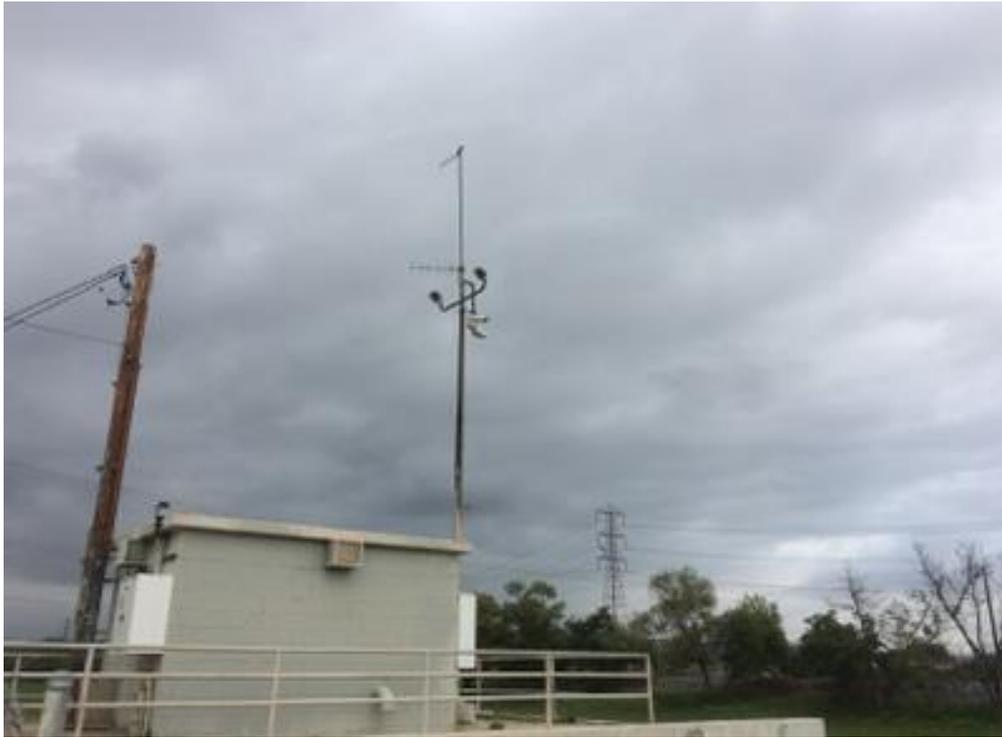
PHOTO 13

RADIO ANTENNA

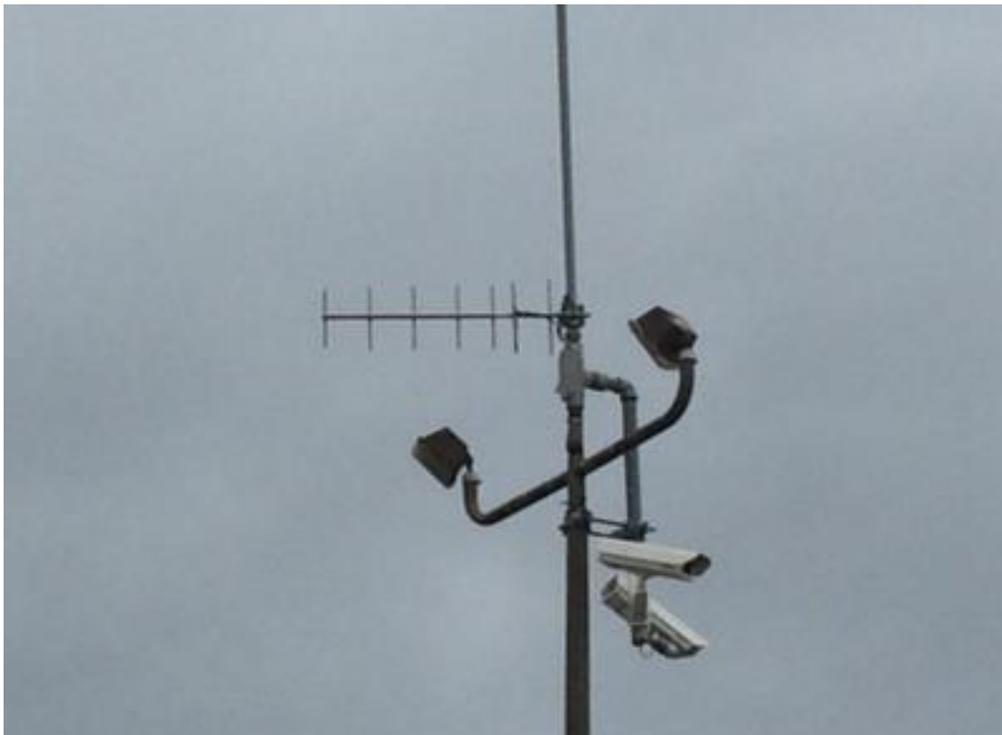
PHOTO 14

ANTENNA DETAIL

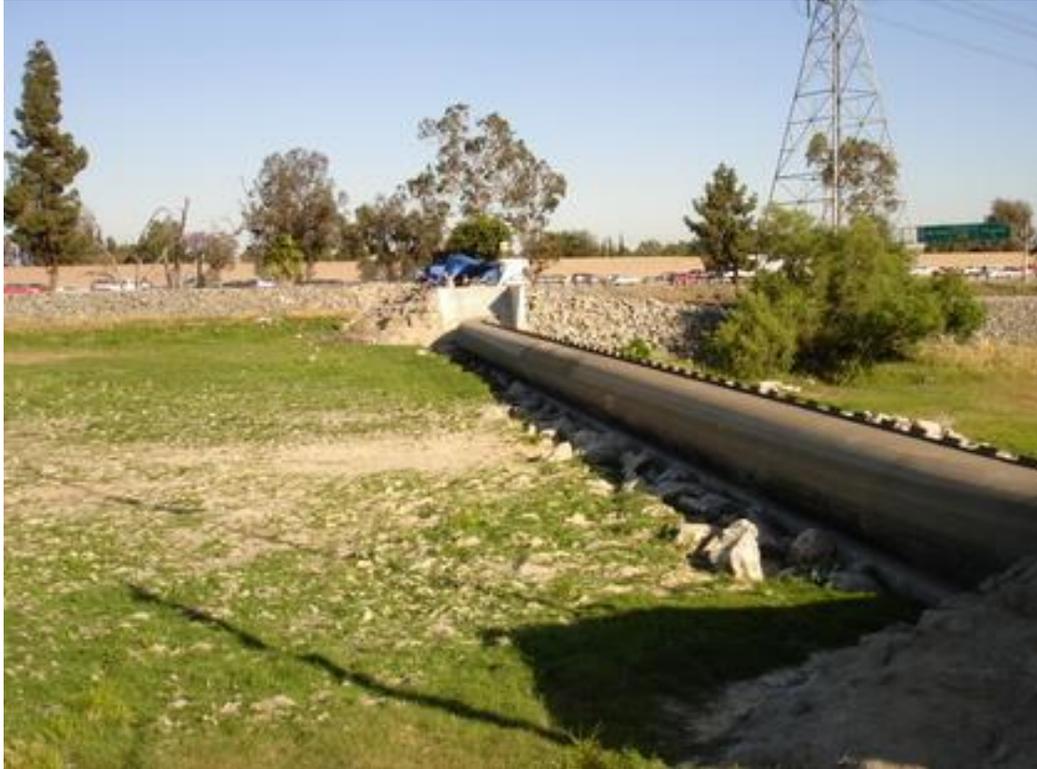
PHOTO 1 INFLATED RUBBER DAM UPSTREAM VIEW (2017)

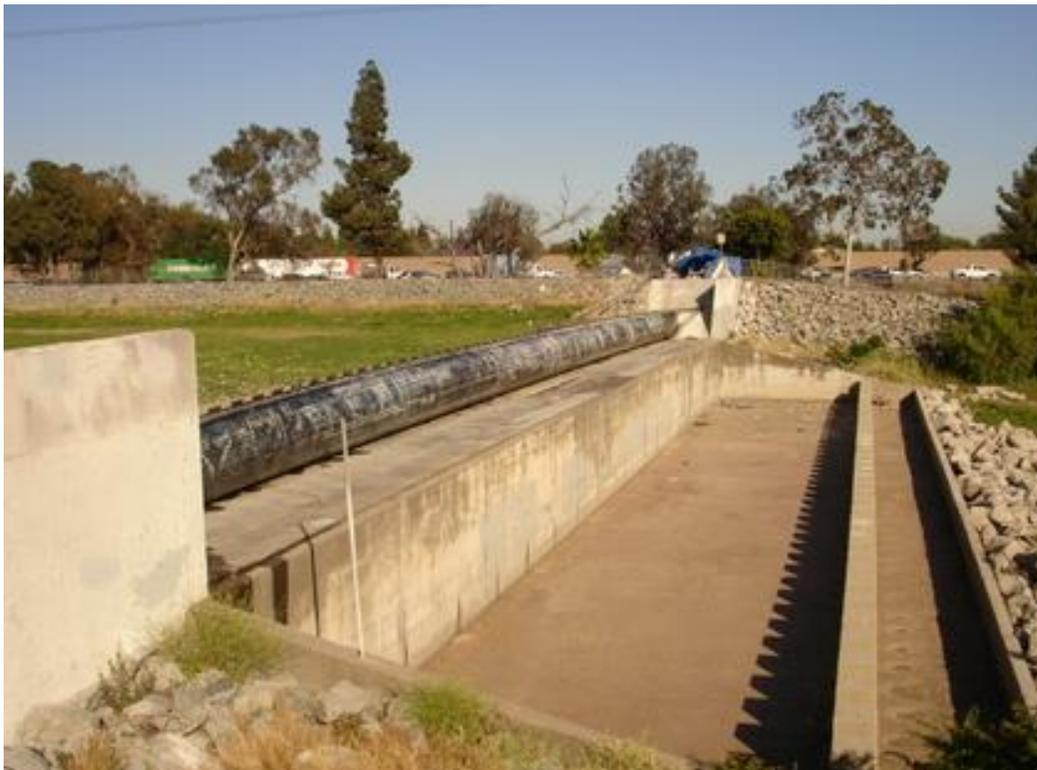
PHOTO 2 INFLATED RUBBER DAM DOWNSTREAM VIEW (2017)
