**REPORT ON 2016-17 INSPECTION OF
LACDPW SCRDS FACILITIES**

**CONTRACT:STORMWATER CAPTURE RUBBER DAM
MAINTENANCE SERVICES (2014-IT001)**

AUGUST 20, 2018

RUBBER DAM INSPECTION REPORT

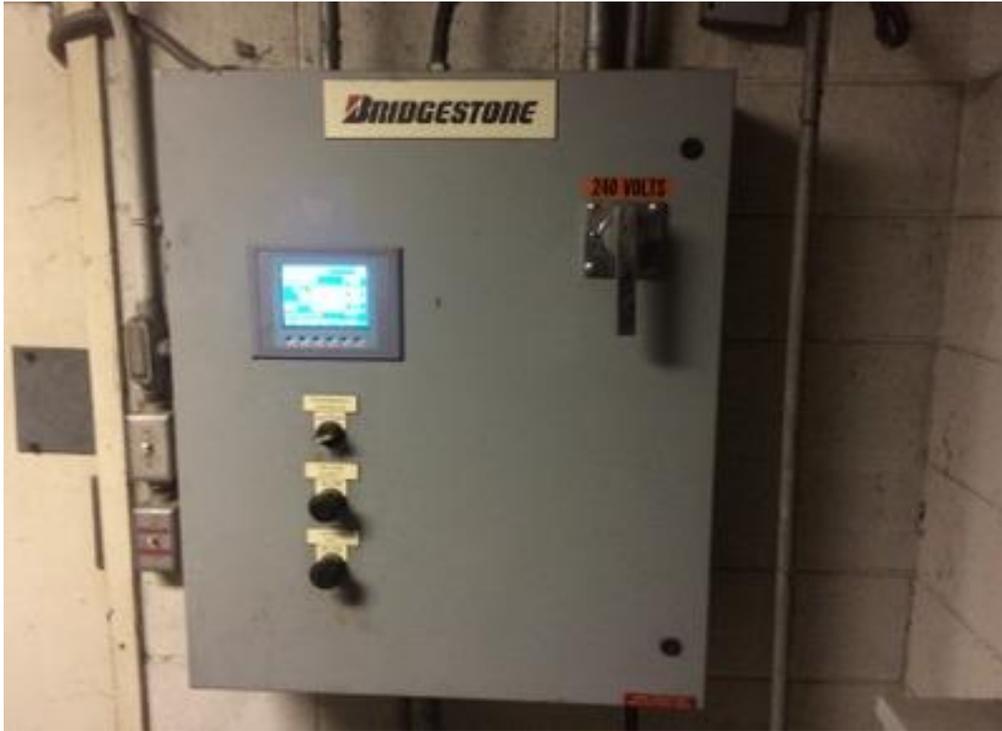
PHOTO 7 CONTROL PANEL EXTERIOR VIEW

- 1) Replace Rubber Dam.
- 2) Replace UPS.
- 3) Replace bolt at right abutment.

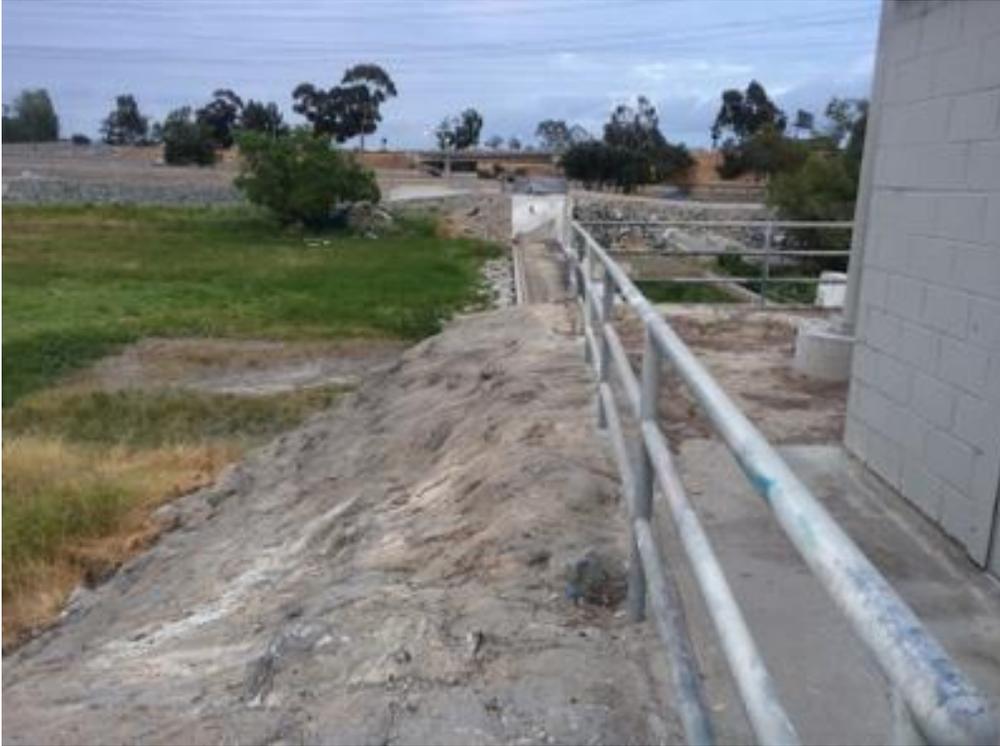
PHOTO 1 DEFLATED DAM UPSTREAM VIEW

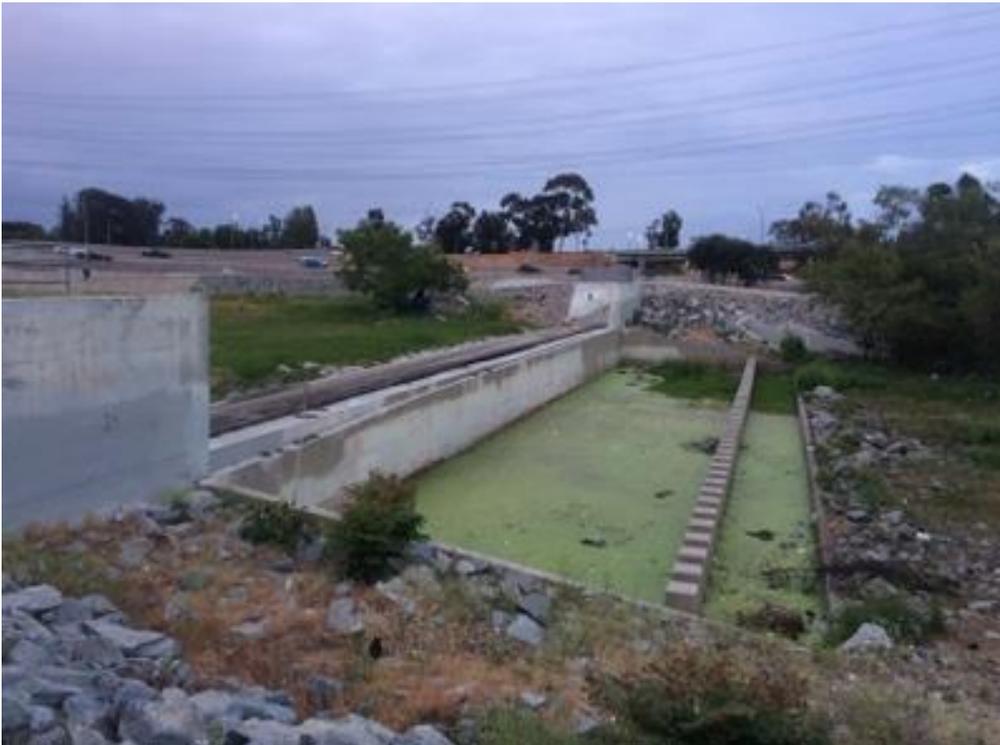
PHOTO 2 DEFLATED DAM DOWNSTREAM VIEW

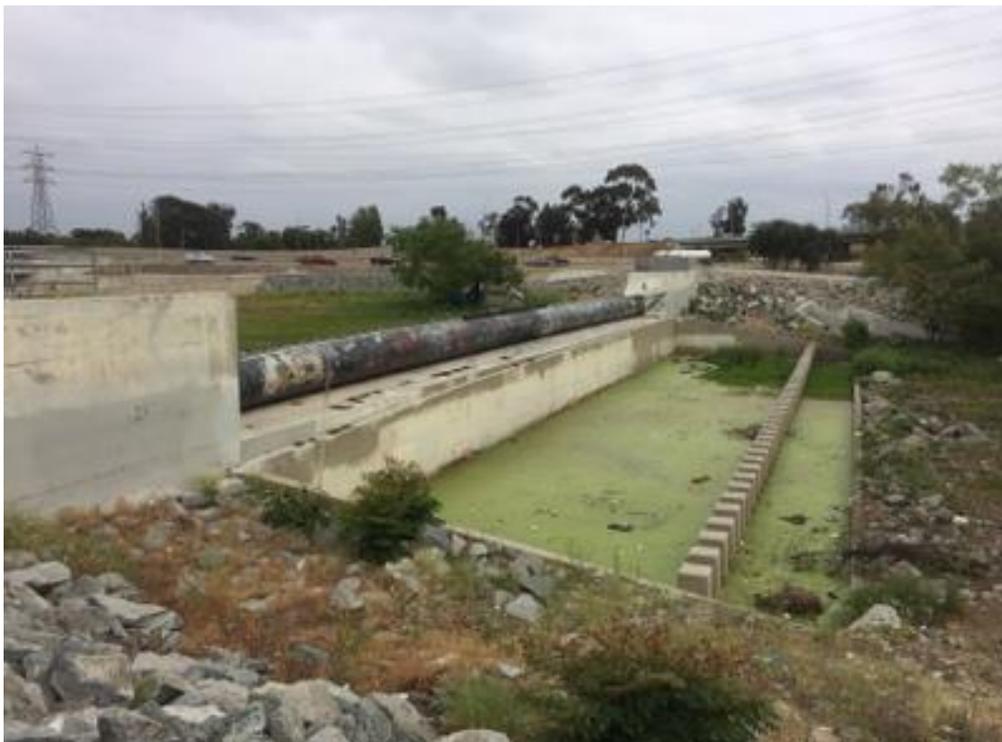
PHOTO 4

INFLATED DAM DOWNSTREAM VIEW

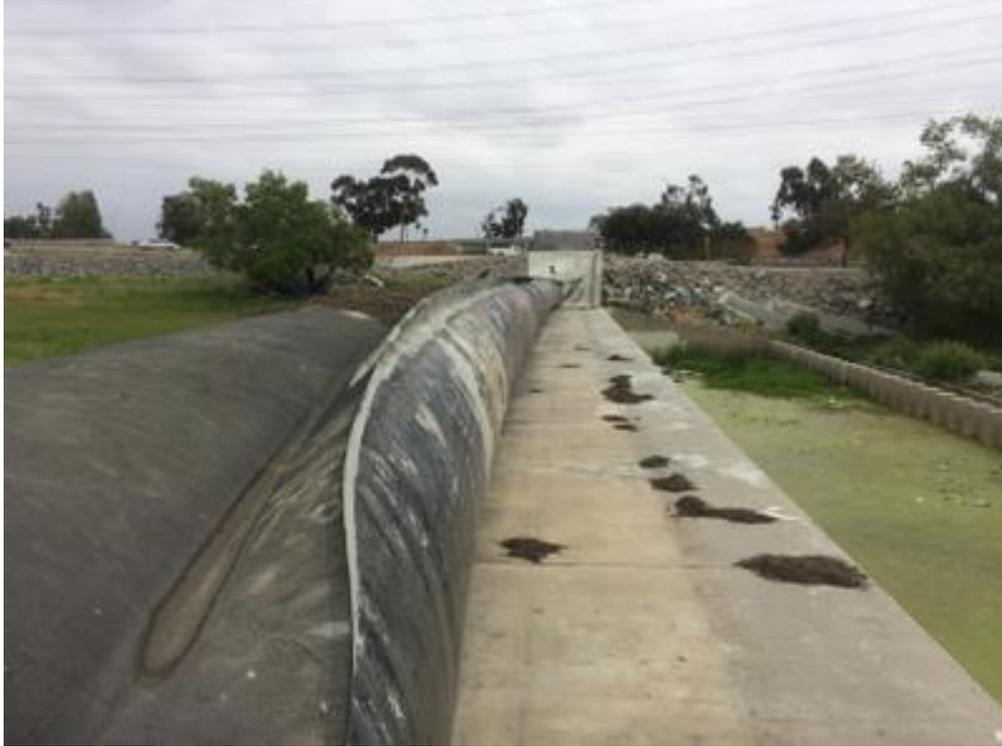
PHOTO 5

INFLATED RUBBER DAM UNDER FIN RIGHT ABUTMENT

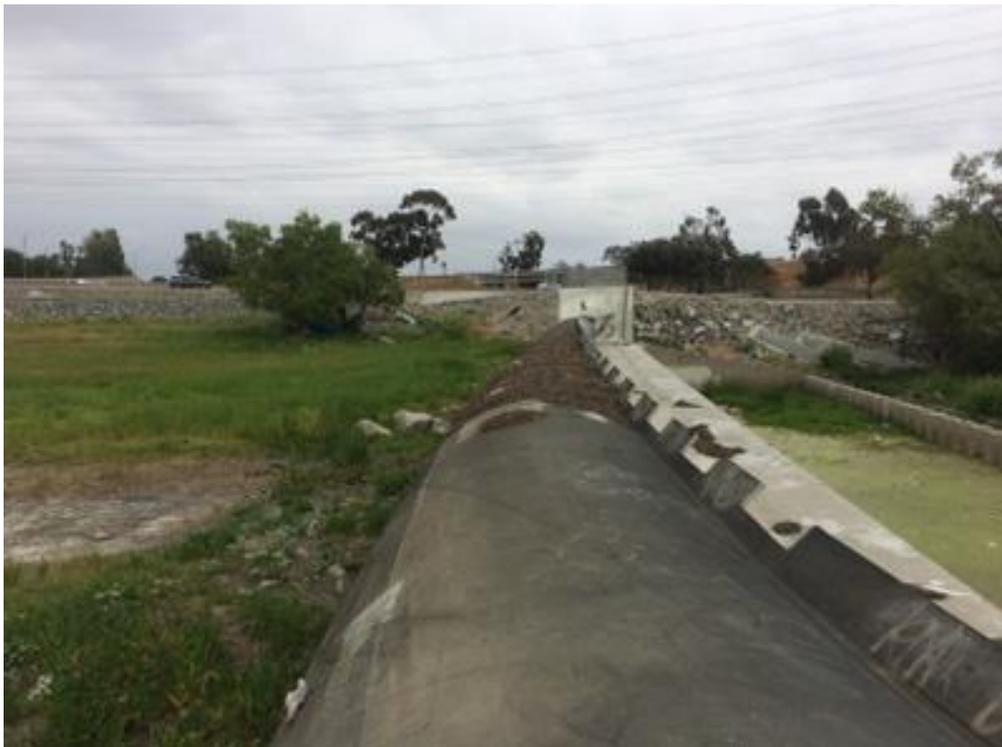
PHOTO 6

INFLATED RUBBER DAM TOP VIEW RIGHT ABUTMENT

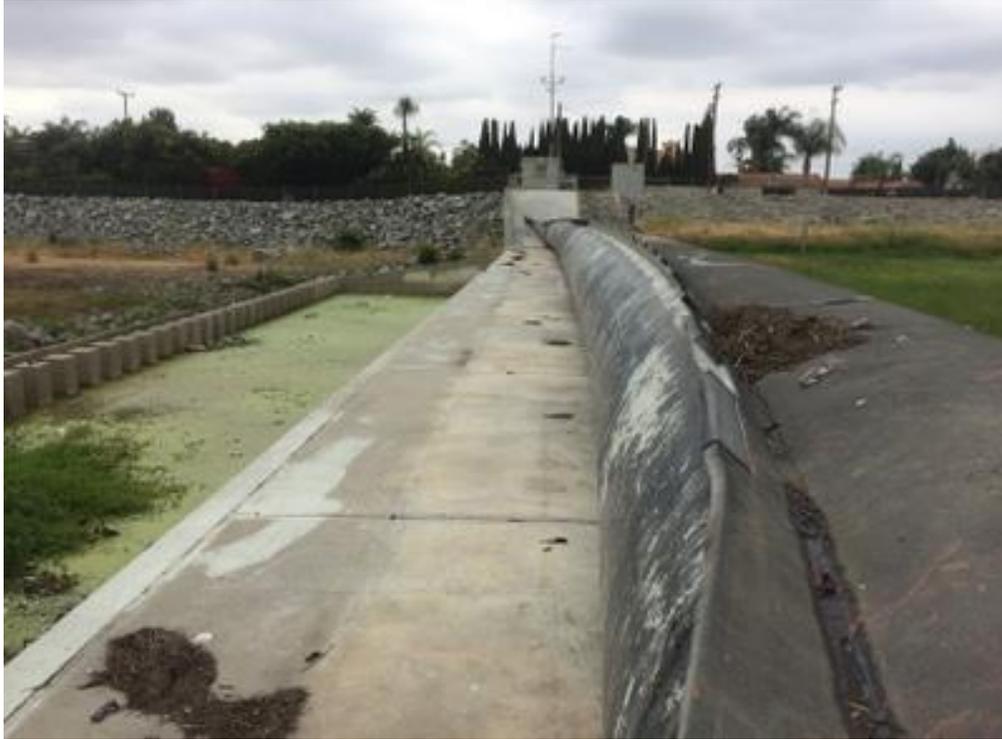
PHOTO 7

INFLATED RUBBER DAM UNDER FIN LEFT ABUTMENT

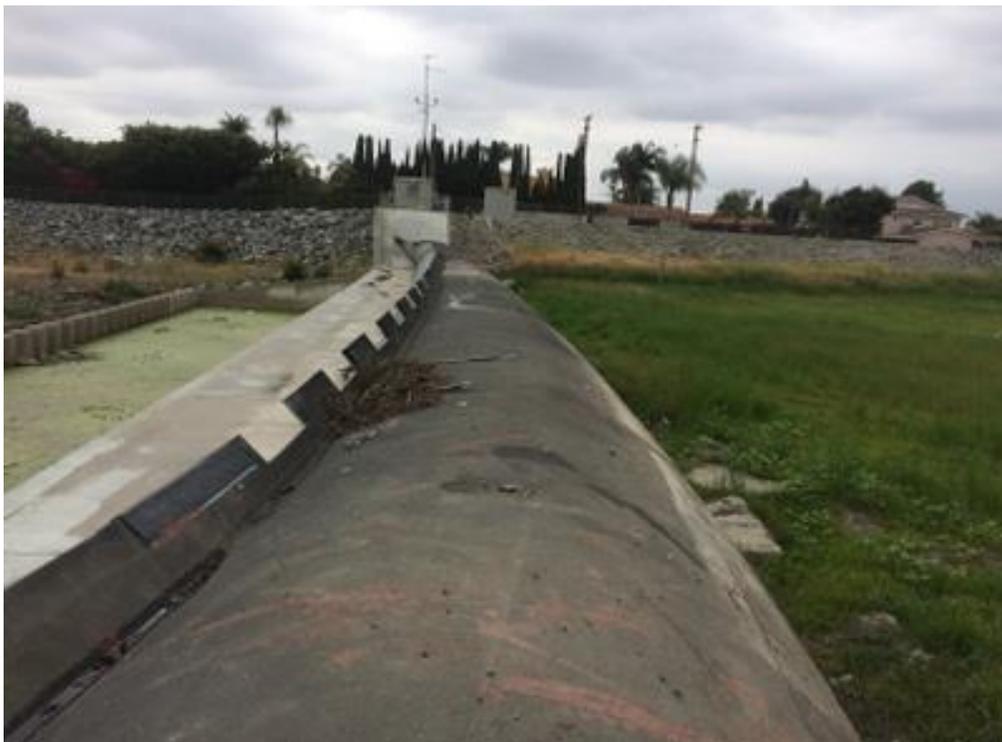
PHOTO 8

INFLATED RUBBER DAM TOP VIEW LEFT ABUTMENT

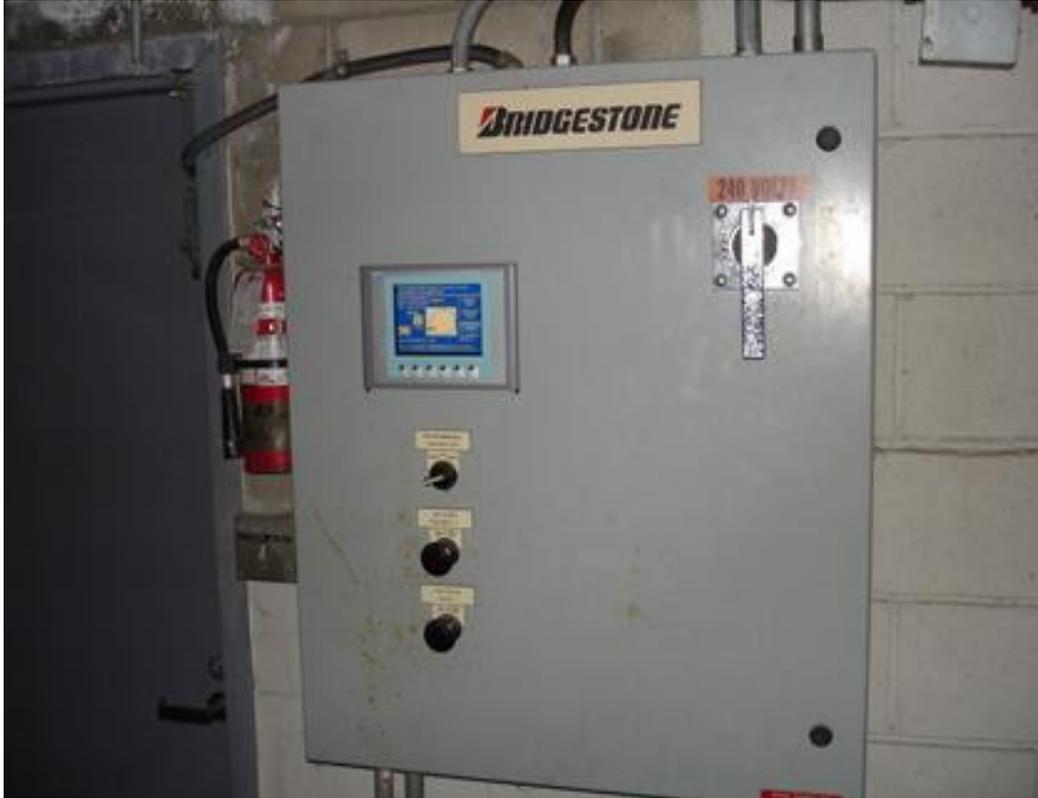
PHOTO 9 CONTROL PANEL EXTERIOR VIEW (2017)

1) Replace UPS and tie in to PLC Programming & Alarms.

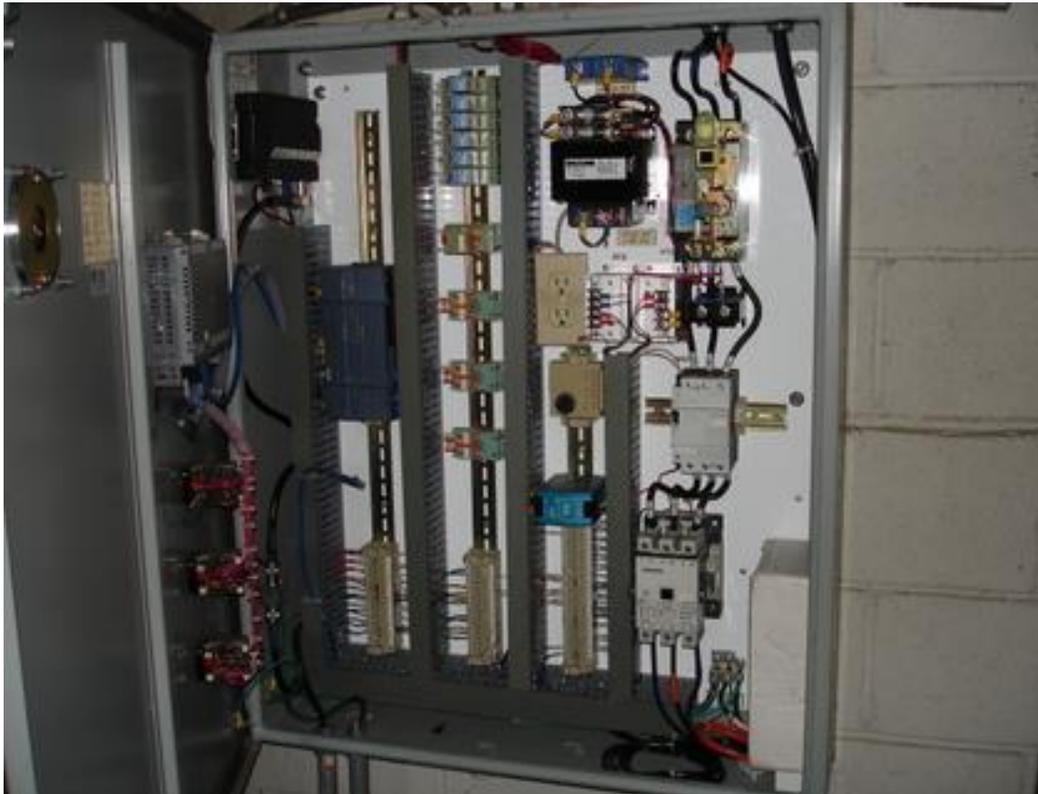
PHOTO 10 CONTROL PANEL INTERIOR VIEW (2017)

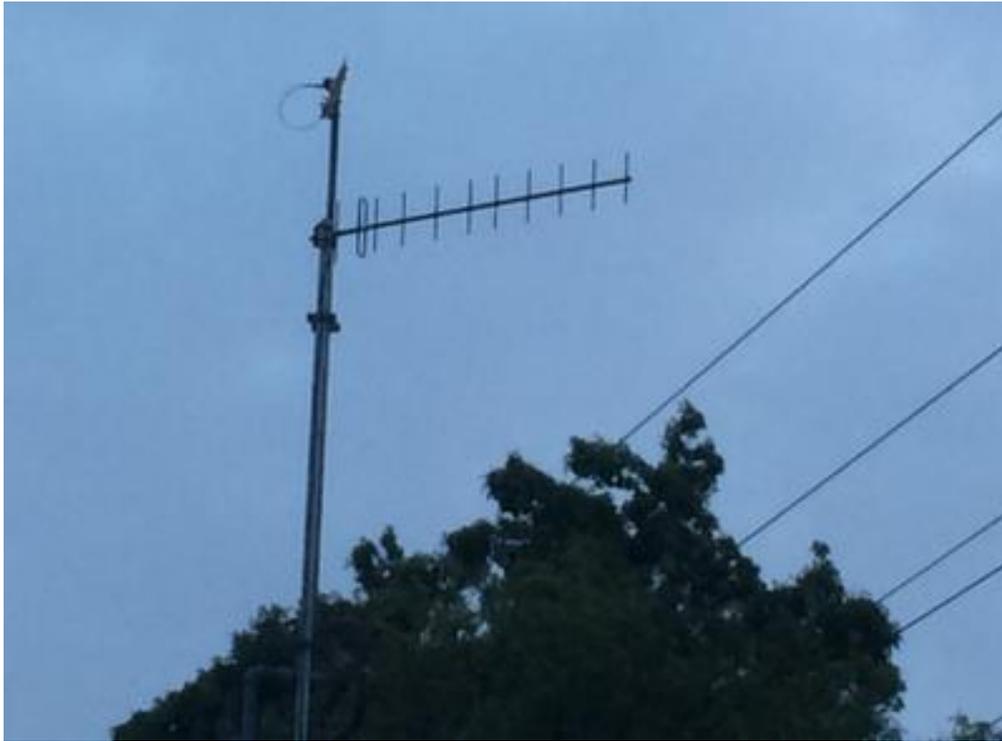
PHOTO 11

ANTENNA MAST

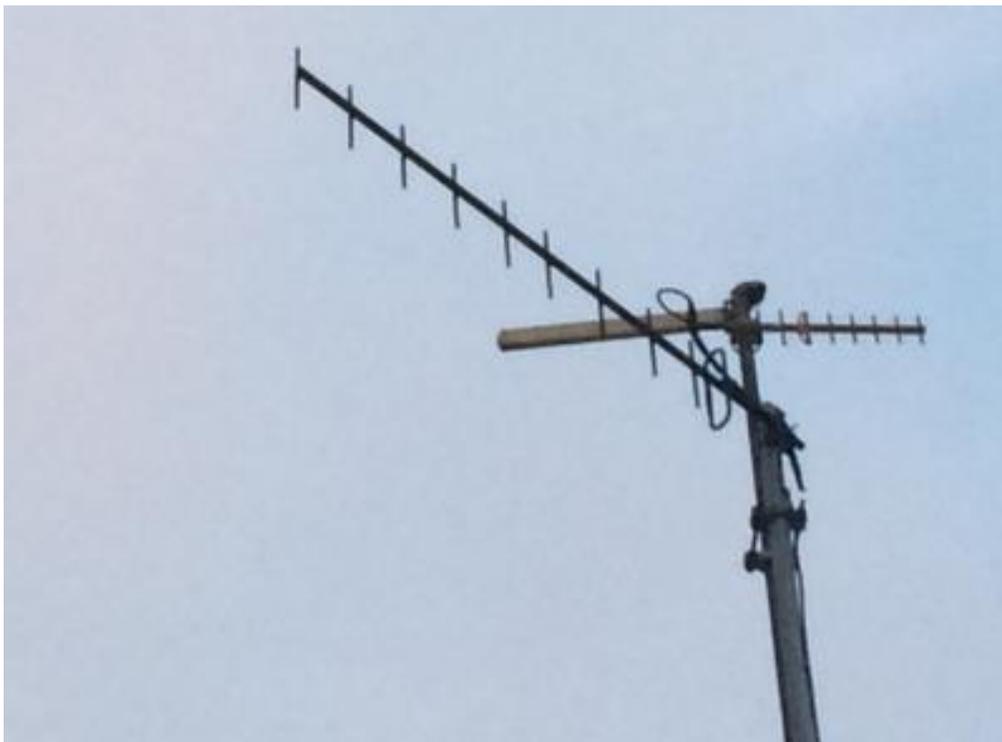
PHOTO 12

ANTENNA DETAIL

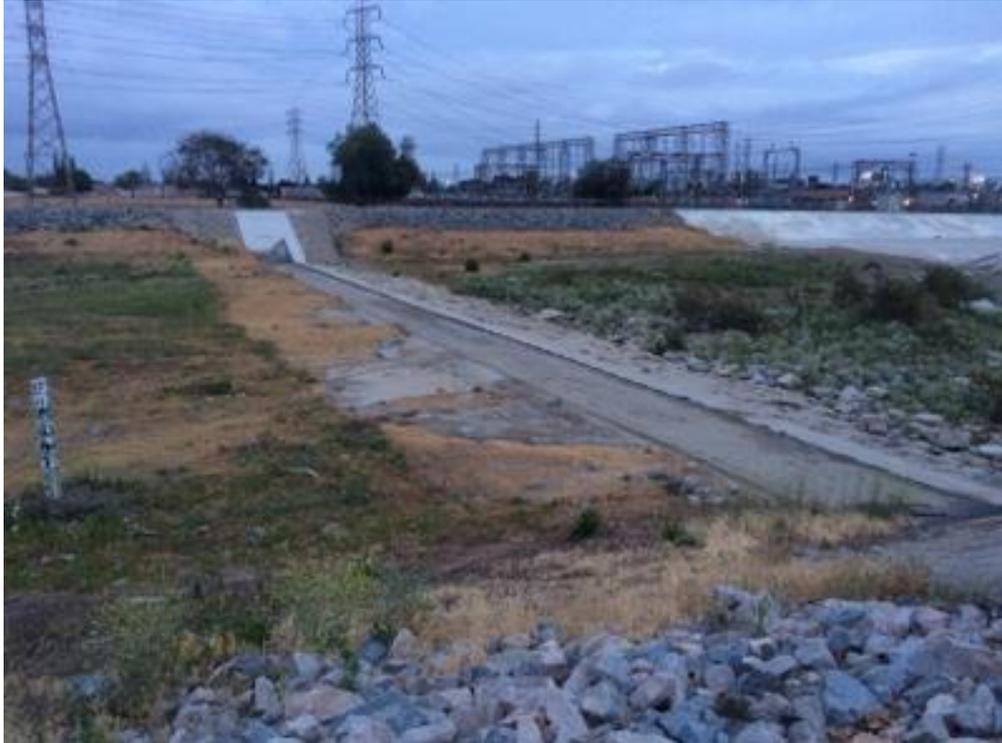
PHOTO 1 DEFLATED RUBBER DAM UPSTREAM VIEW

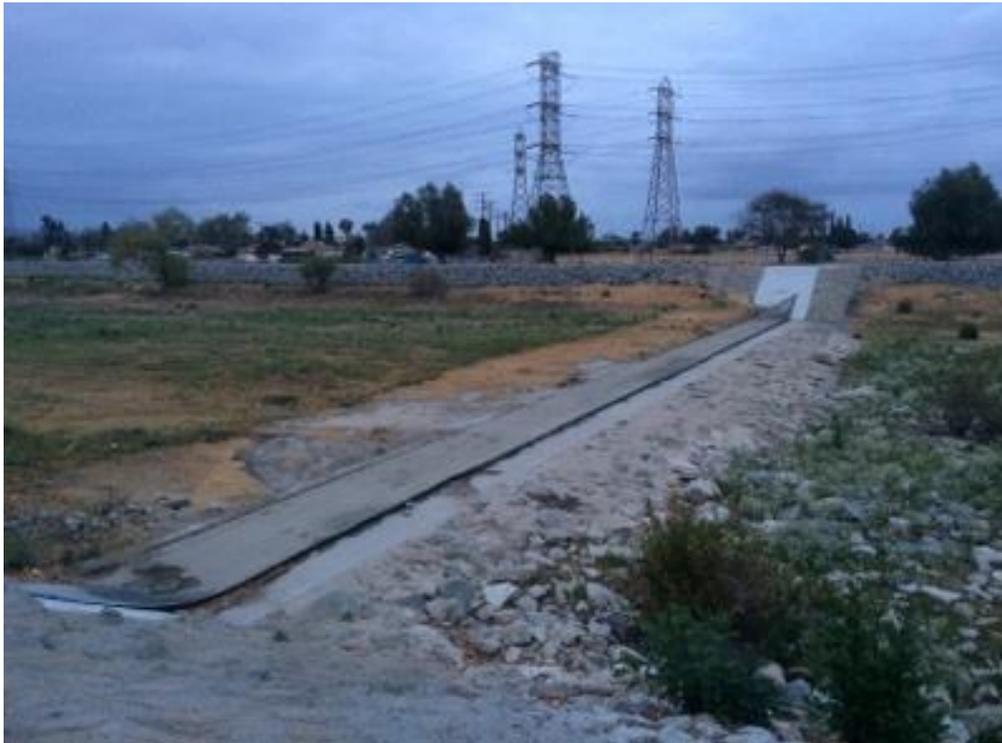
PHOTO 2 DEFLATED RUBBER DAM DOWNSTREAM VIEW

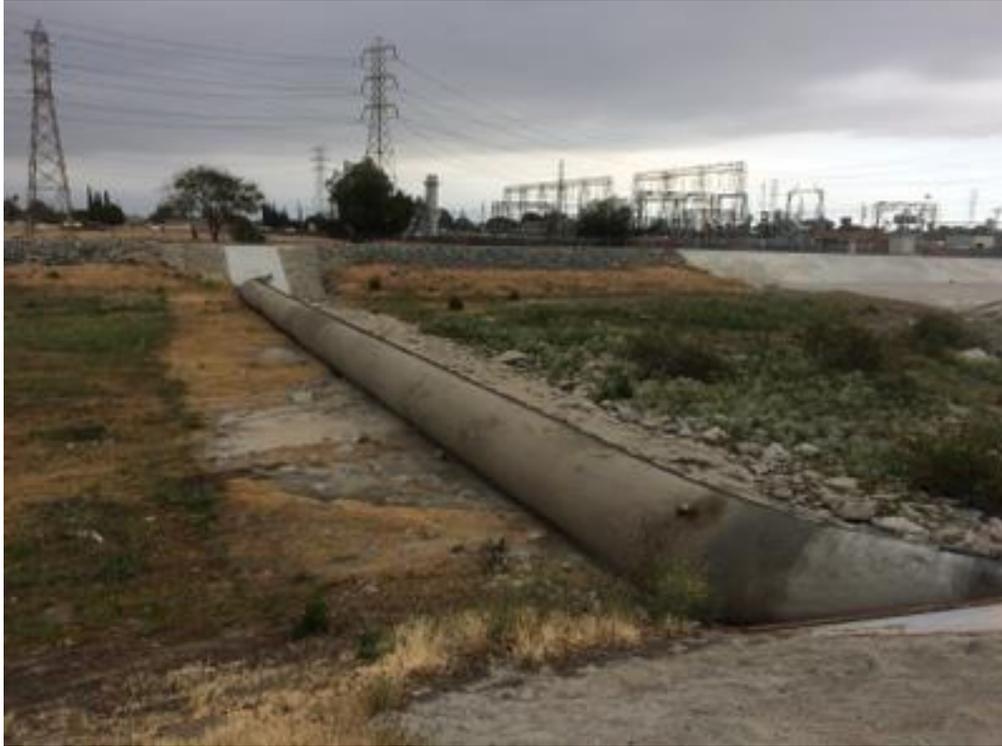
PHOTO 3

INFLATED RUBBER DAM UPSTREAM VIEW

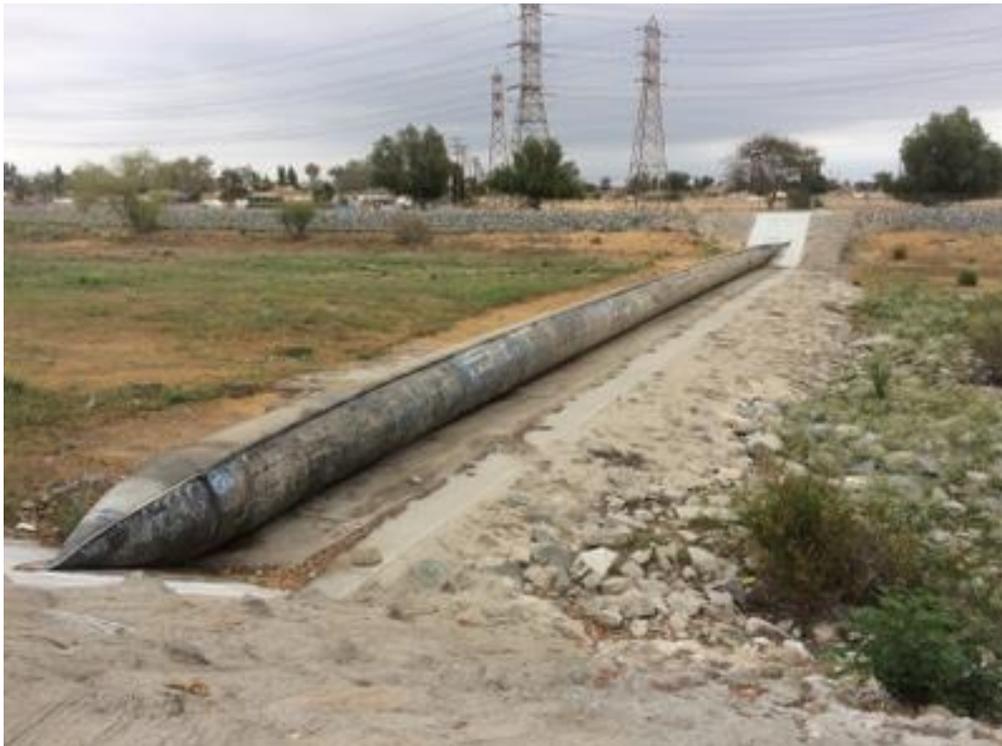
PHOTO 4

INFLATED RUBBER DAM DOWNSTREAM VIEW

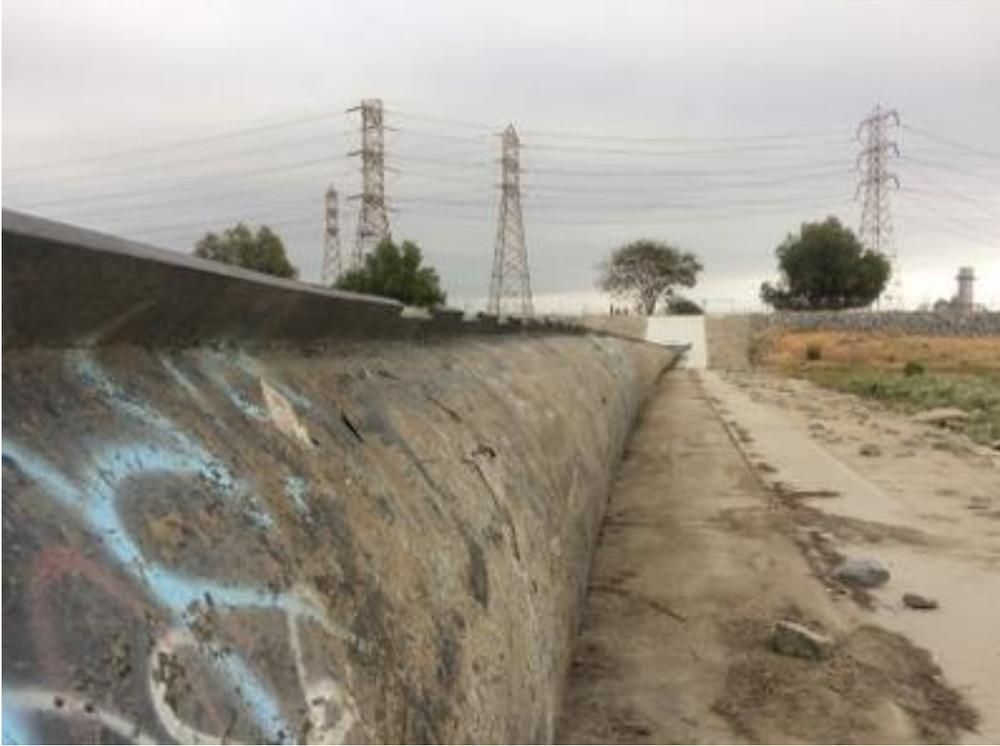
PHOTO 5

INFLATED RUBBER DAM UNDER FIN RIGHT ABUTMENT

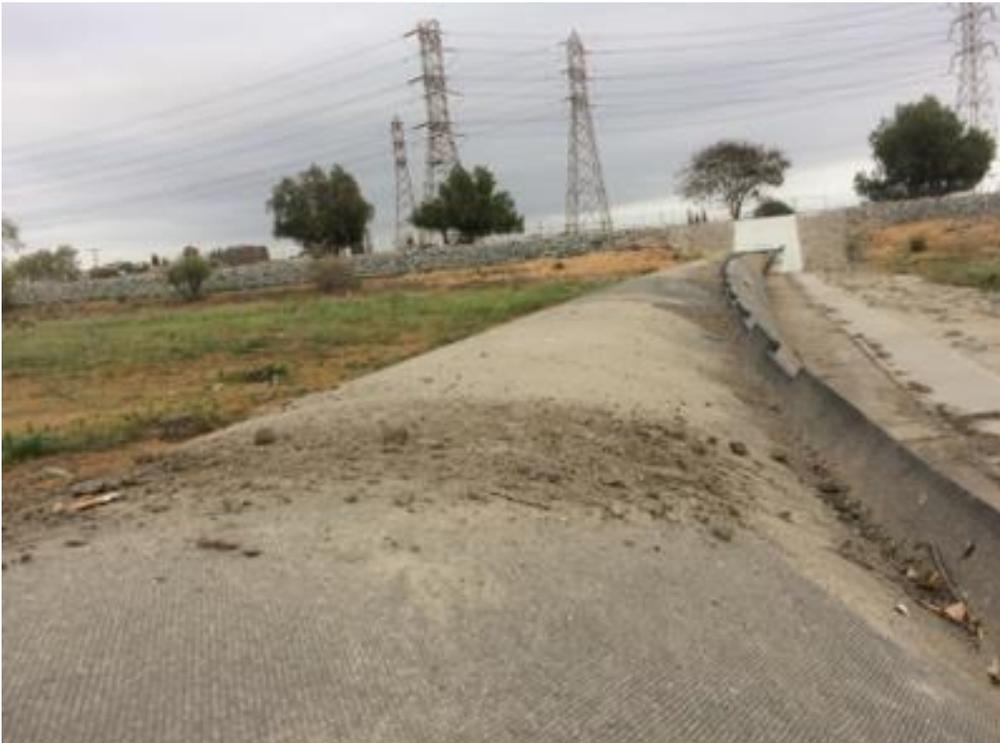
PHOTO 6

INFLATED RUBBER DAM TOP VIEW RIGHT ABUTMENT

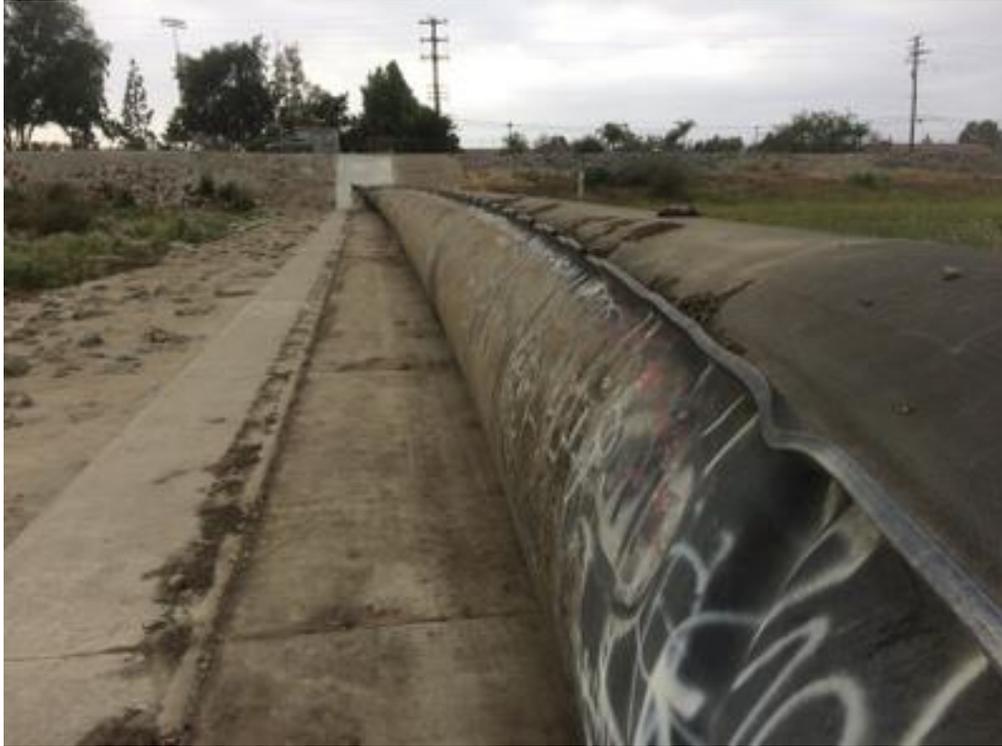
PHOTO 7

INFLATED RUBBER DAM UNDER FIN LEFT ABUTMENT

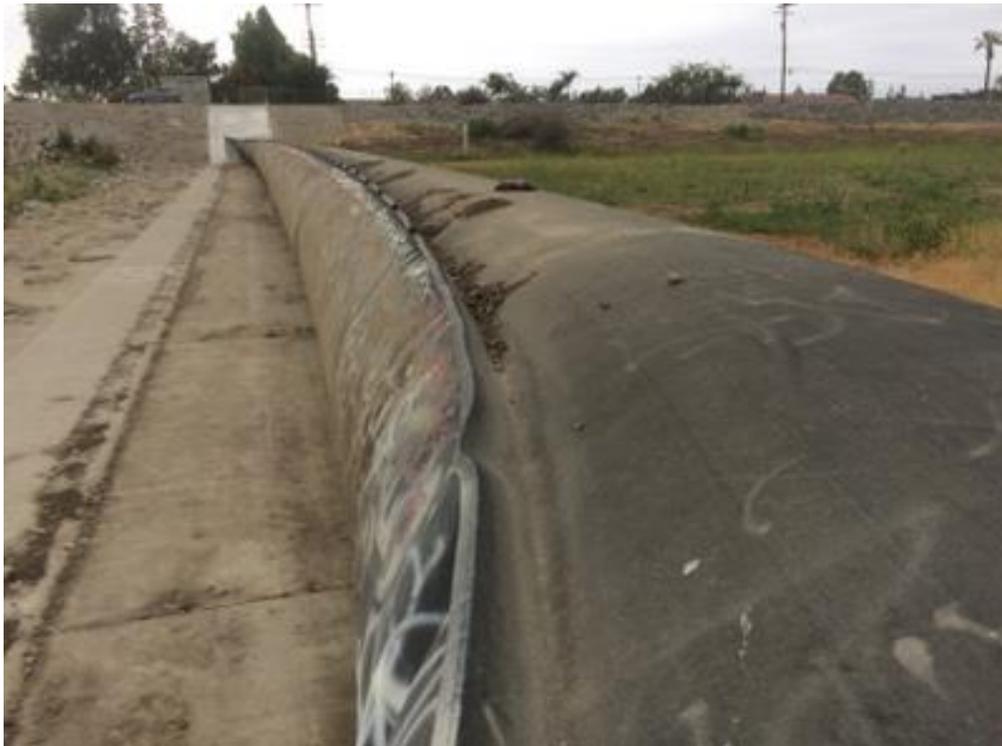
PHOTO 8

INFLATED RUBBER DAM TOP VIEW LEFT ABUTMENT

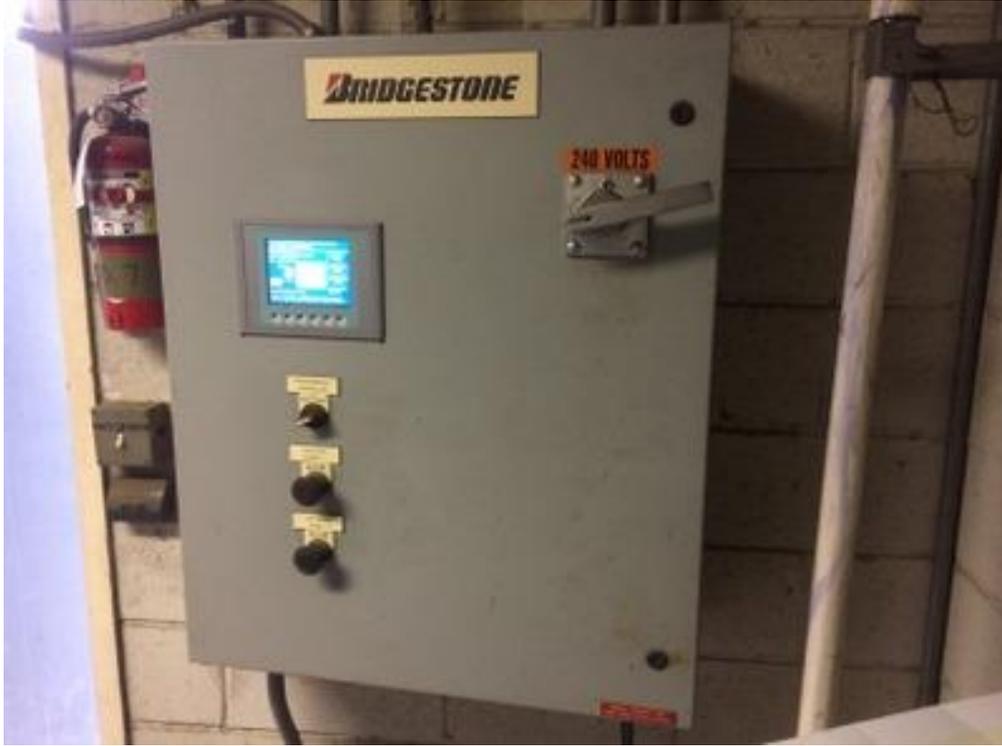
PHOTO 9 CONTROL PANEL EXTERIOR VIEW

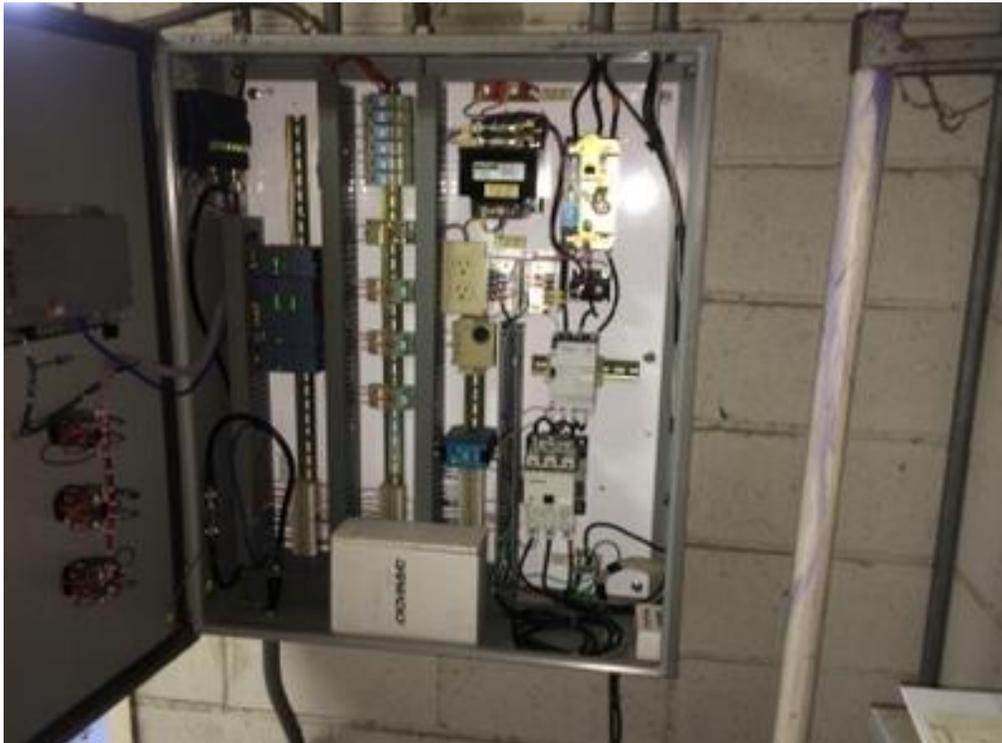
PHOTO 10 CONTROL PANEL INTERIOR VIEW

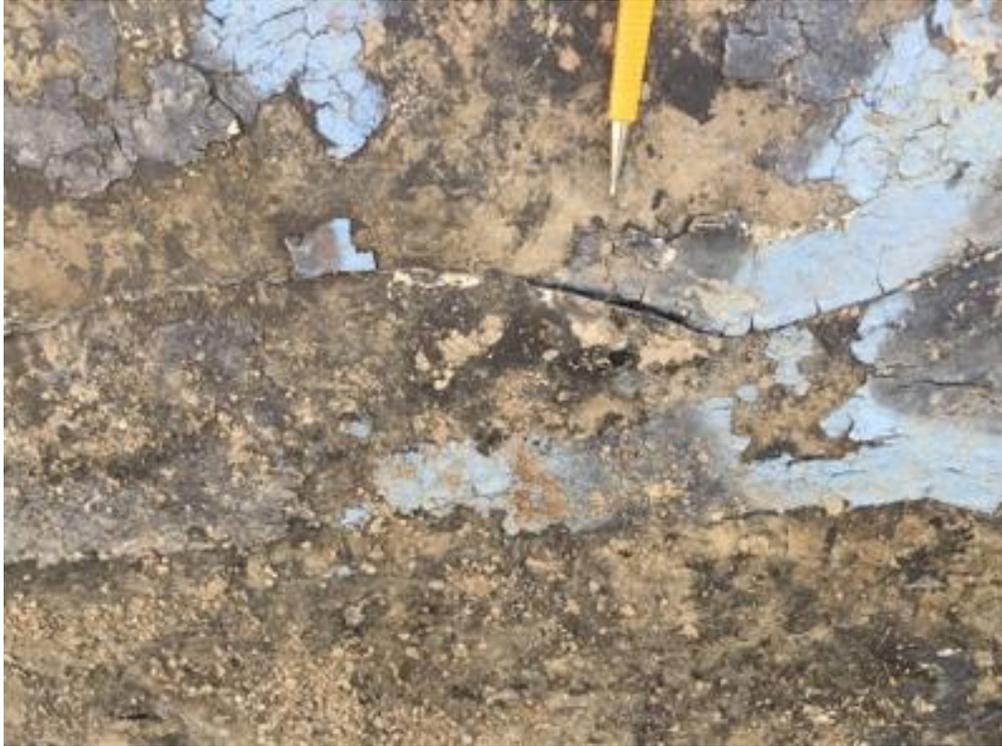
PHOTO 11

- 1) Overall condition of Rubber Dam, Mechanical and Electrical equipment at site:
 Rubber Body - Separation at seam found downstream.
 Mechanical Equipment - No significant damage observed
 Electrical Equipment - No significant damage observed, UPS needs replacement.
 Radio, Antenna & Antenna Mast - No significant damage observed

SEAM SEPERATION DOWNSTREAM

- 1) Replace UPS and tie in to PLC Programming & Alarms.
- 2) Rubber dam needs two Class A repairs at seam downstream.

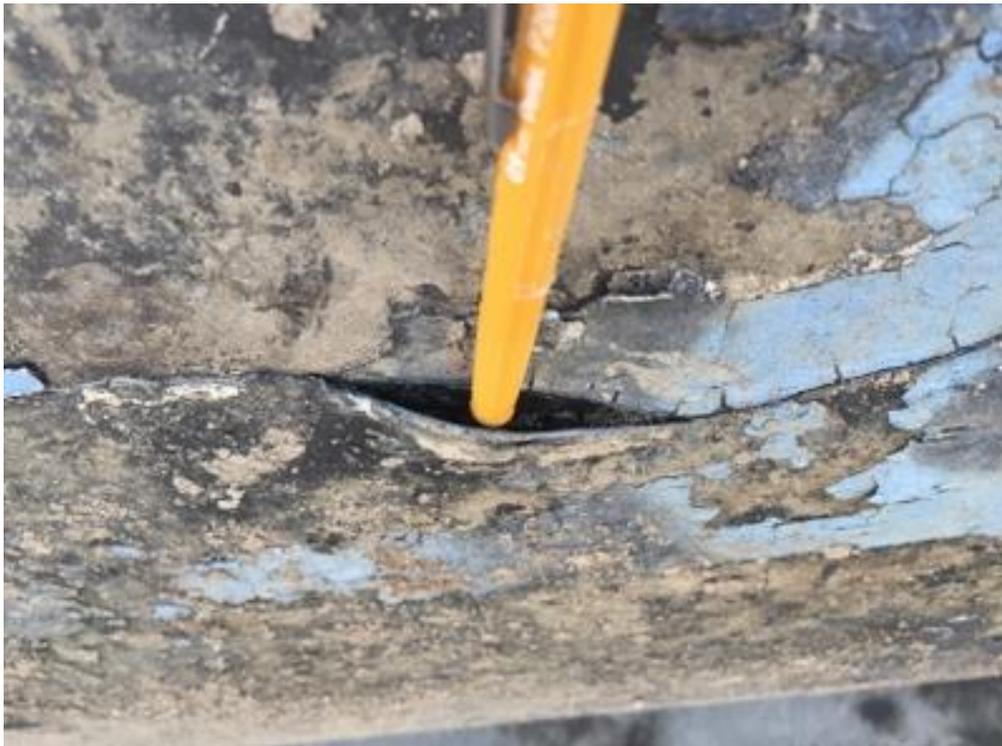
PHOTO 12

SEAM SEPERATION DOWNSTREAM

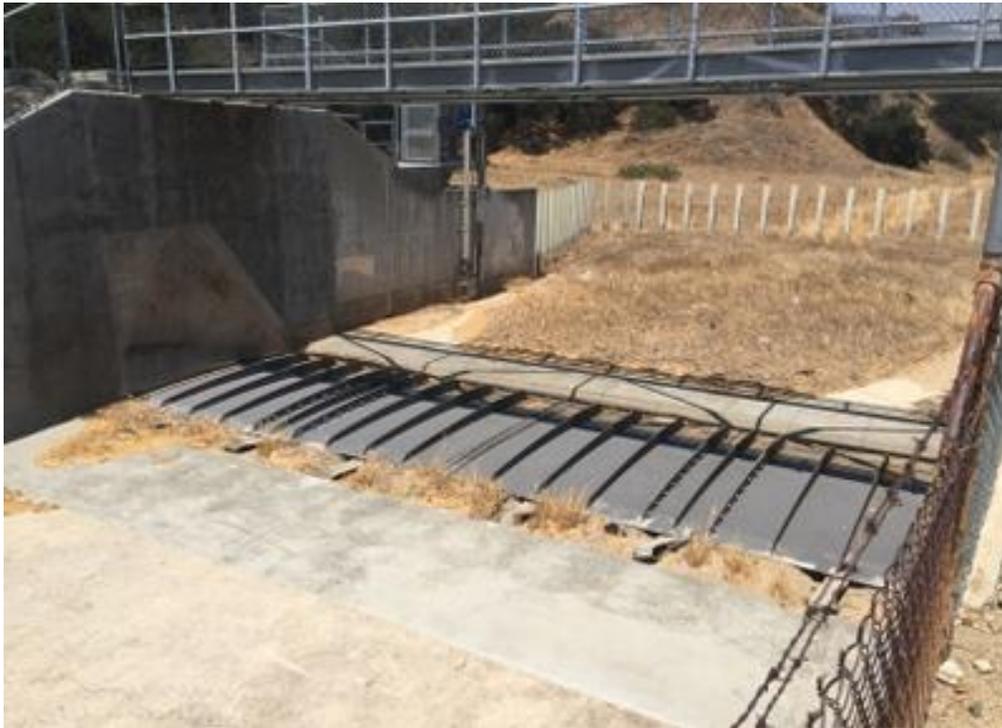
PHOTO 1 DEFLATED RUBBER DAM UPSTREAM VIEW

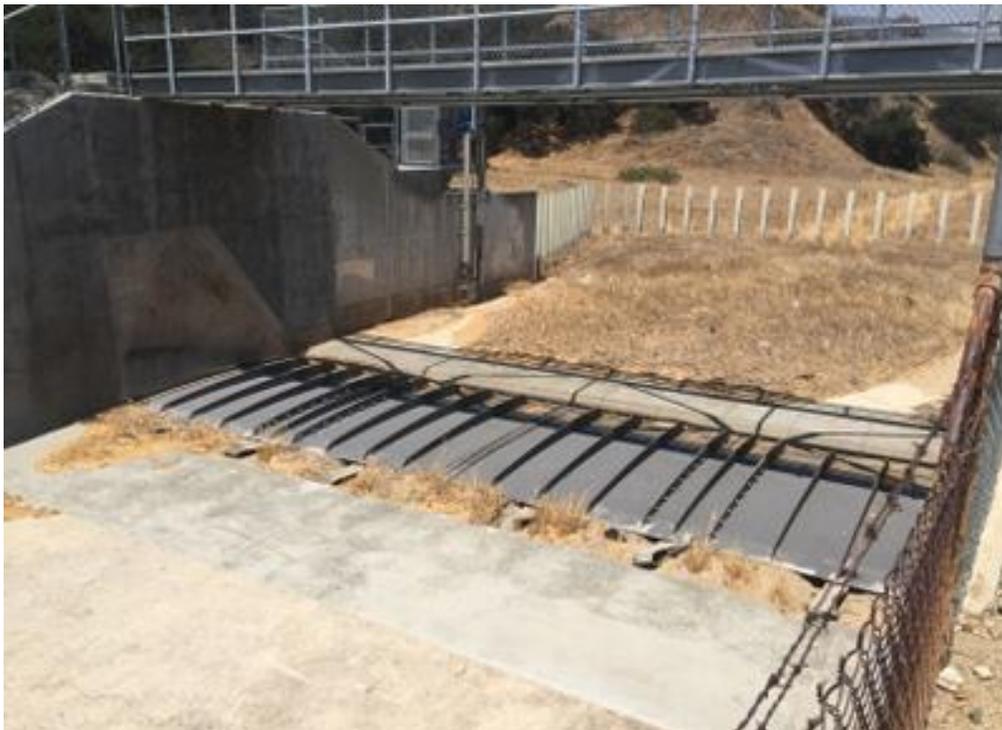
PHOTO 2 DEFLATED RUBBER DAM DOWNSTREAM VIEW

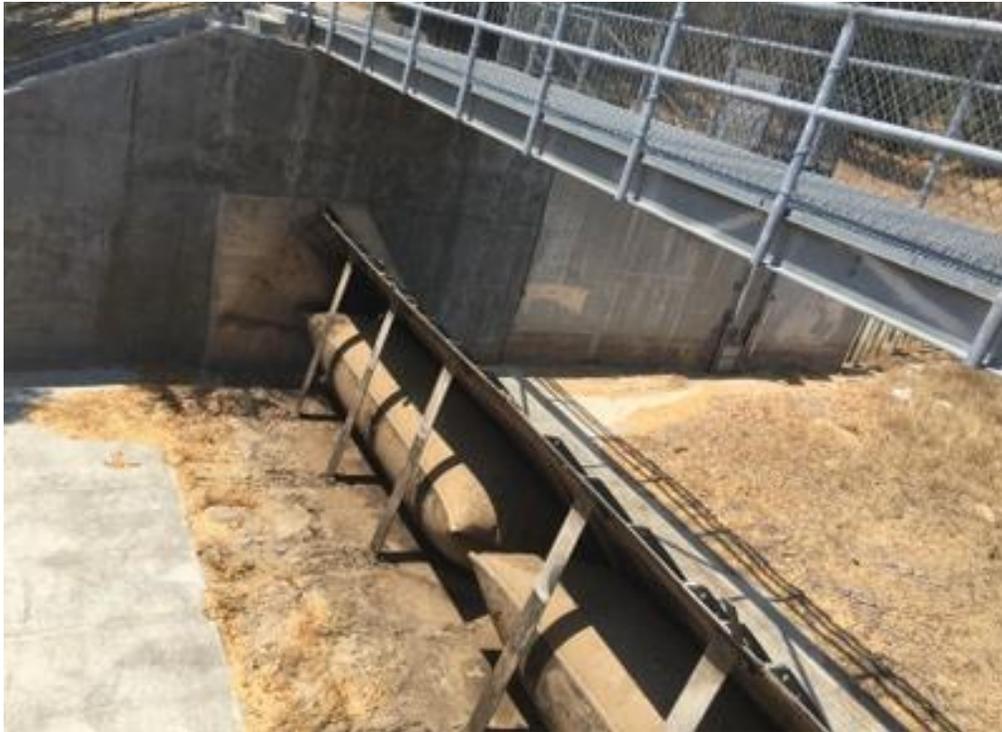
PHOTO 3

INFLATED RUBBER DAM UPSTREAM VIEW

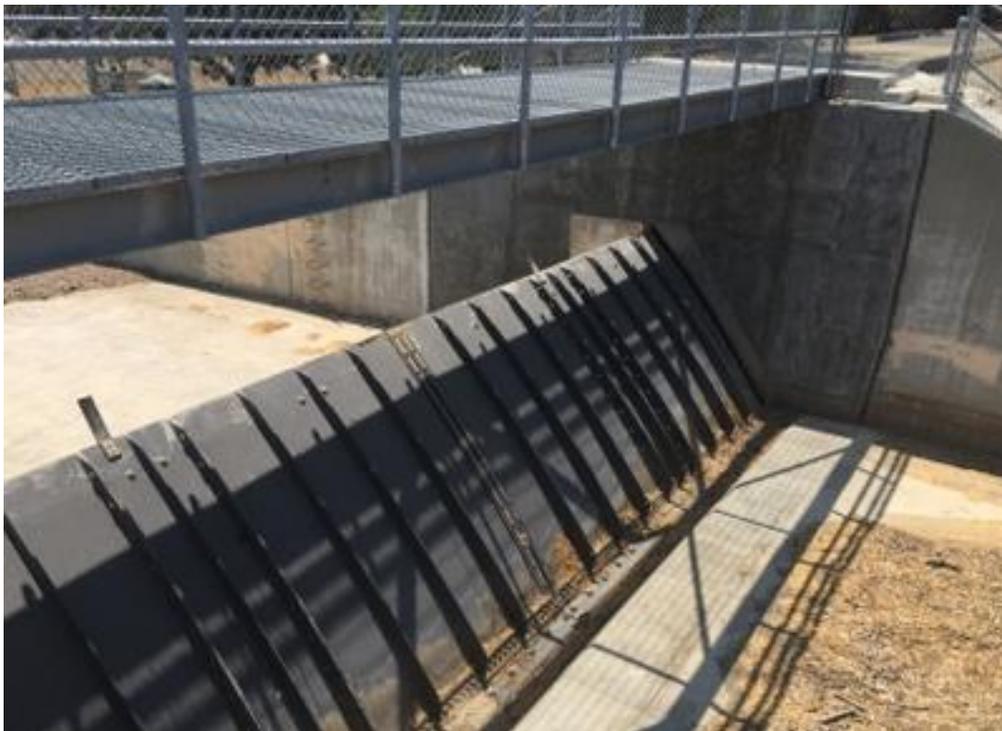
PHOTO 4

INFLATED RUBBER DAM DOWNSTREAM VIEW

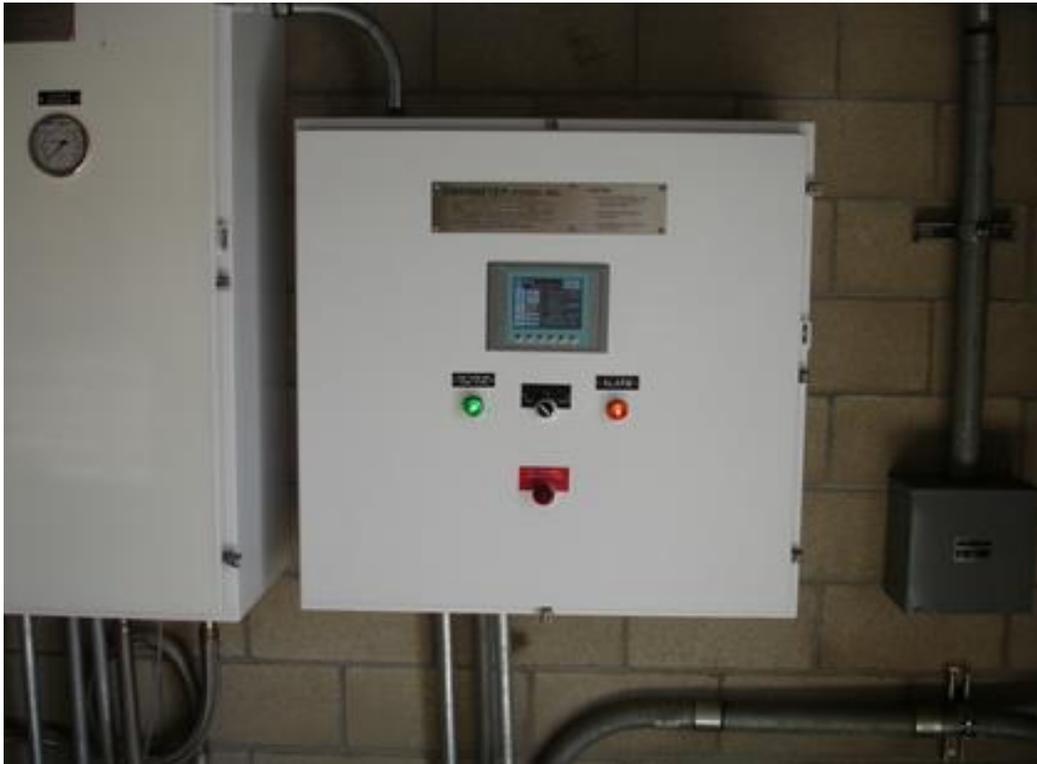
PHOTO 5

PLC PANEL

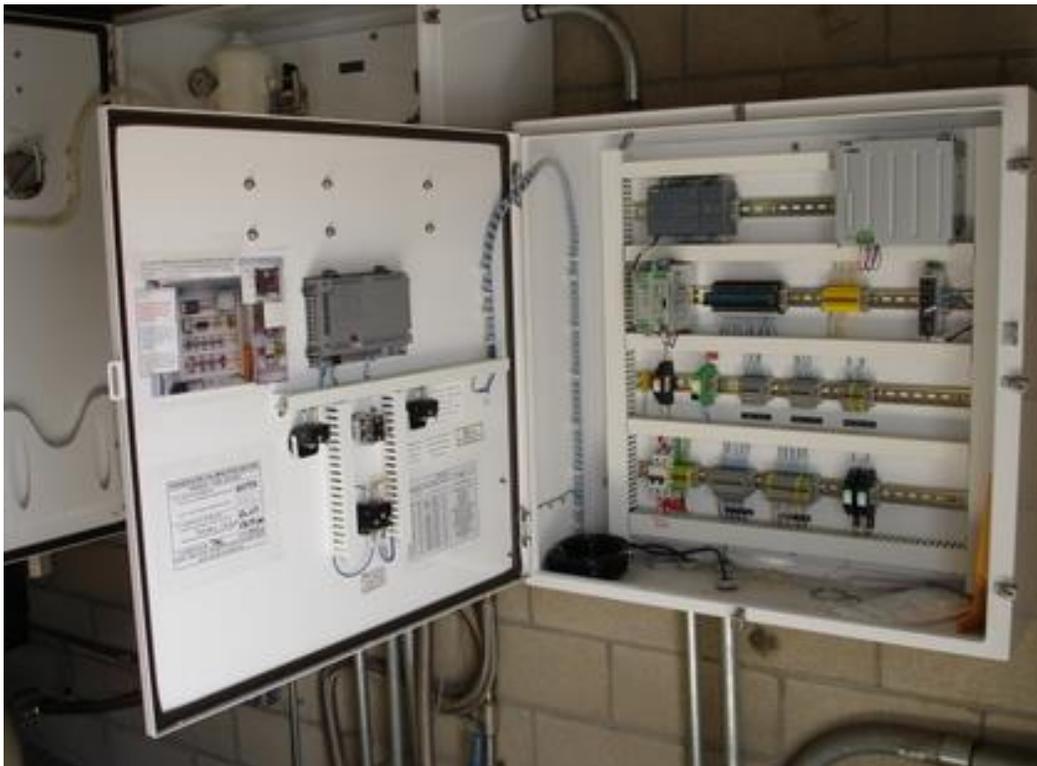
PHOTO 6

PLC PANEL INTERIOR
