**REPORT ON 2016-17 INSPECTION OF
LACDPW SCRDS FACILITIES**

**CONTRACT:STORMWATER CAPTURE RUBBER DAM
MAINTENANCE SERVICES (2014-IT001)**

AUGUST 20, 2018

RUBBER DAM INSPECTION REPORT

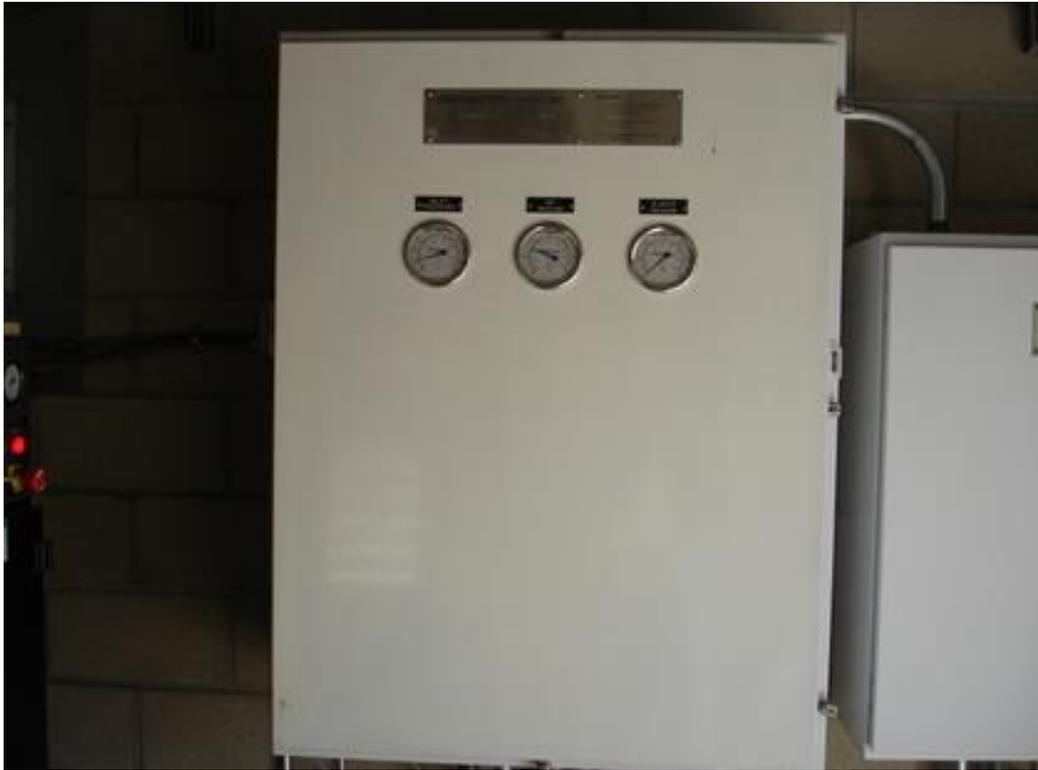
PHOTO 7

VALVE PANEL (2017)

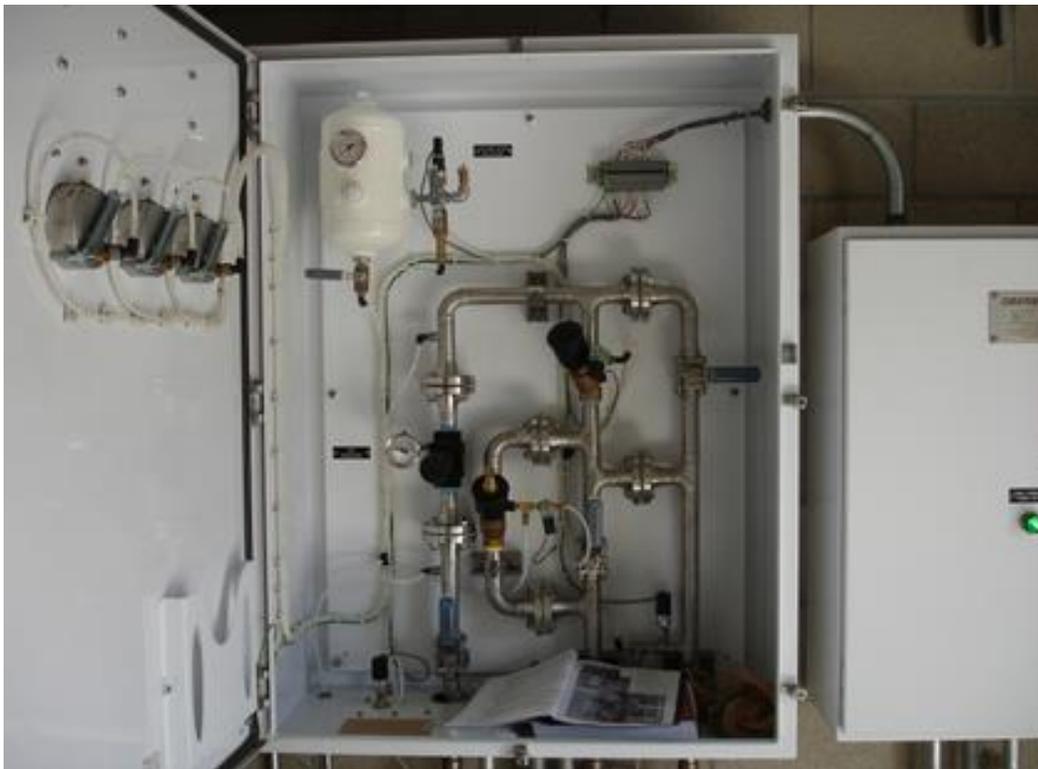
PHOTO 8

VALVE PANEL INTERIOR (2017)

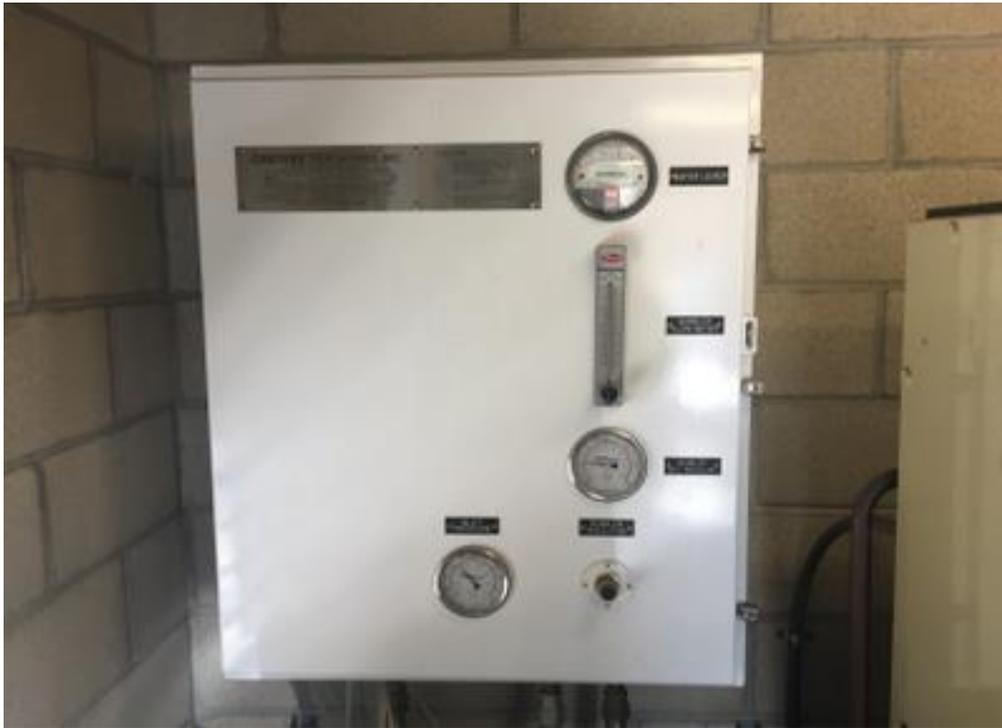
PHOTO 9

PRESSURE RELIEF PANEL

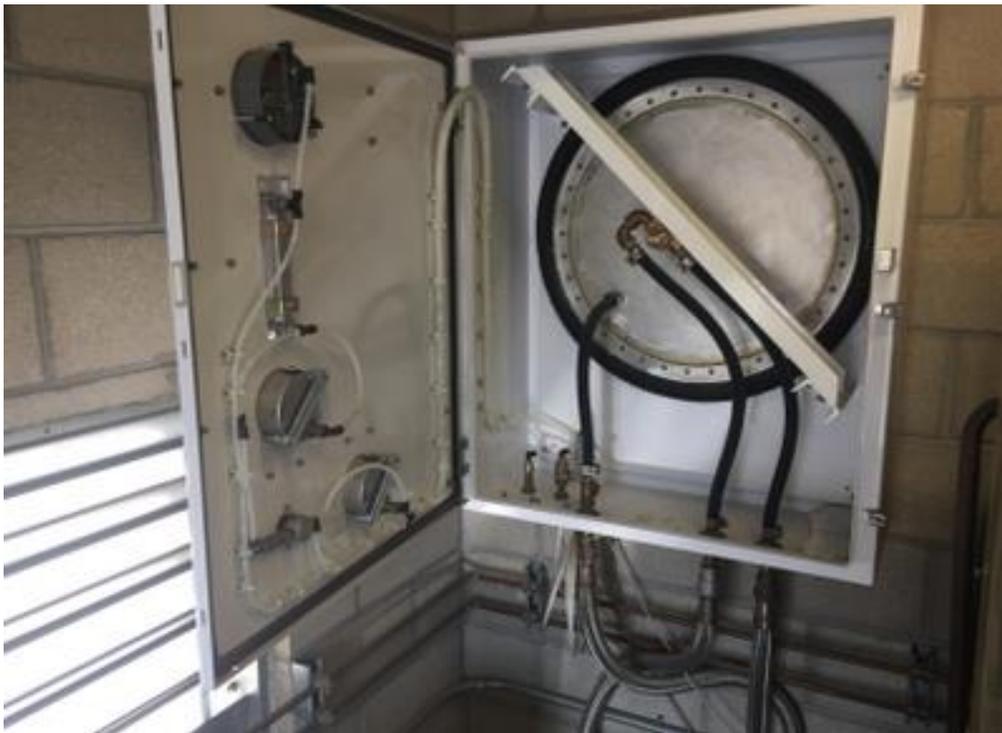
PHOTO 10

PRESSURE RELIEF PANEL INTERIOR

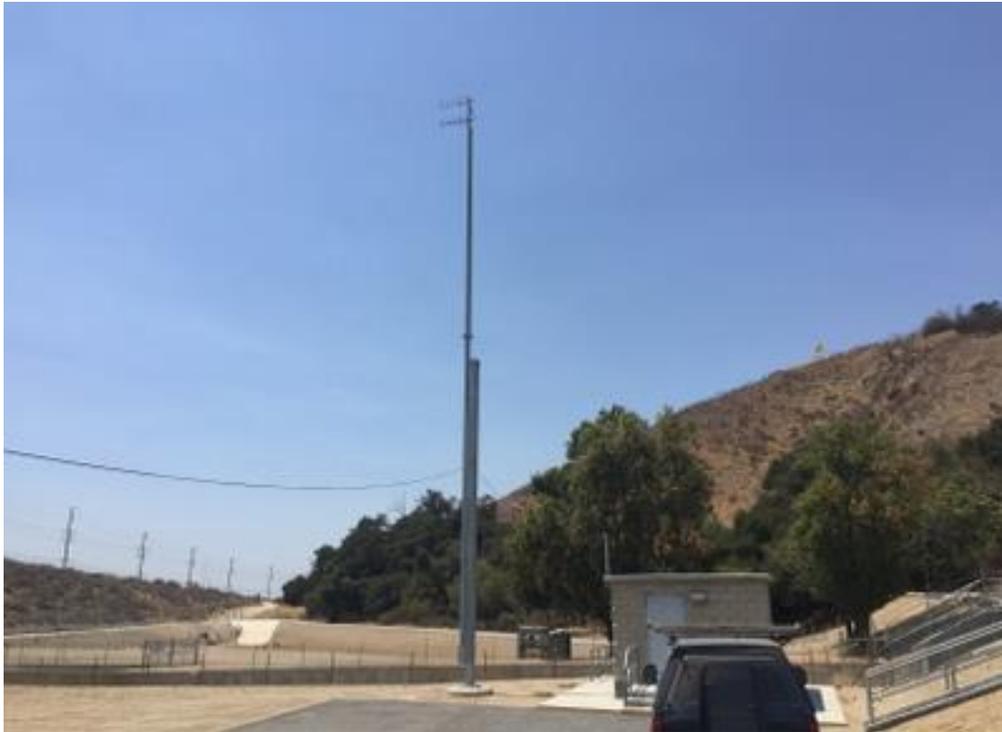
PHOTO 11

ANTENNA MAST

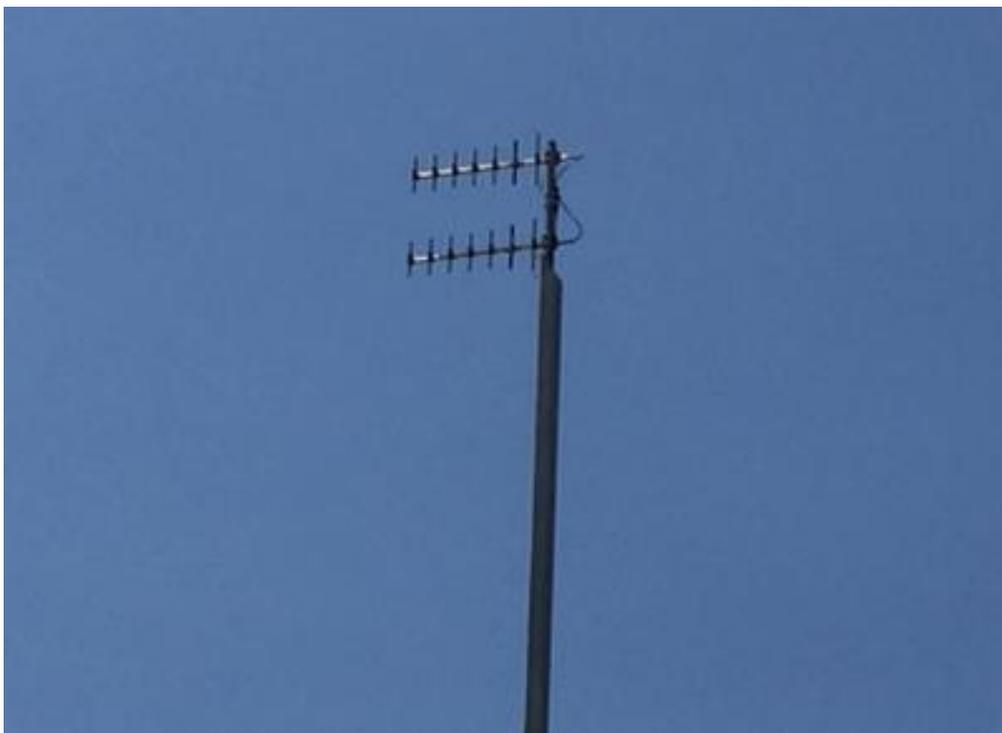
PHOTO 12

ANTENNA DETAIL

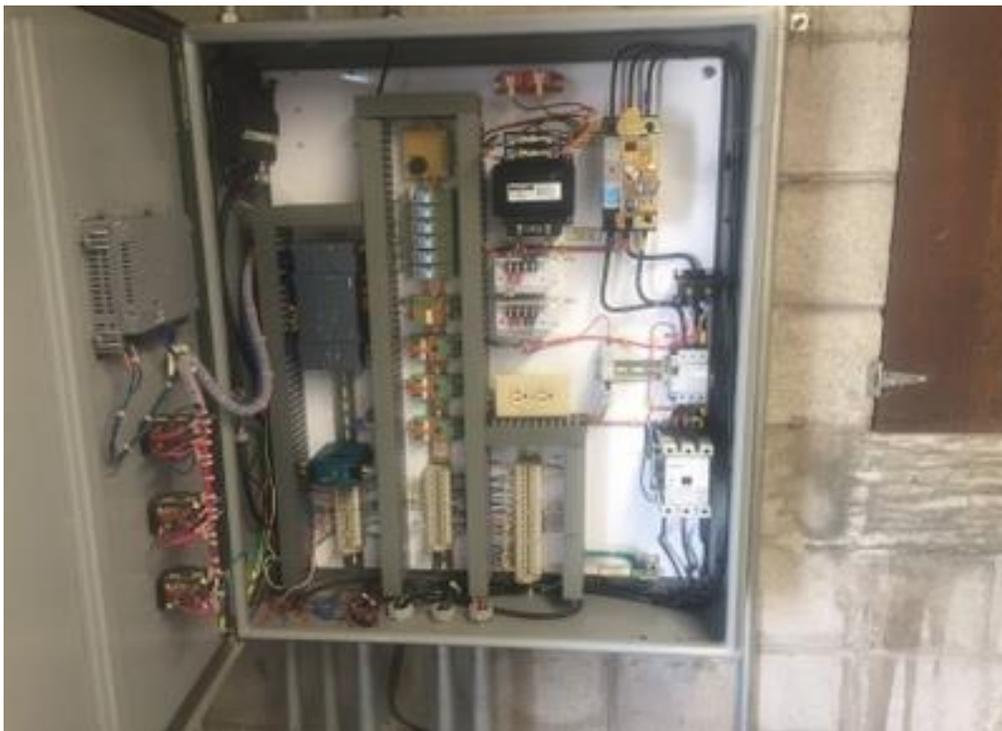
1) UPS needs replacement.

PHOTO 8 CONTROL PANEL INTERIOR VIEW

1) Replace UPS and tie in to PLC Programming & Alarms.

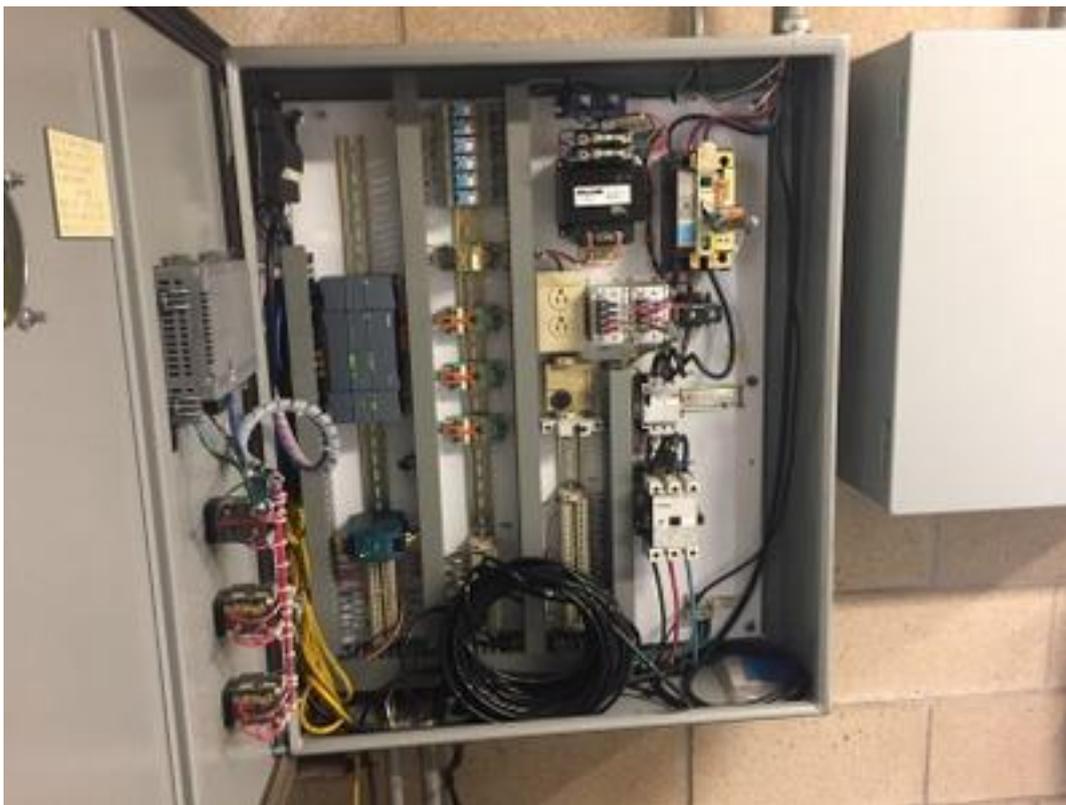
- Rubber Body - No significant damage observed.
- Mechanical Equipment - No significant damage observed.
- Electrical Equipment - Water level transmitter failed.
- Radio, Antenna & Antenna Mast - No significant damage observed

PHOTO 8 CONTROL PANEL INTERIOR

- 1) Replace failed water level transmitter.

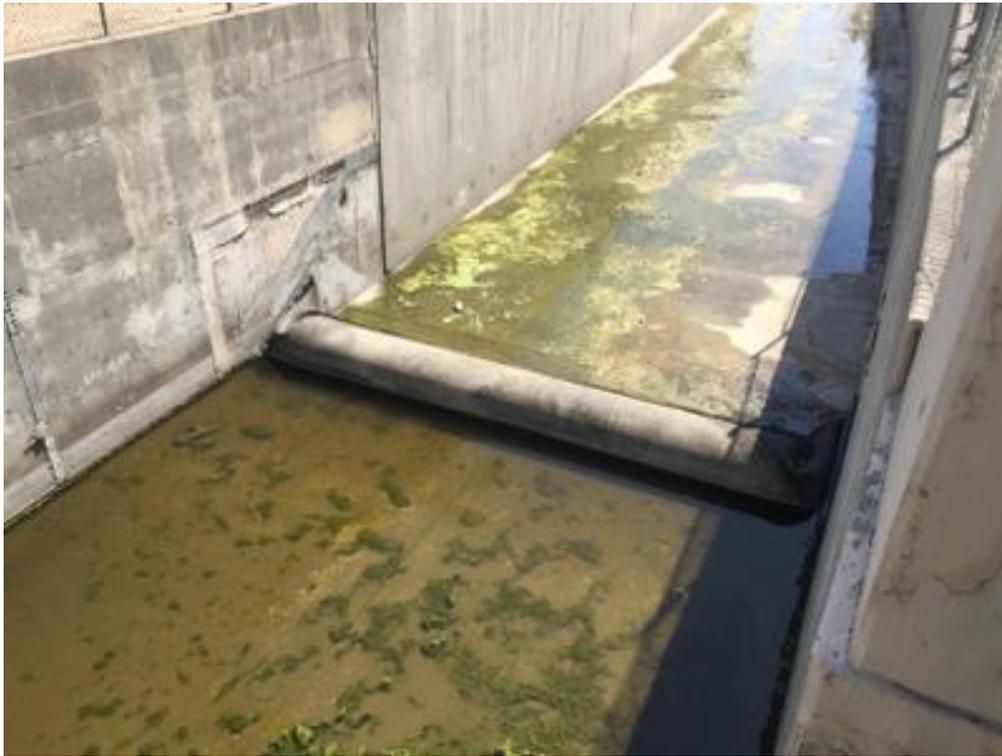
PHOTO 1

INFLATED RUBBER DAM UPSTREAM VIEW

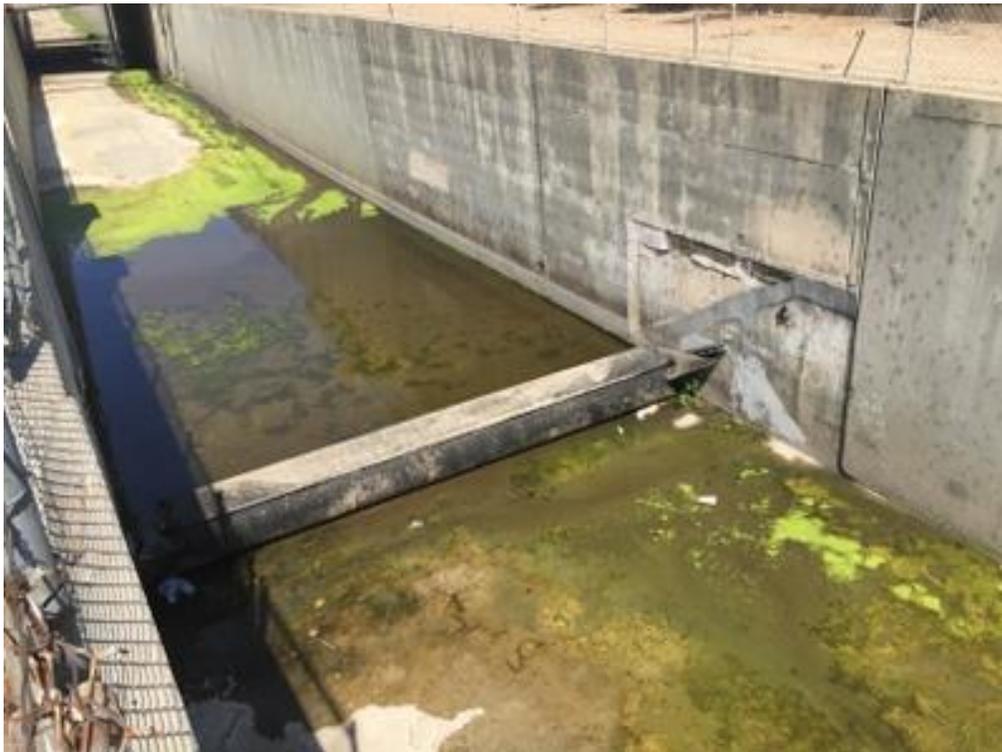
PHOTO 2

INFLATED RUBBER DAM DOWNSTREAM VIEW

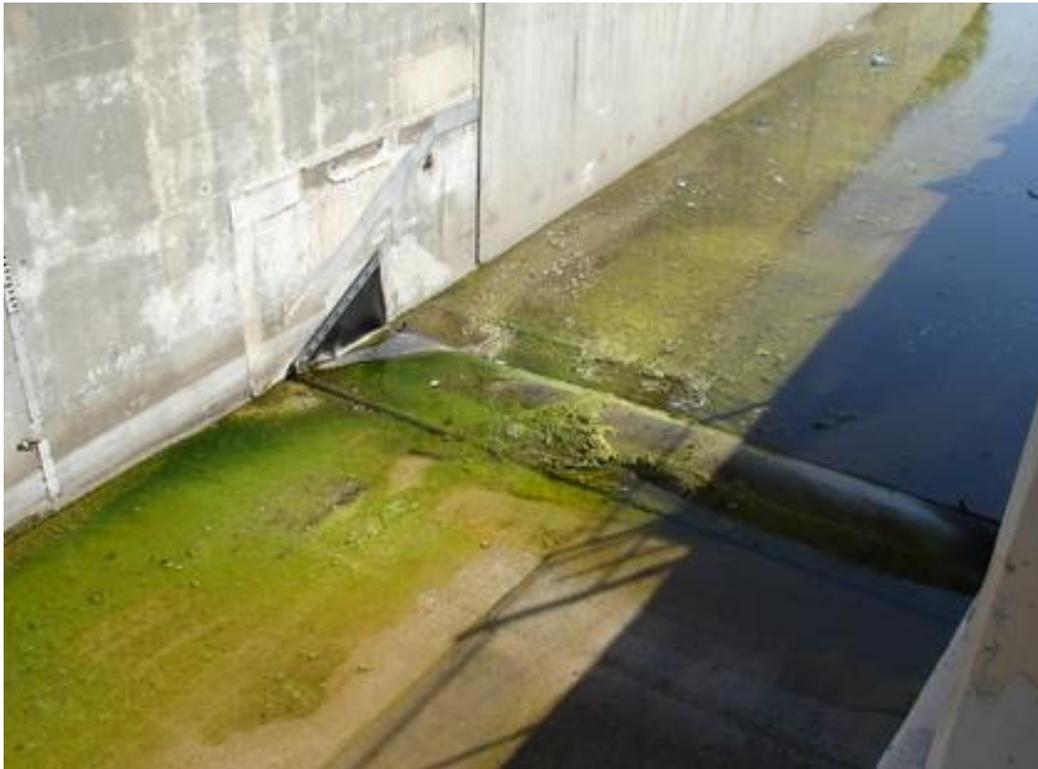
PHOTO 3

DEFLATED RUBBER DAM UPSTREAM VIEW (2017)

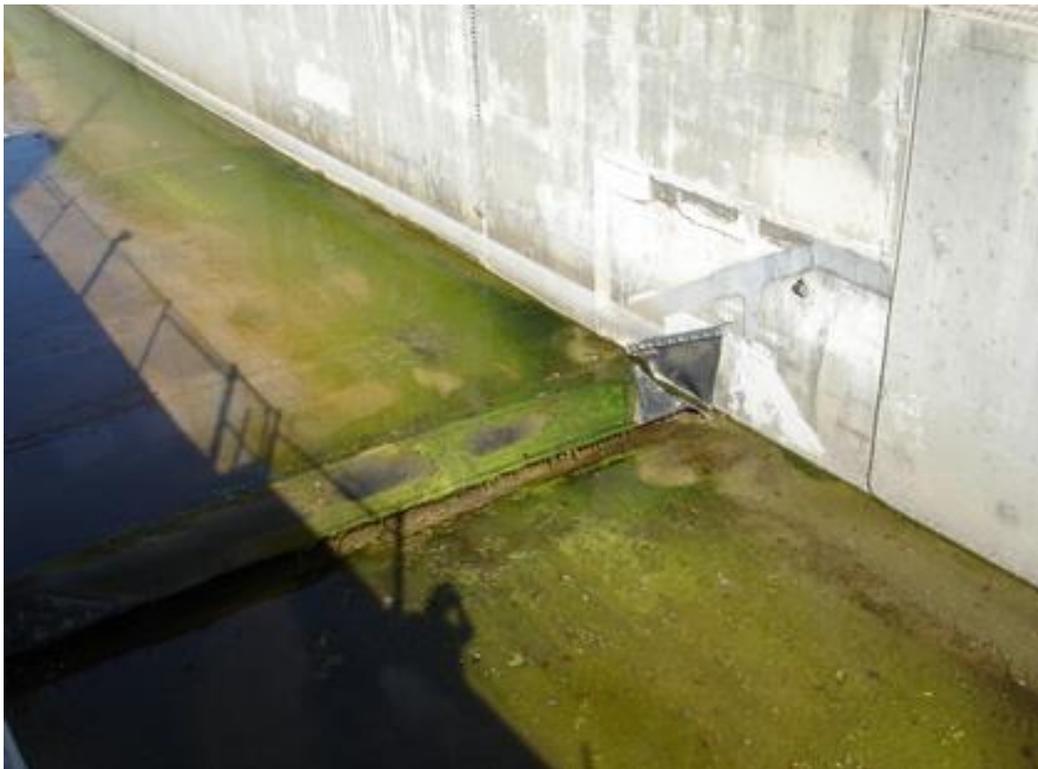
PHOTO 4

DEFLATED RUBBER DAM DOWNSTREAM VIEW (2017)

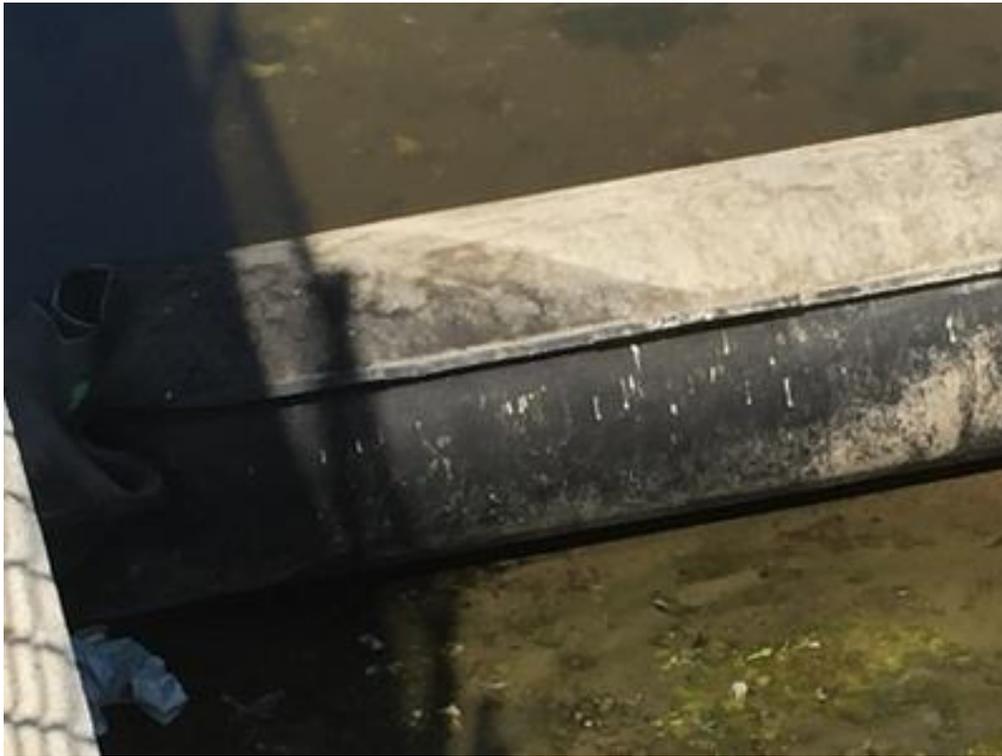
PHOTO 5

INFLATED RUBBER DAM UNDER FIN RIGHT ABUTMENT

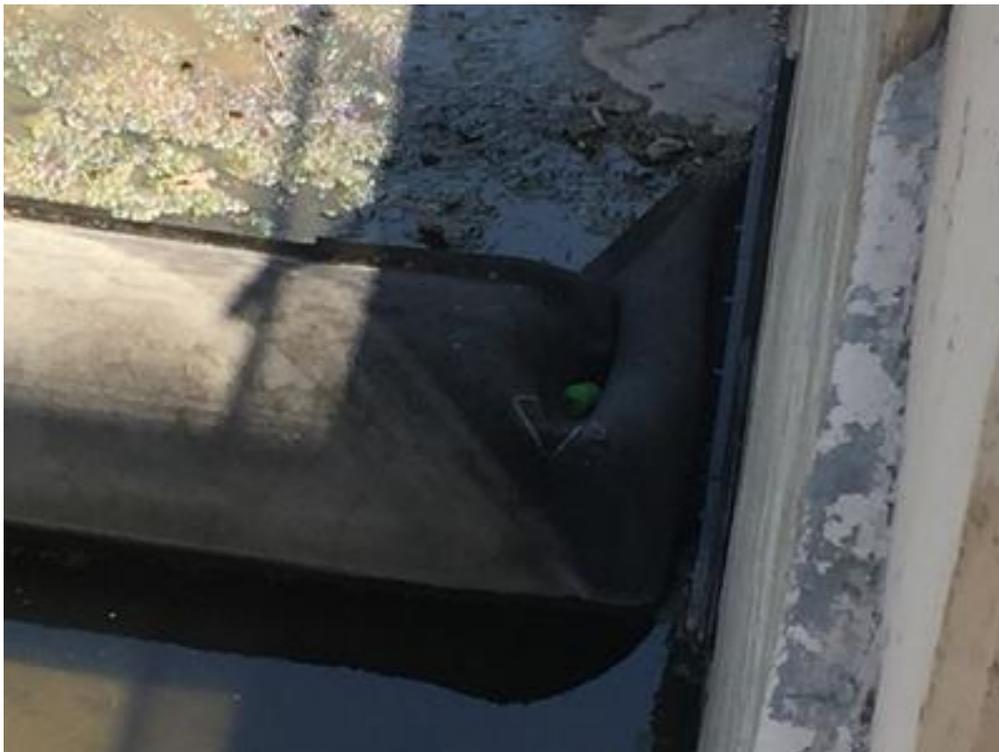
PHOTO 6

INFLATED RUBBER DAM TOP VIEW RIGHT ABUTMENT

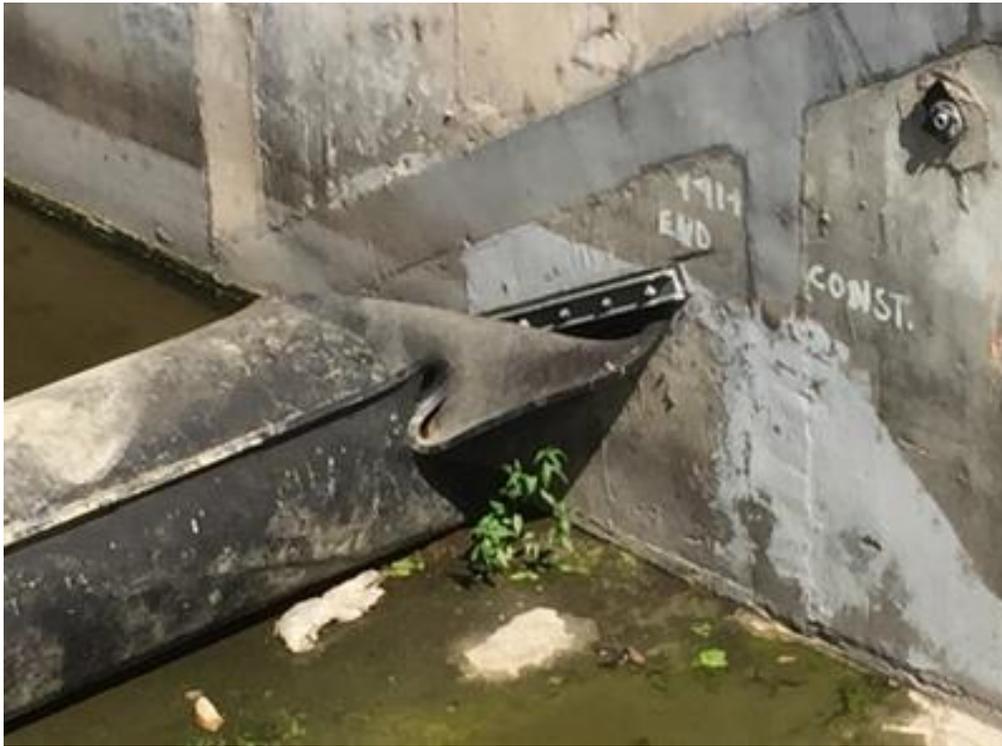
PHOTO 7

INFLATED RUBBER DAM UNDER FIN LEFT ABUTMENT

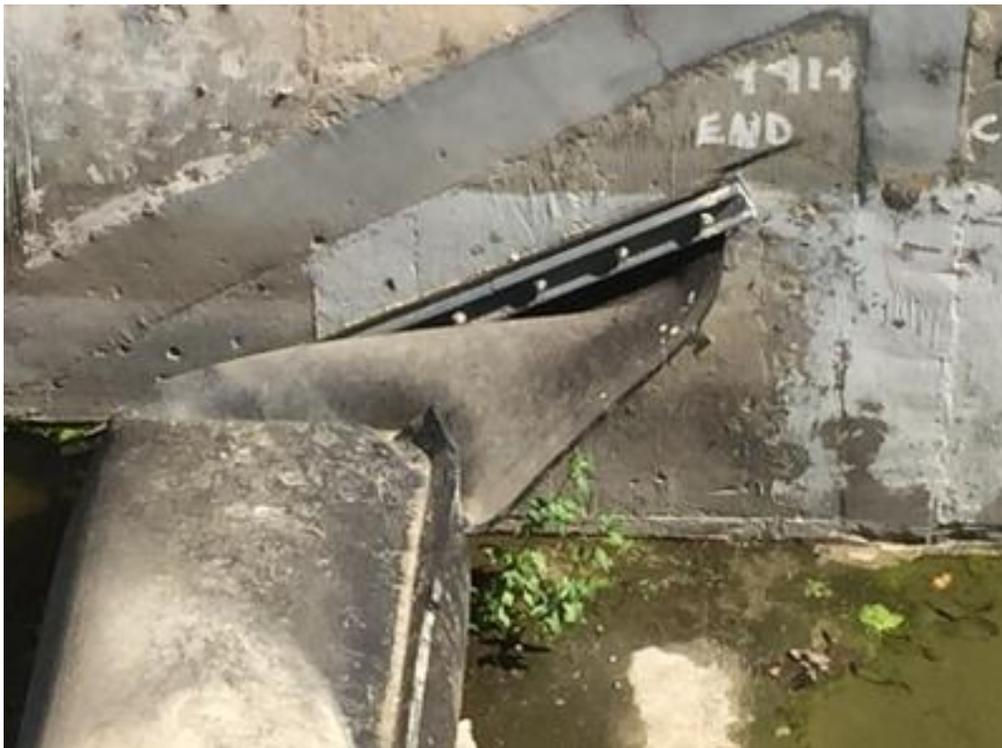
PHOTO 8

INFLATED RUBBER DAM TOP VIEW LEFT ABUTMENT

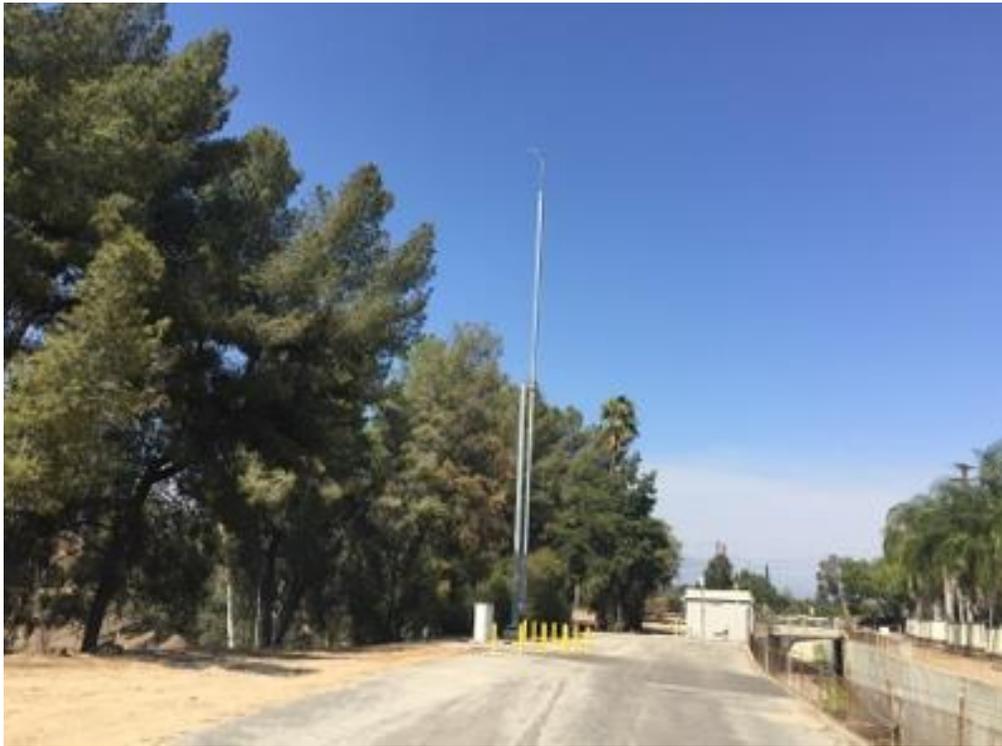
PHOTO 11

ANTENNA MAST

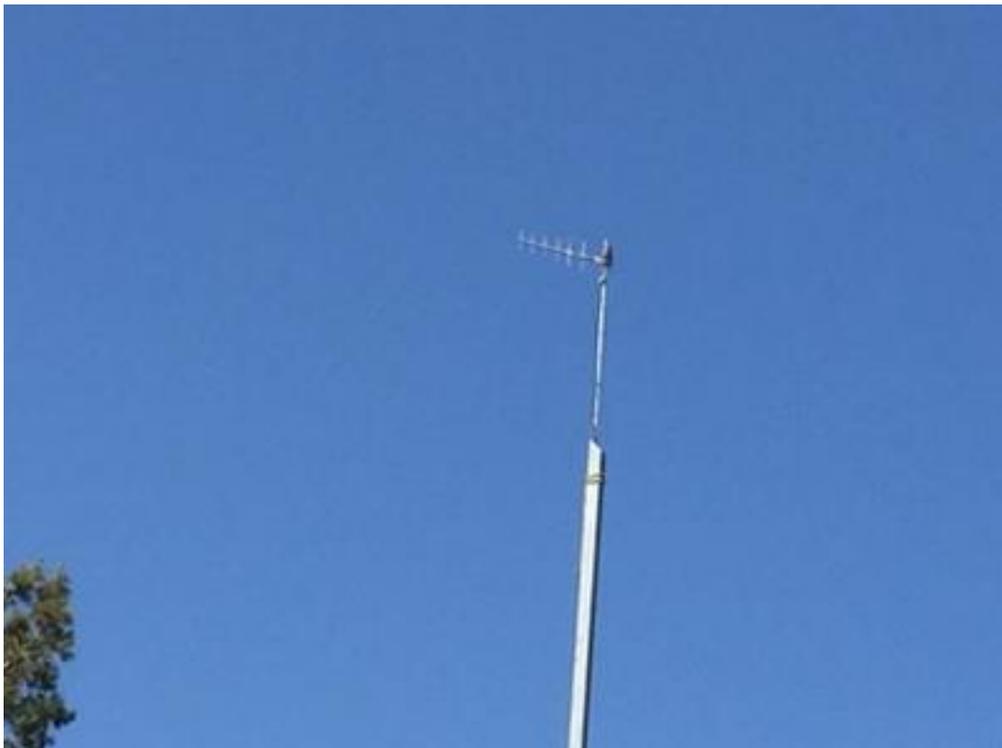
PHOTO 12

ANTENNA DETAIL

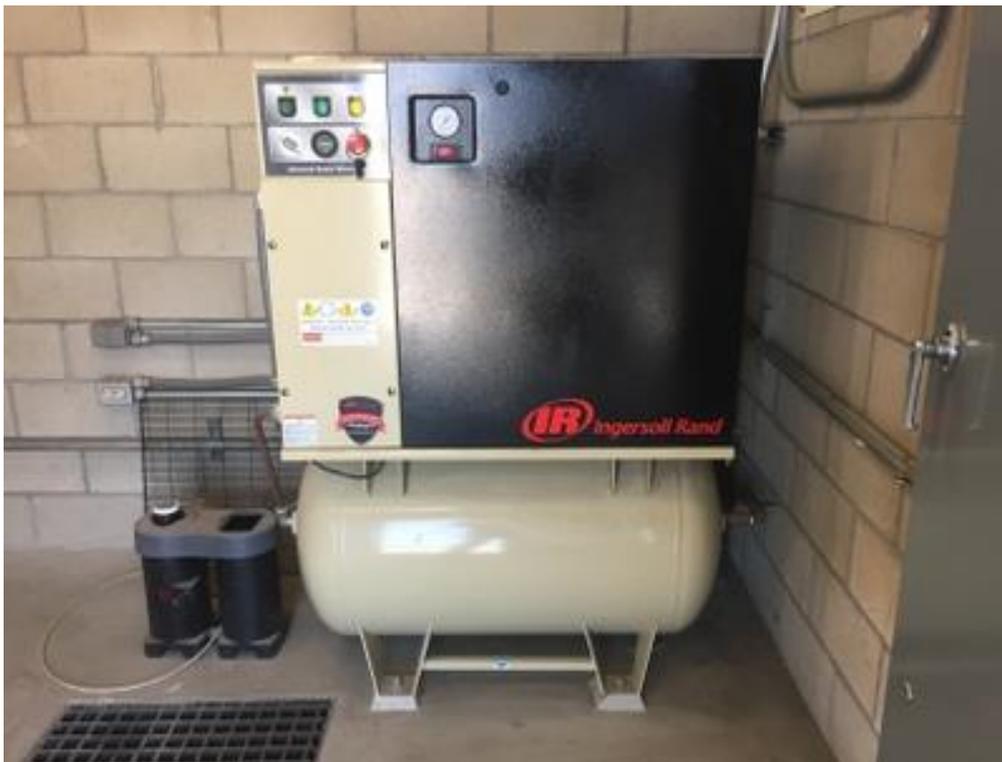
PHOTO 10

Mechanical Equipment - Compressor failed.

INGERSOLL RAND COMPRESSOR

- 1) Repair or replace compressor.
- 2) Move water level sensor down stilling well intake pipe to base of channel wall at 0 -0.5 ft above invert of channel.
- 3) Recalibrate or replace inclinometer.

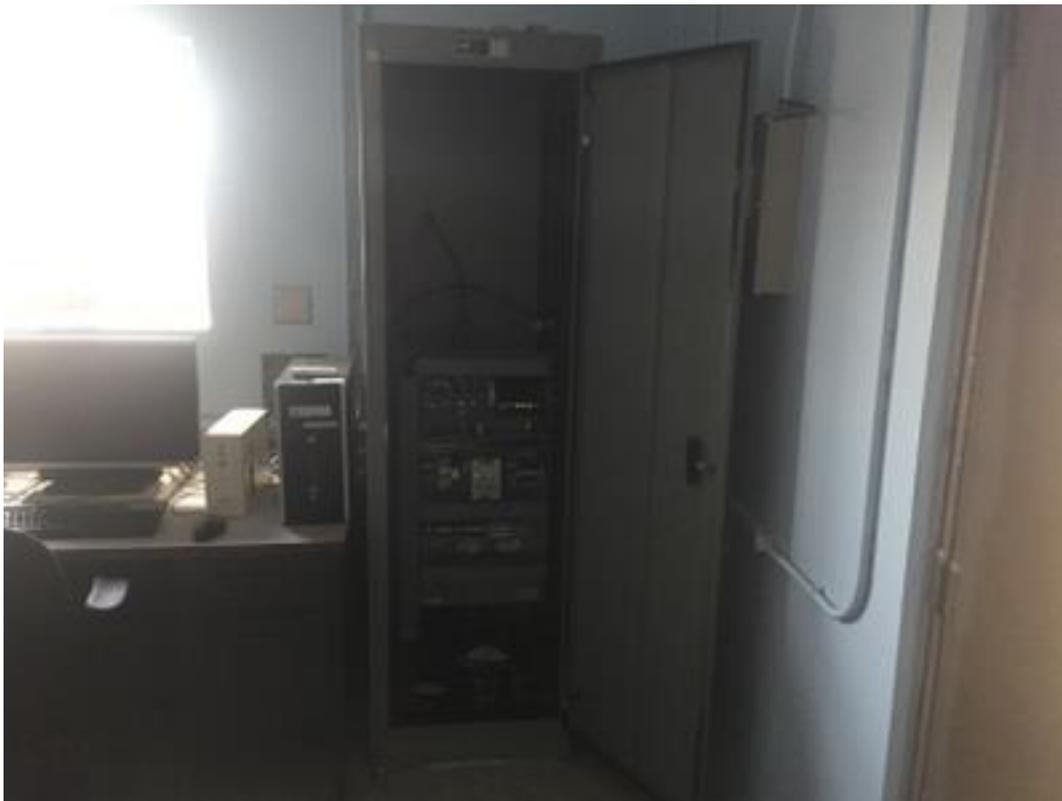
PHOTO 4 RADIO EQUIPMENT CABINET

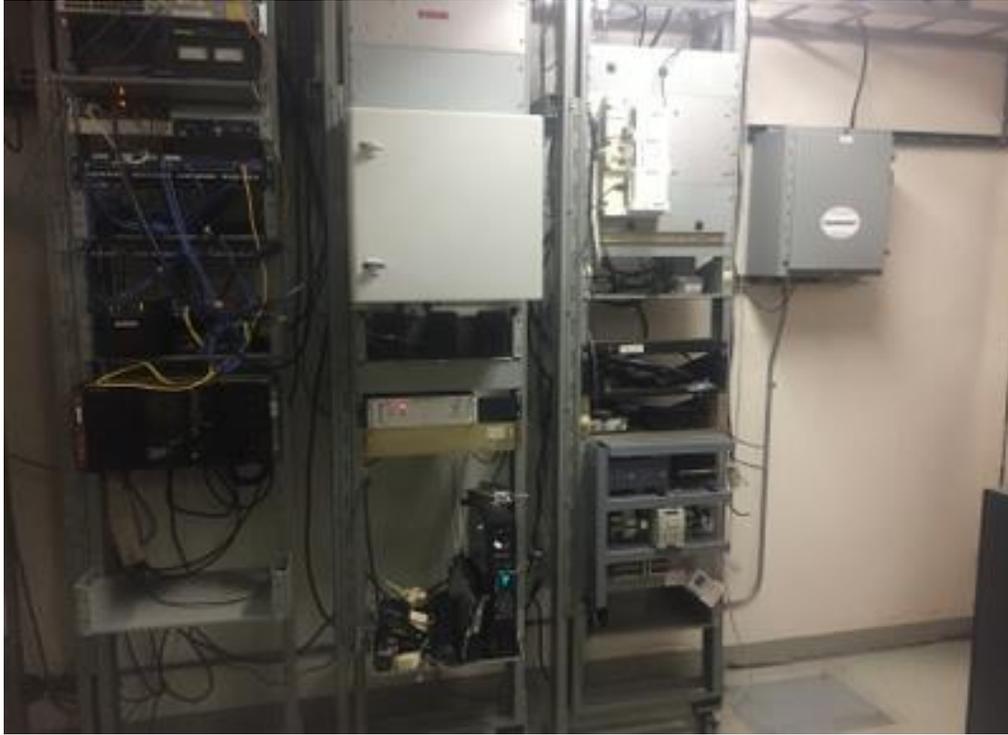
PHOTO 1 COMMUNICATIONS EQUIPMENT IN 12TH FLOOR PENTHOUSE

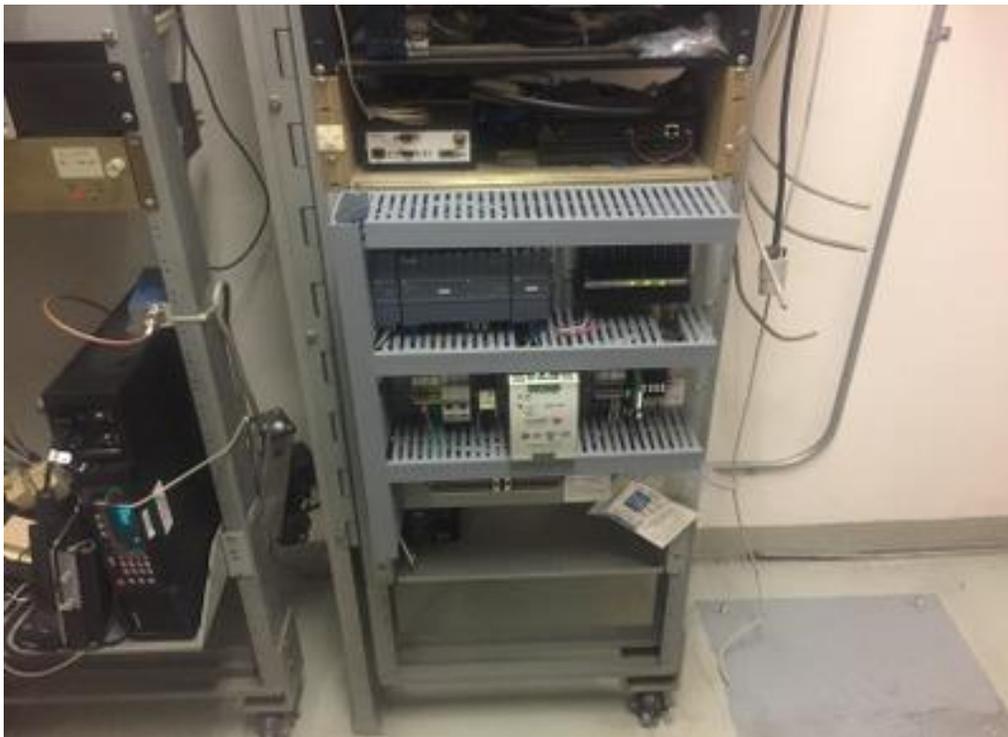
Radio - No problems noted.

PHOTO 2 RADIO DETAIL

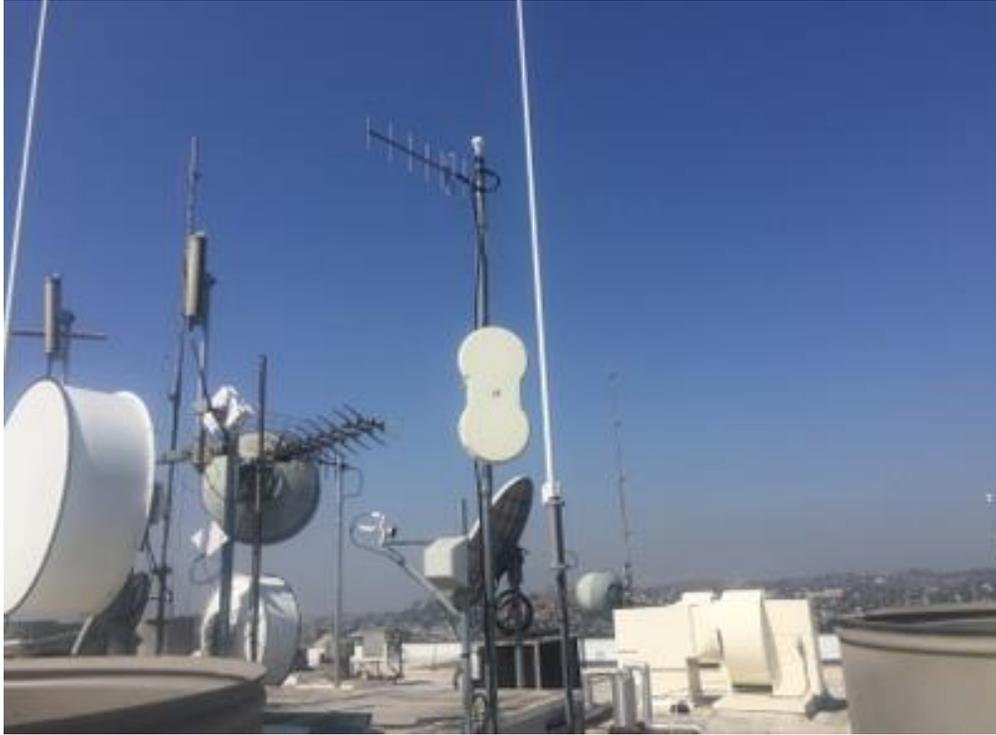
PHOTO 3

Antenna mast - No problems noted with either mast.

ANTENNA MAST

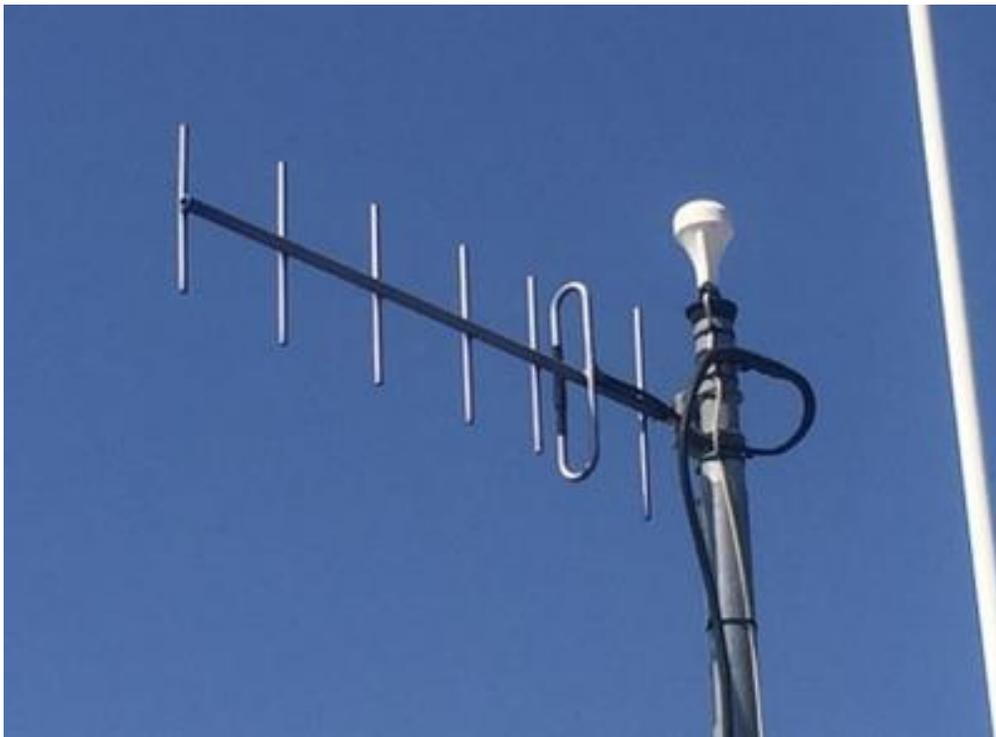
PHOTO 4

ANTENNA MAST DETAIL

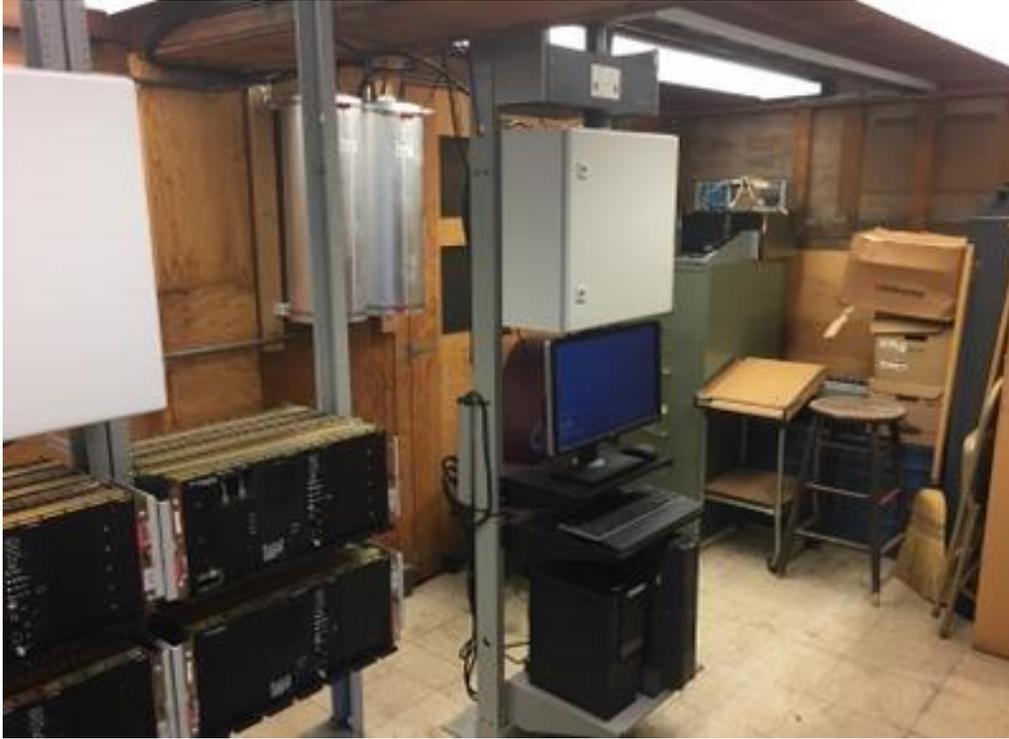
- Radio - No problems noted.
- PLC - No problems noted.
- Antenna - No problems noted.
- Antenna mast - No problems noted
- Cabling - No problems noted.

PHOTO 1 COMMUNICATIONS EQUIPMENT

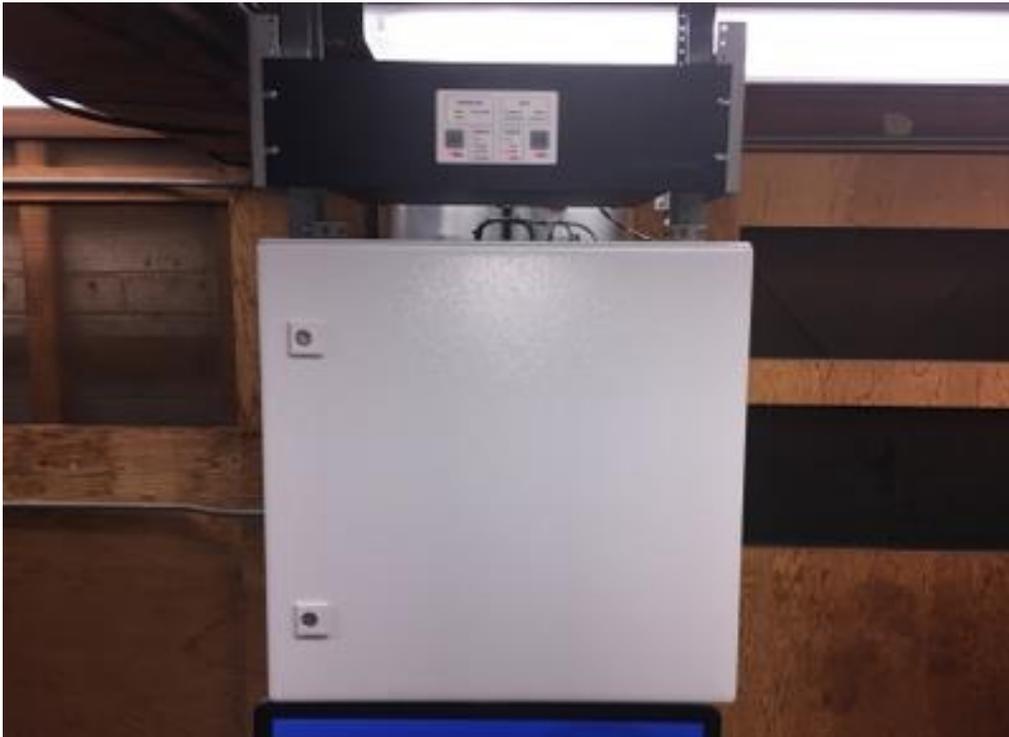
PHOTO 2 COMMUNICATIONS EQUIPMENT

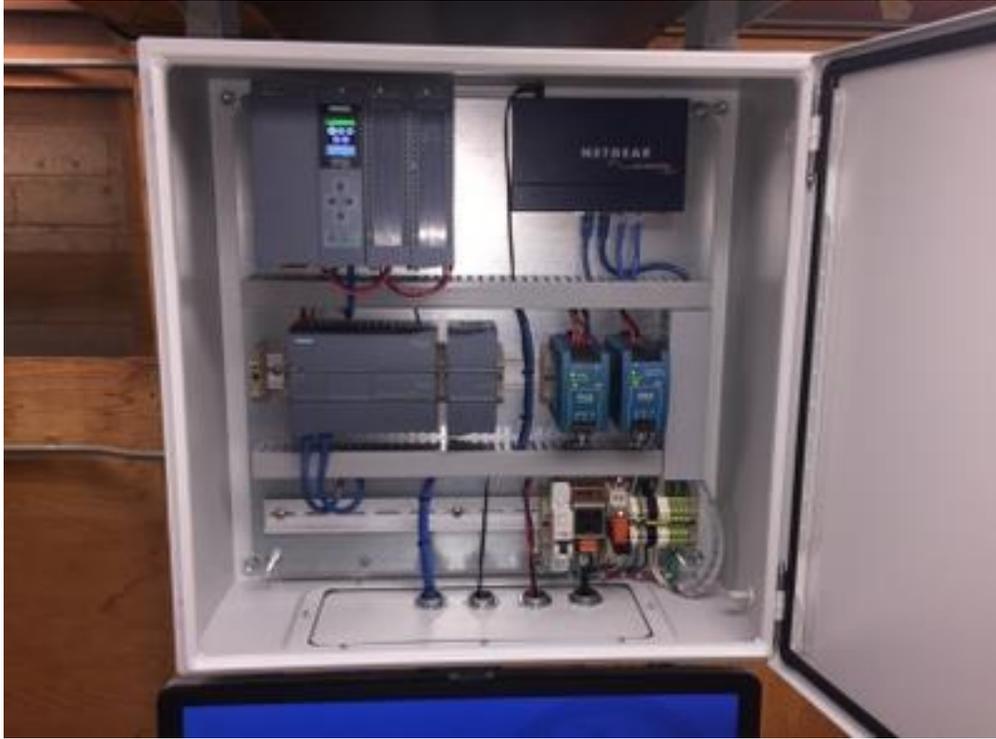
PHOTO 3 COMMUNICATIONS EQUIPMENT

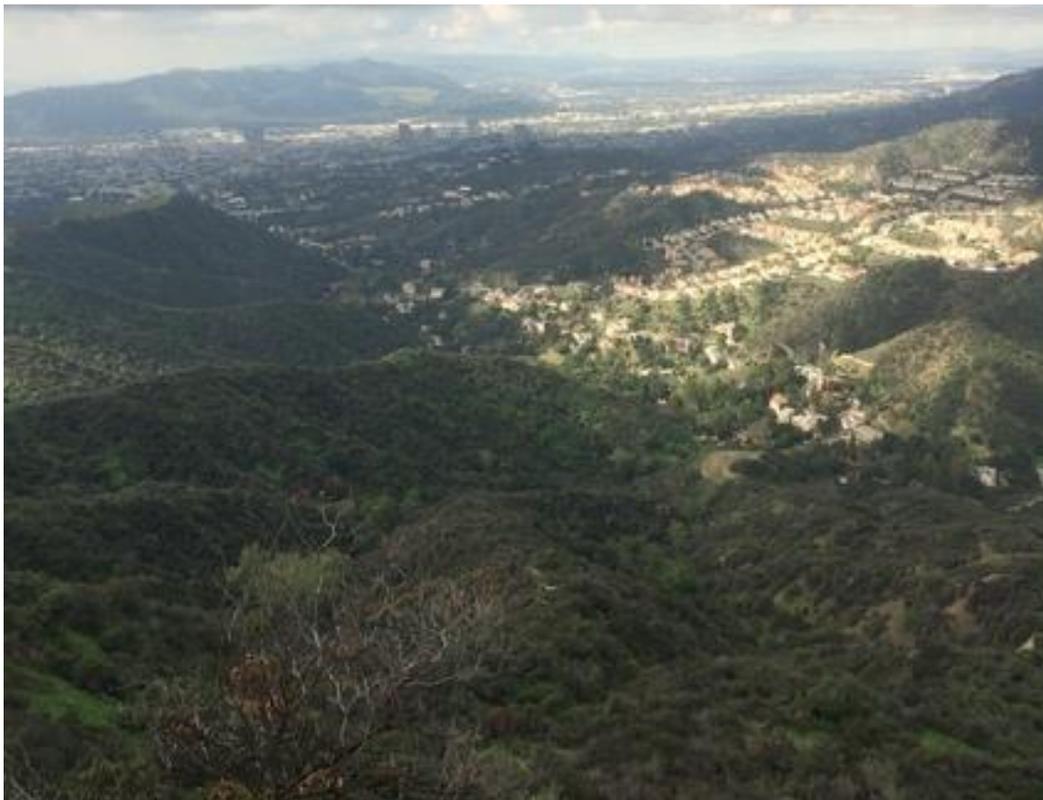
PHOTO 4 VIEW FROM FLINT PEAK REPEATER (2017)

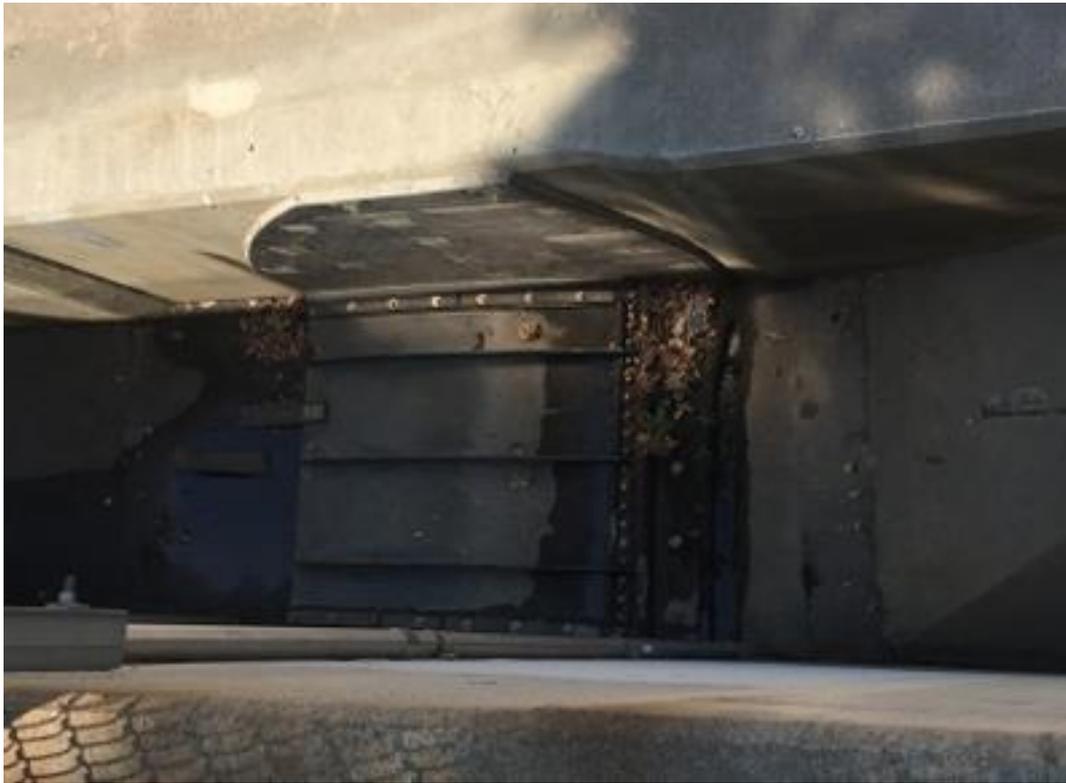
PHOTO 1

DEFLATED RUBBER DAM UPSTREAM VIEW
