**REPORT ON 2016-17 INSPECTION OF
LACDPW SCRDS FACILITIES**

**CONTRACT:STORMWATER CAPTURE RUBBER DAM
MAINTENANCE SERVICES (2014-IT001)**

AUGUST 20, 2018

RUBBER DAM INSPECTION REPORT

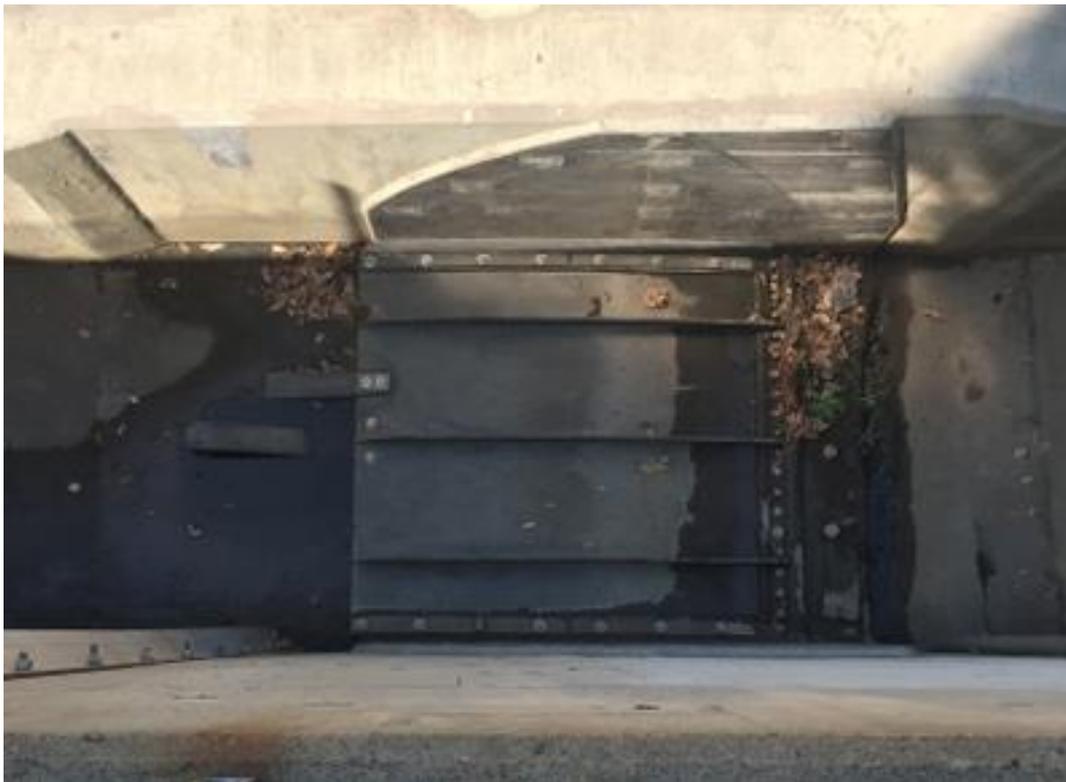
PHOTO 2

DEFLATED RUBBER DAM DOWNSTREAM VIEW

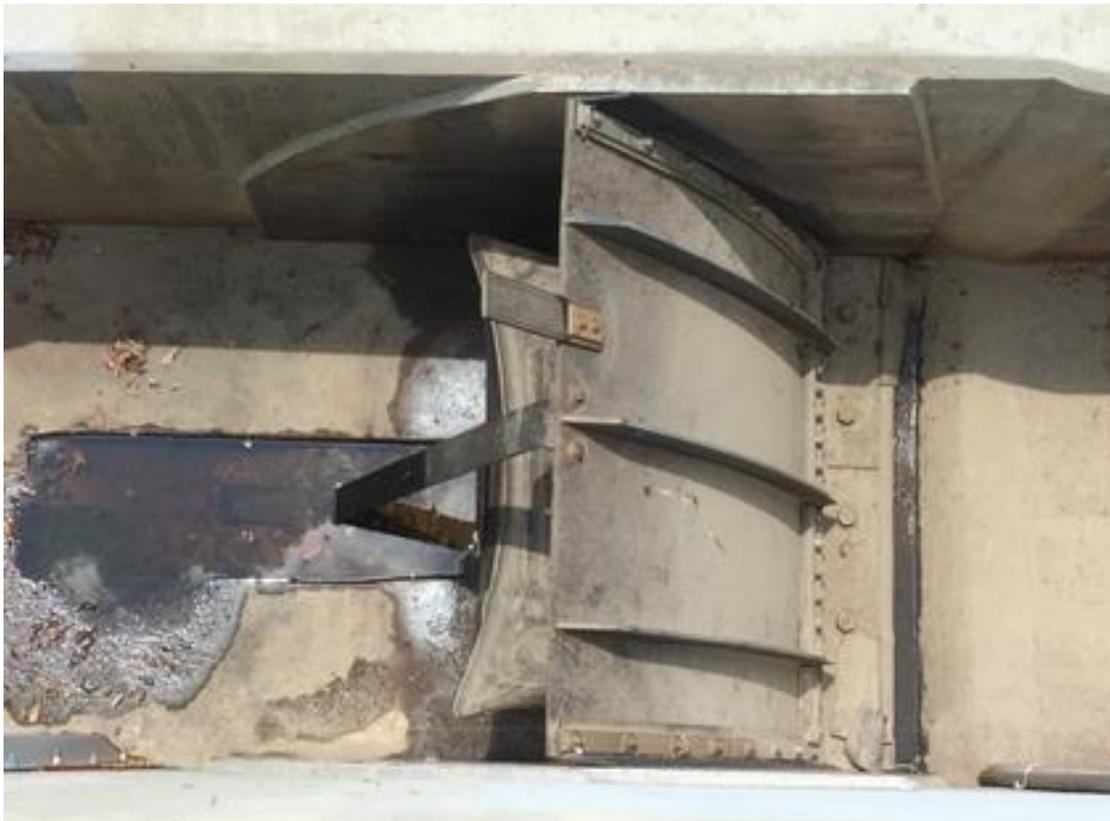
PHOTO 3 INFLATED RUBBER DAM UPSTREAM VIEW (2017)

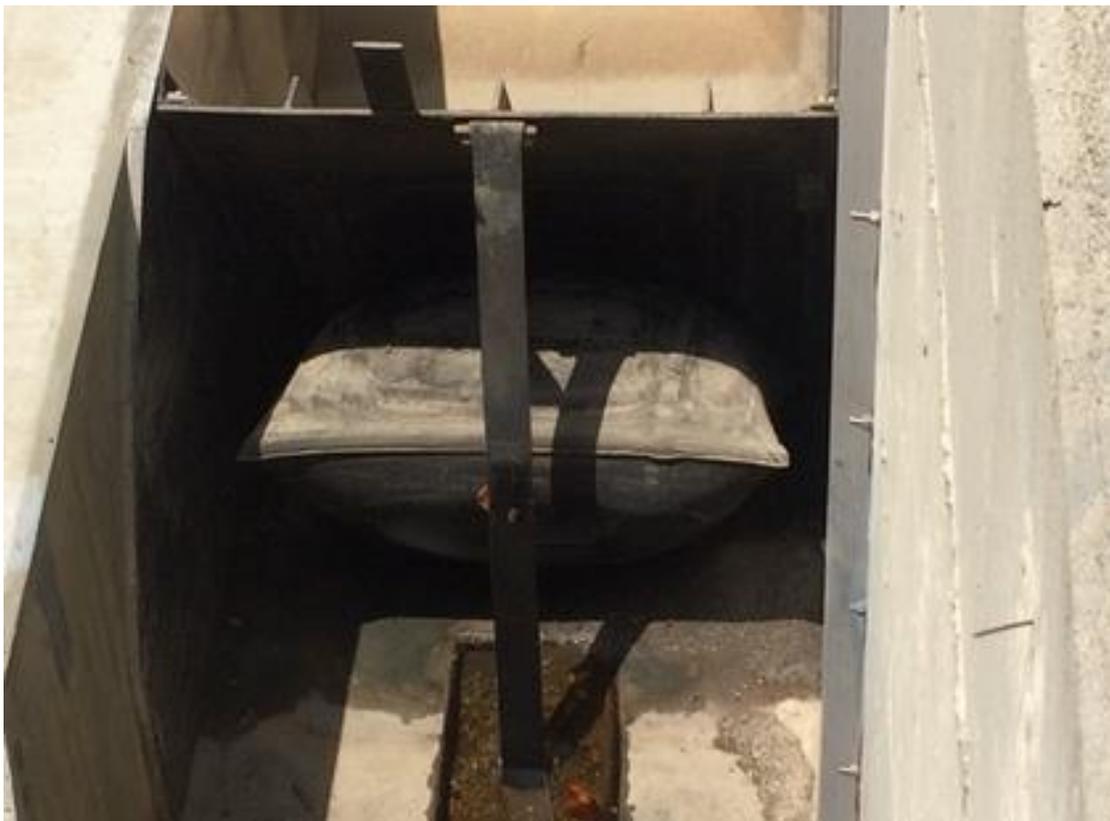
PHOTO 4 INFLATED RUBBER DAM DOWNSTREAM VIEW (2017)

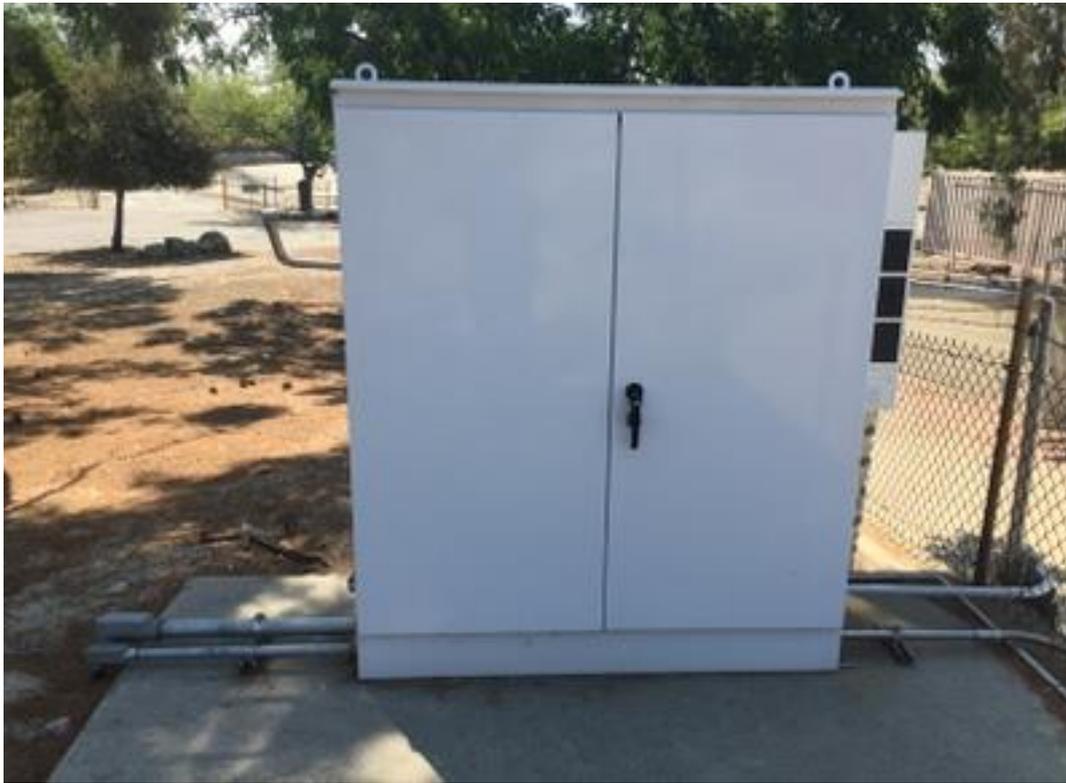
PHOTO 5 PLC CONTROL PANEL EXTERIOR VIEW

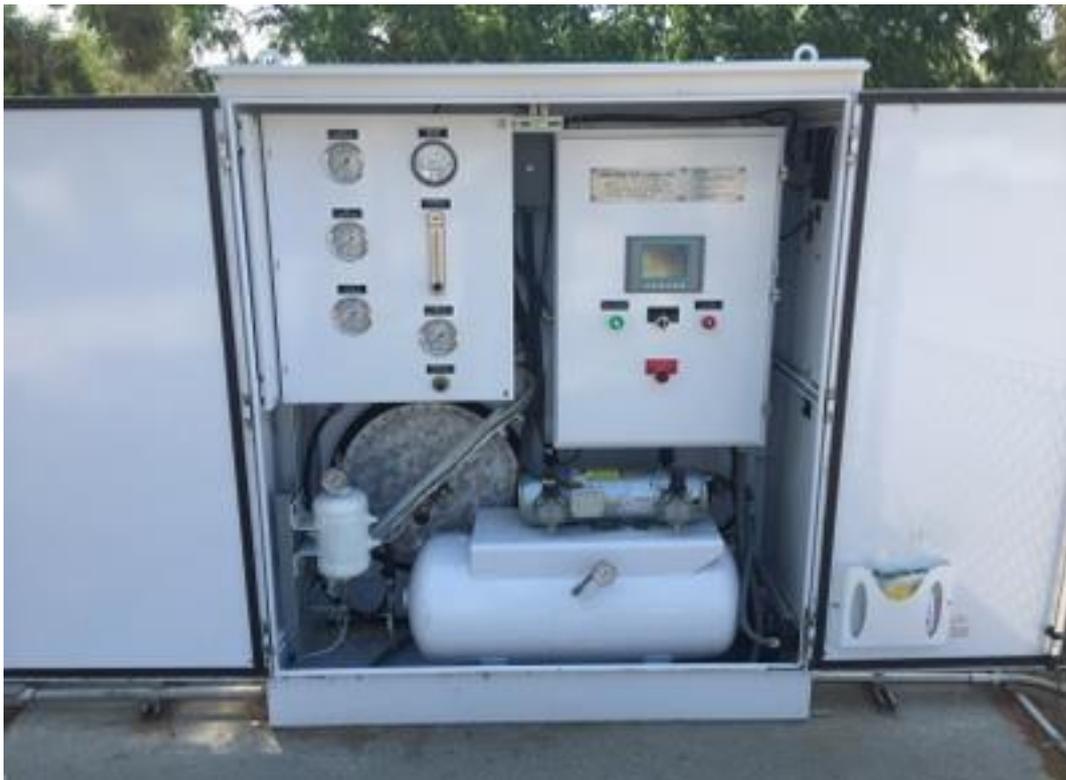
1) UPS battery fault alarm noted.

PHOTO 6 PLC CONTROL PANEL INTERIOR VIEW
